A preliminary assessment of potential barriers to fish migration in the Manawatu River catchment, North Island, New Zealand

A report prepared for Horizons Regional Council, June 2008

Dr Alex James and Dr Mike Joy

**Foundation of Research, Science & Technology
EnviroLink Contract Ref: 437-HZLC45**

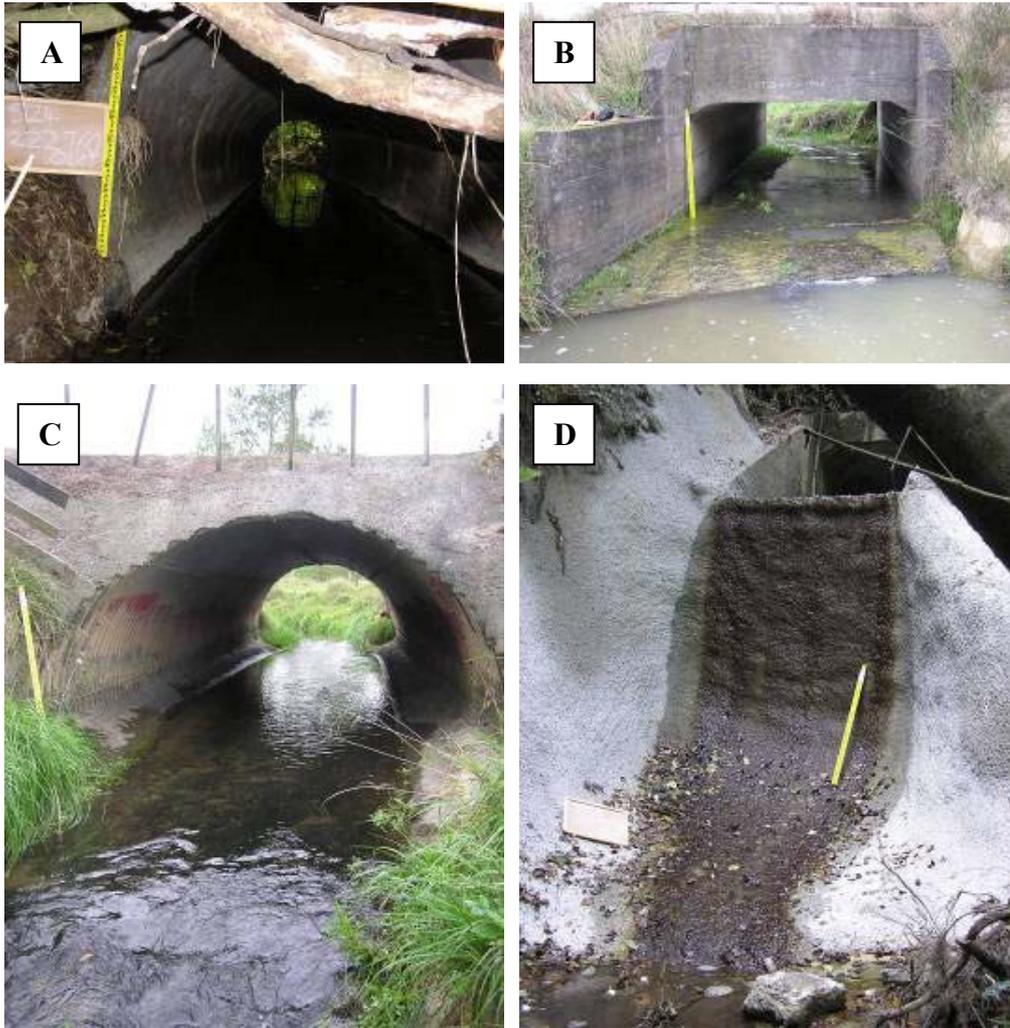
Figure 2. **A.** Culvert that may restrict fish passage at high flows. It has a smooth base, fairly deep water at low flow and would likely cause a velocity barrier at high flows. **B.** Culvert that may be a barrier to fish under low flow conditions because of the shallow water depth. **C.** Culvert that is unlikely to restrict fish passage. This culvert has a rough base and is a similar width to the stream channel. **D.** Culvert that impedes fish passage under most flows due to a perched outlet structure with a vertical wall.

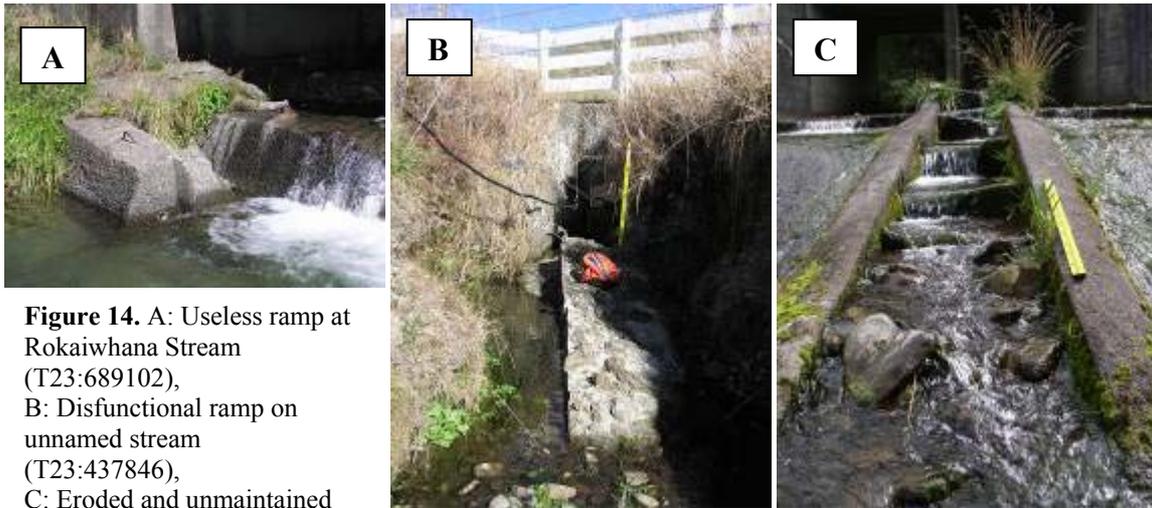
The vast majority of sites visited had no evidence of any pre-existing fish pass structures (Fig. 13). Unfortunately, none of the fish passes encountered appeared functional as they either had a concreted-up inlet (Fig. 14A), were eroded and high out of the water (Fig. 14B), or were eroded, blocked by debris and had perch heights greater than the main structure (Fig. 14C).

Figure 14. A: Useless ramp at Rokaiwhana Stream (T23:689102), B: Disfunctional ramp on unnamed stream (T23:437846), C: Eroded and unmaintained ramp on upper Manawatu River (U23:821241).

The remaining two structures are perhaps both the most difficult and highest of priority. On the upper Manawatu River is a large ramp and weir structure with an eroded and unmaintained fish pass up the middle (see pg 28). Upstream of this structure are the high quality forested headwaters of the Manawatu River in the Ruahine Ranges. The repair/alteration of the existing fish pass here may improve the ability of fish to move upstream of this structure. The other difficult structure is the double concrete block weir below a bridge over the Rokaiwhana Stream (see pg 29). This structure forms a waterfall complex where formerly there was none and again there is a significant area of high quality forested catchment upstream. There is also evidence of some old fish pass structures on the upper weir that are no longer operational. Given these weirs were likely built to prevent scour around the base of the bridge, then serious consideration is required at this site to ascertain what can be done to improve fish passage.

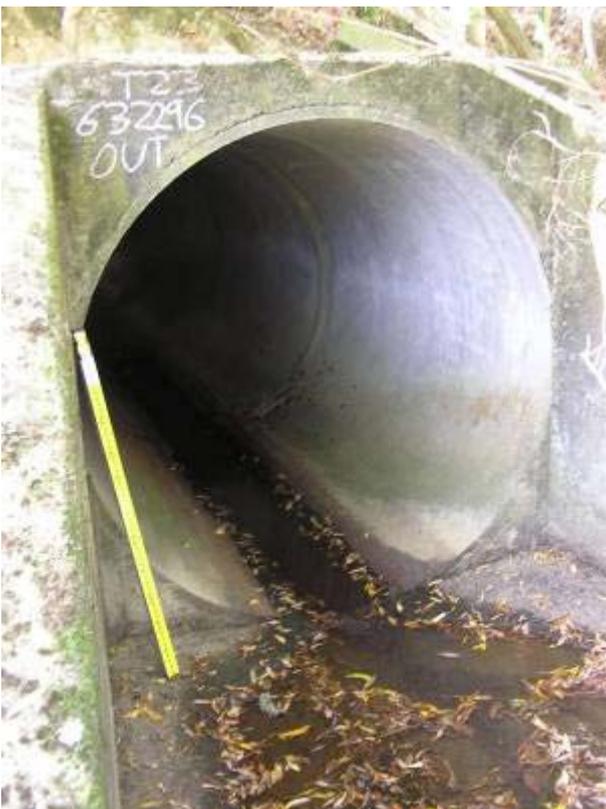
Below: Outlet.

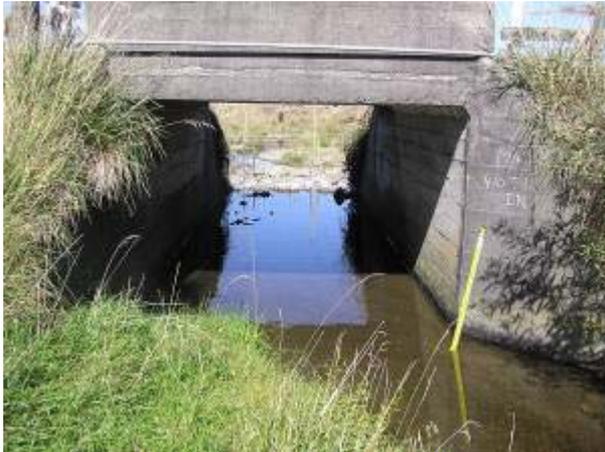
Potential as migratory barrier	Medium
Priority for remediation	High (easy fix)

Above: Inlet

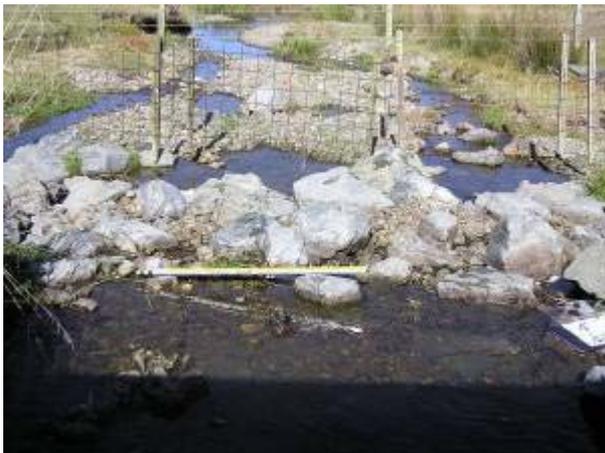
Below: Outlet looking downstream. Rocks have recently been dumped in an effort to repair a perched outlet.

Below: Outlet showing how a dam has been created during low flow period.

dam during low flow periods and prevents the passage of fish under such conditions (e.g. see pg 36).

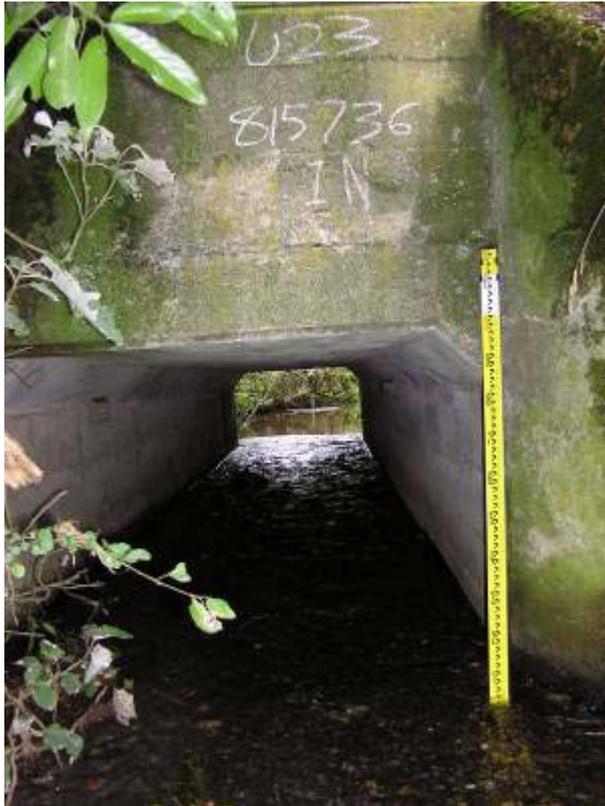
Potential as migratory barrier	Medium
Priority for remediation	High (easy fix, long length upstream)

Above: Inlet. Note that this culvert is incorrectly labeled in the photo.

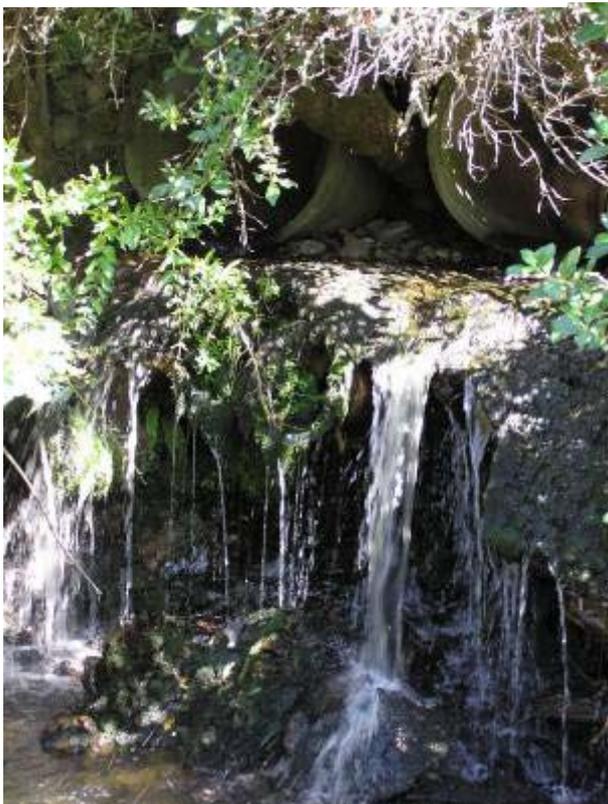
Below: Perched and undercut outlet.

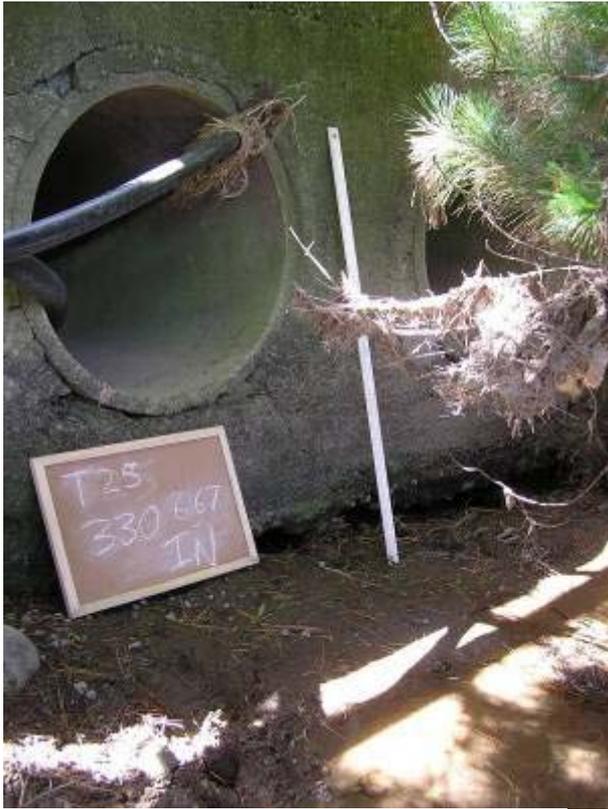
Potential as migratory barrier	High
Priority for remediation	Medium (difficult fix, forested upstream)

Above: Inlet well above substrate surface.

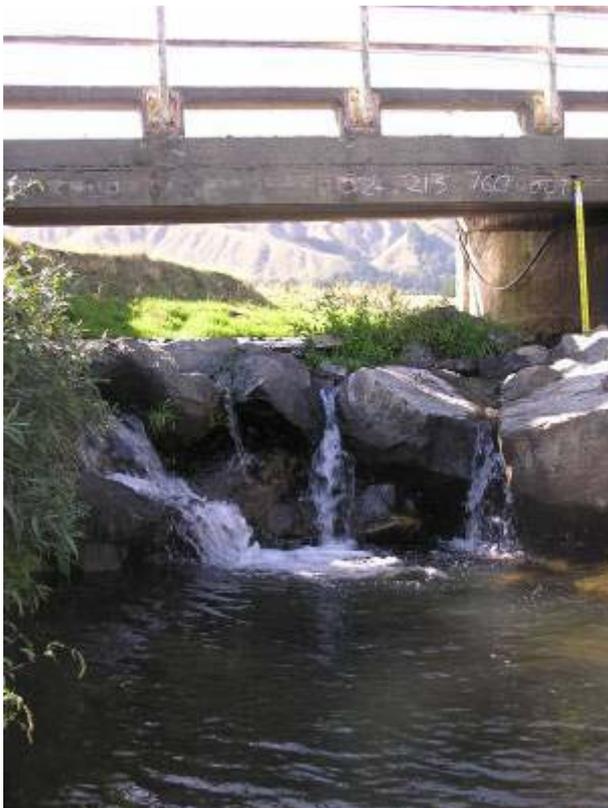
Below: Perched outlet.

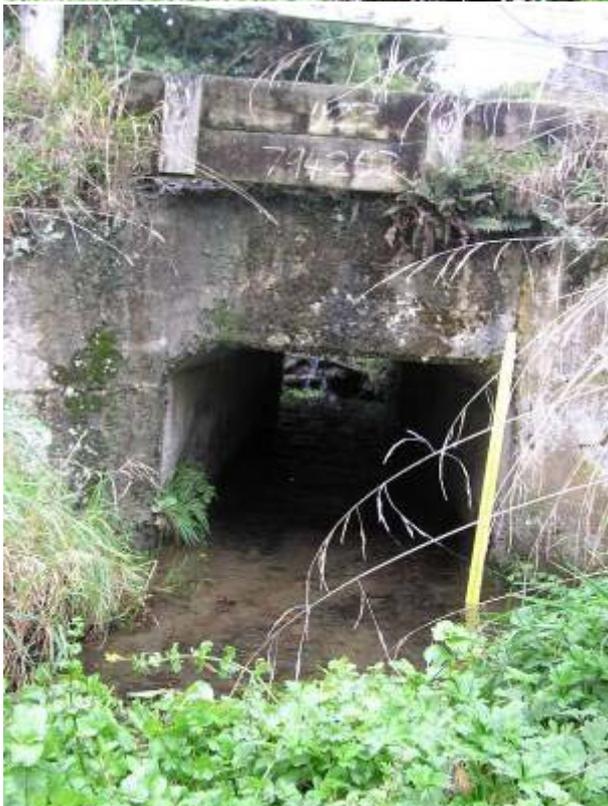
Below: Debris dam just upstream of inlet.

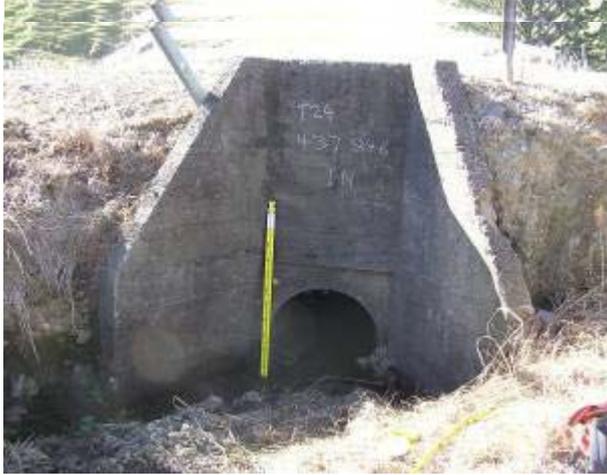
Potential as migratory barrier	High
Priority for remediation	Medium (difficult fix, degraded upstream)

Above: Inlet

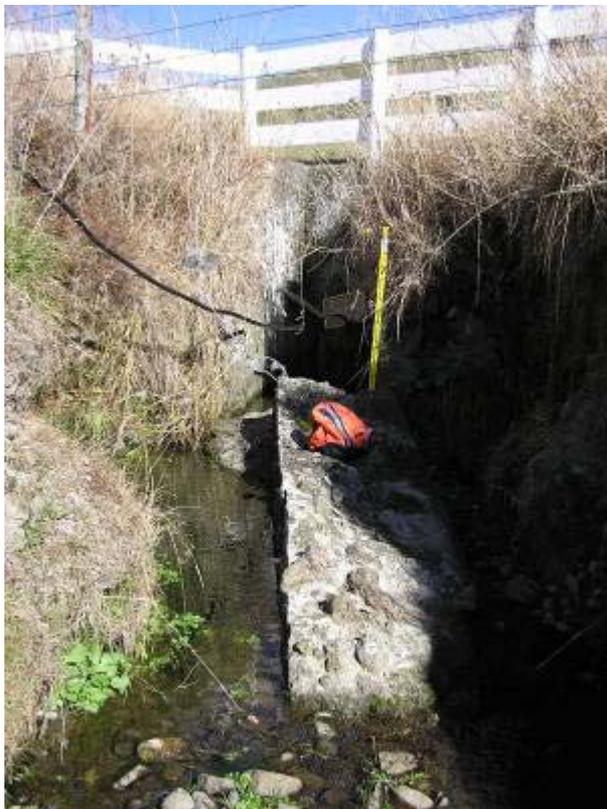
Below: Outlet showing long defunct fish ramp

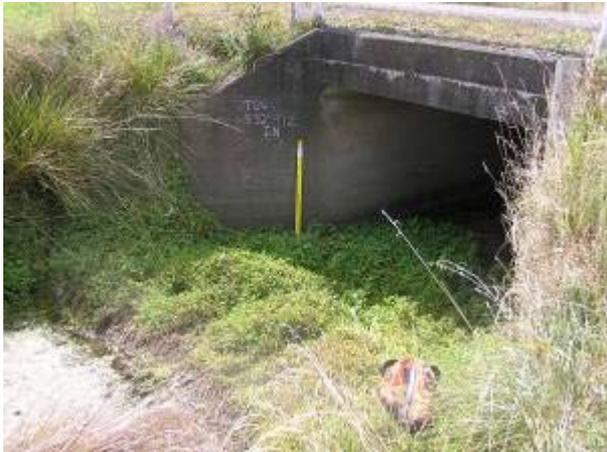
Potential as migratory barrier	High
Priority for remediation	Low (degraded and limited upstream)

Above: Inlet that is above the level of water flow at low flows.

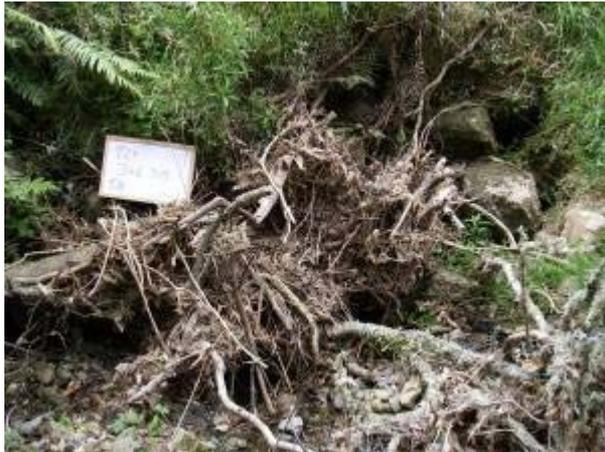
Potential as migratory barrier	High
Priority for remediation	Low (difficult fix, degraded upstream)

Above: Inlet concealed by debris.

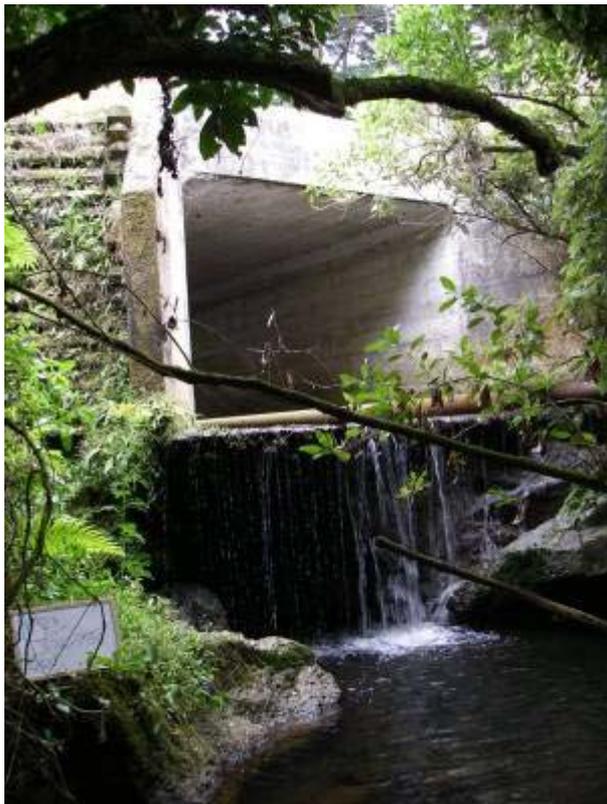
Below: Perched outlet. Note this photo is incorrectly labelled on whiteboard.

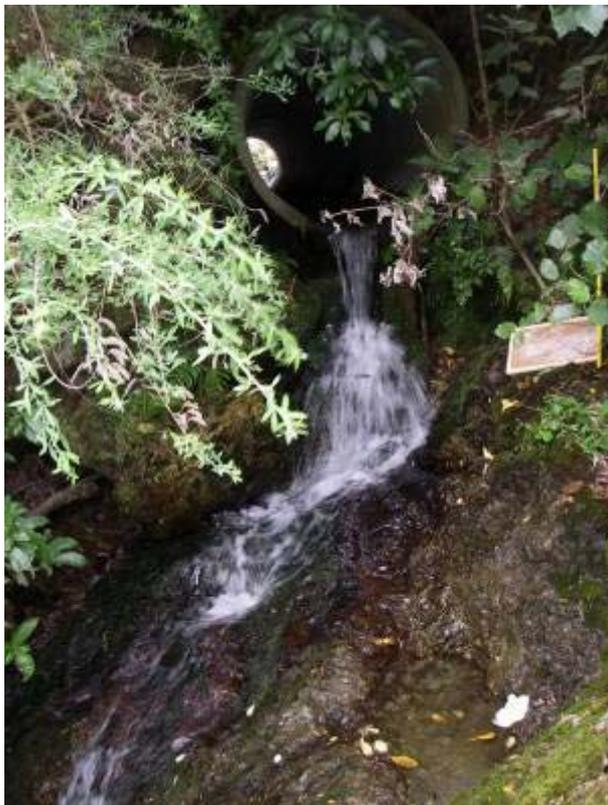
Below: Perched outlet.

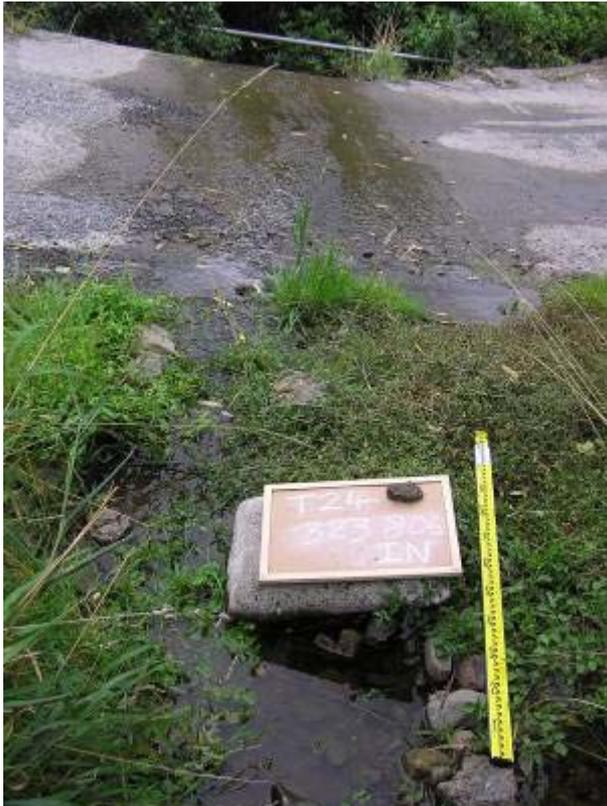
Above: Inlet with culvert totally buried by sediment.

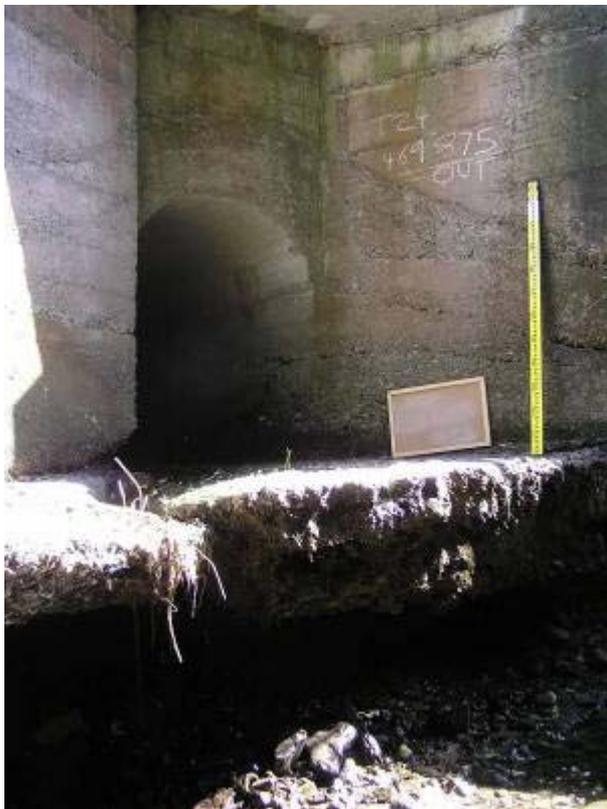
Below: Perched outlet.

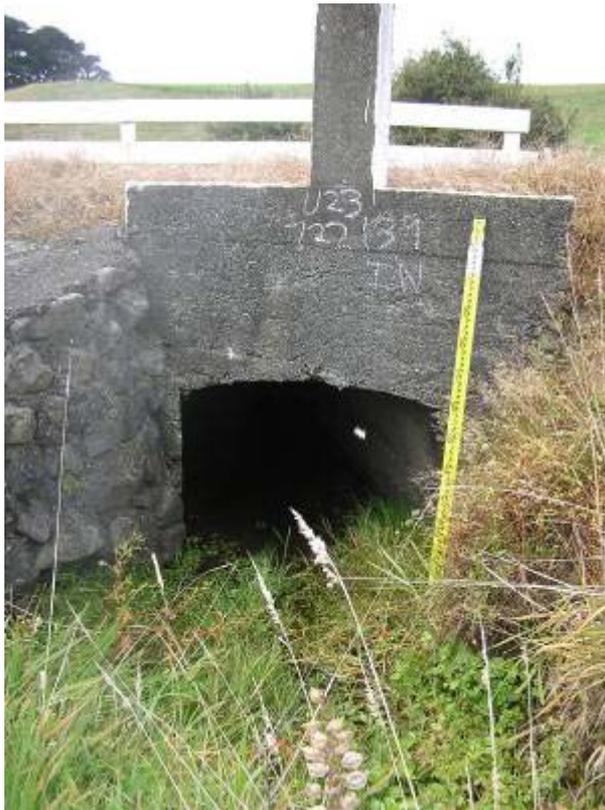
Potential as migratory barrier	High
Priority for remediation	Low (degraded upstream)

Above: Inlet.

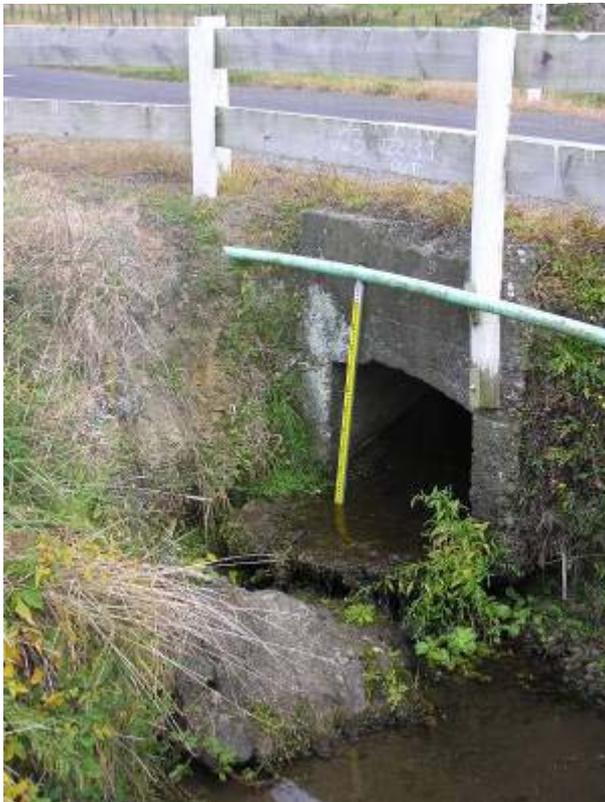
Below: Perched outlet with damaged fish ramp.

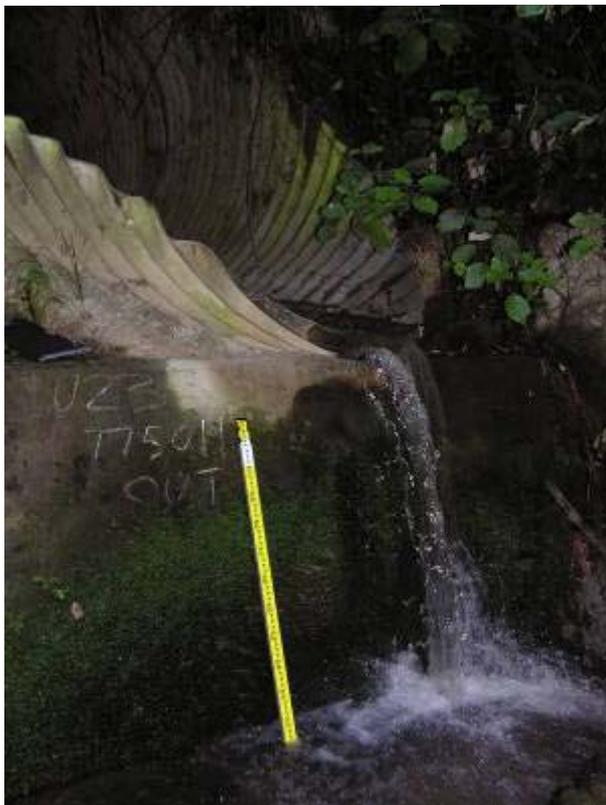
Below: Perched outlet.

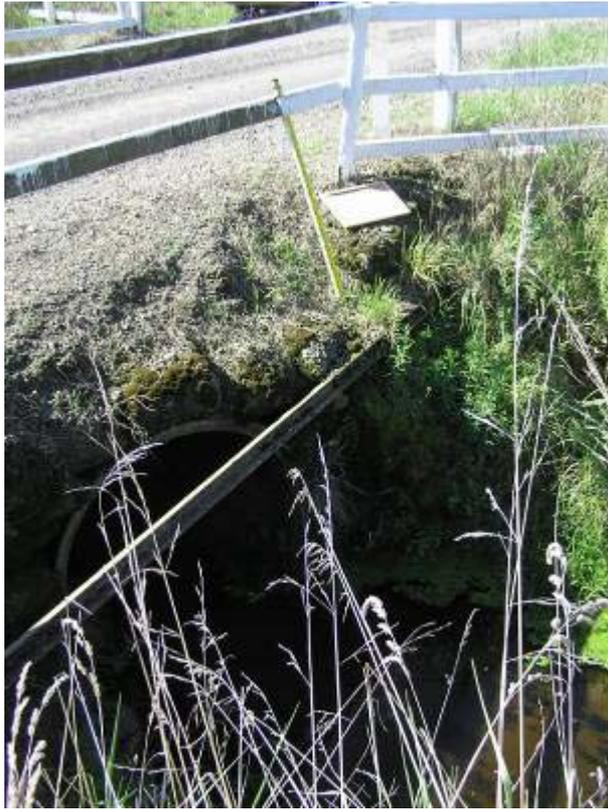
Below: Perched outlet.

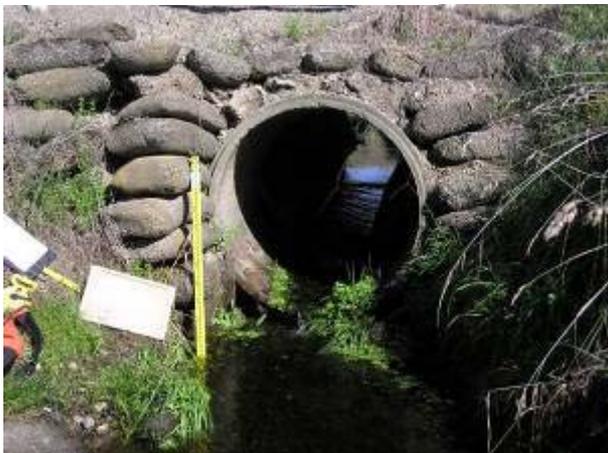
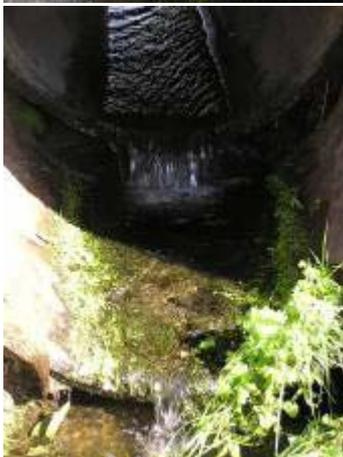
Left: Double perch due to broken pipe segment at outlet.

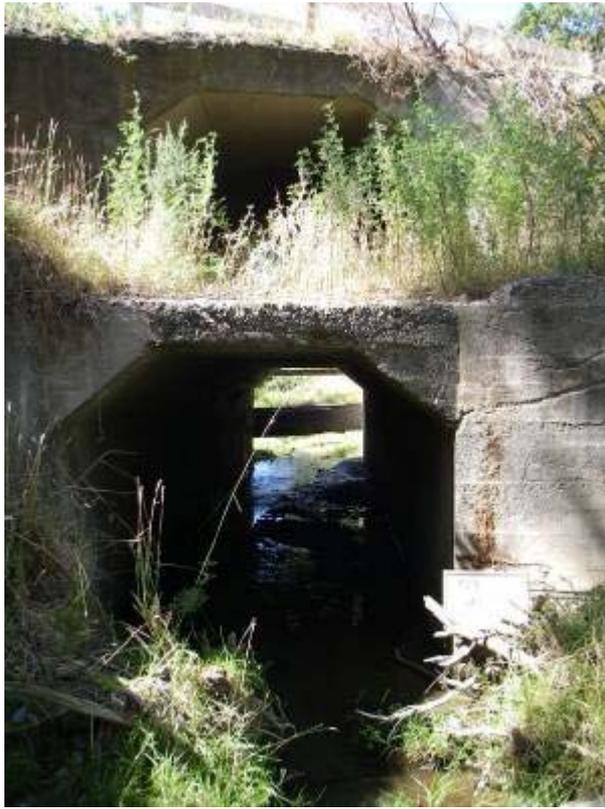
Above: Inlet. Note double decker culvert design. The culvert is a replacement for one destroyed in February 2004 flood event.

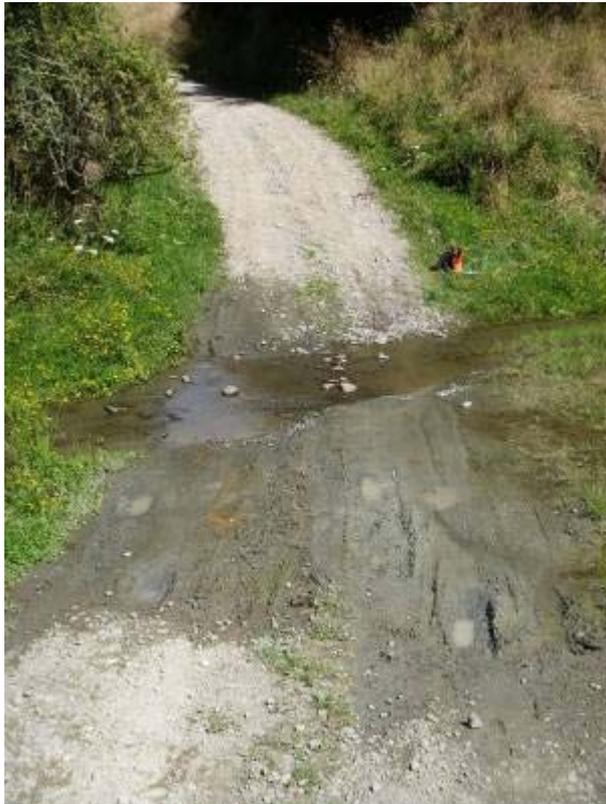
Above: Side view of this natural substrate ford
