# Successful fish passage past weirs

*An innovative fish-pass design allows small native fish to safely undertake their upstream migration yet does not interfere with hydrological measurements.*

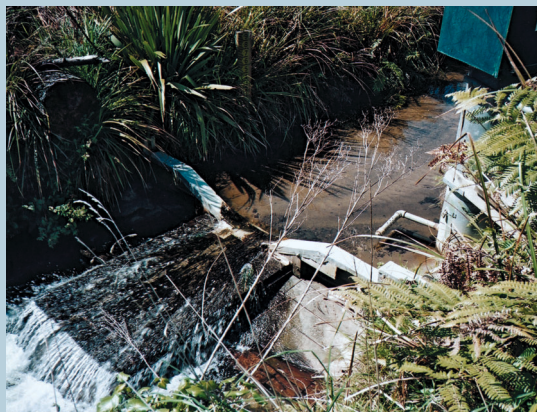
Initially, this pass seemed to work: fish thought to be inanga or smelt were seen above the weir between 1996 and 1998. However, during that period several large floods partially scoured out the stream bed directly below the weir. As a result, from time to time, the ramp was higher than the water level in the pool below the weir. Water spilling into the pool created an insurmountable barrier for small native fish.

water level above the bottom edge of the ramp. But in 1999, a large flood scoured out the streambed leaving a free fall of approximately 100 mm between the ramp and the pool (top photo, opposite). A fisheries survey carried out after this flood confirmed that the fish pass was no longer working. Action was needed to provide a more permanent solution.
