# EVALUATION OF IMPACTS OF HARBOUR ENGINEERING ANIBARE BAY, REPUBLIC OF NAURU

May 2003

SOPAC Miscellaneous Report 506

## EVALUATION OF THE IMPACTS OF HARBOUR ENGINEERING IN ANIBARE BAY, REPUBLIC OF NAURU<sup>1</sup>

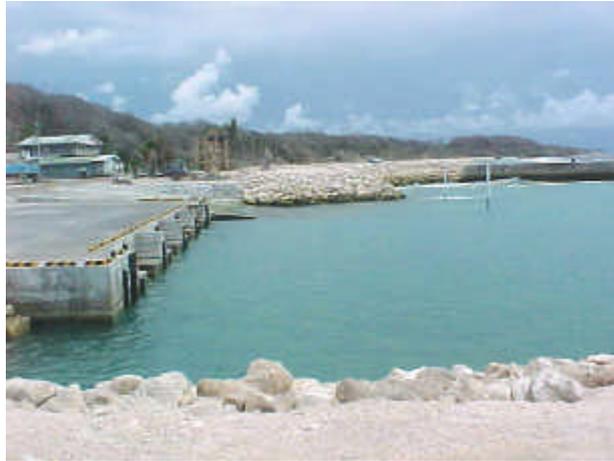
Figure 2. The harbour. Left – mooring basin/wharf, with quay wall and apron; top right – sub-breakwater; top center – rubble groin with rip-rap spending slope, lower center – rubble groin.

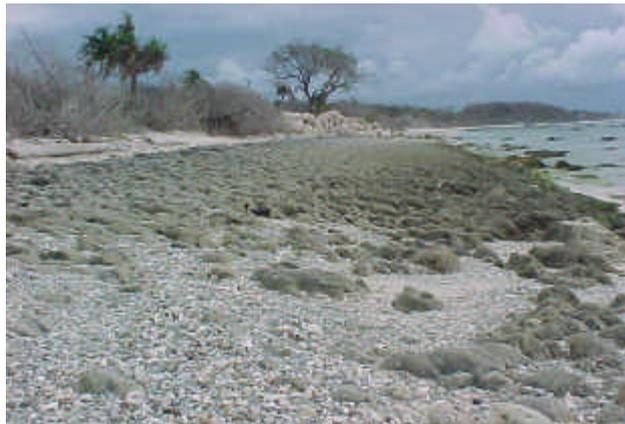
Figure 3. Beach morphology and erosion. Note exposed dolomite substrate on the lower beach and erosion at beach-land interface.

Figure 3 show some erosion characteristics of the beach. Rip-rap protection is being used for segments of eroding coast like this, South of the harbour site. This segment of eroding roadway developed during harbour development. Erosion scarps have exposed plant roots. Several shrubs fell on the beach at the site. Scouring of the upper beach and beach-land interface has exposed the underlying dolomite. This is common during EHWST, and is associated with Easterly wind waves and plunging breakers. One can see the typical scoured surface of the exposed limestone bedrock. Scouring became pronounced after construction. To date, the sand which was eroded has never recovered. The present erosion which has exposed plant roots, and is now threatening to erode the coastal road, behind the vegetation line. Eroded areas are also common along continuous segments of the beach, North and South of the harbour site. A typical 1.15 m high erosion scarp is present. One can observe large clumps of surficial soil, which toppled onto the upper beach. The beach fronting these scarp is typically narrow, with a thin sediment cover exposing the underlying dolomite. To arrest erosion, dolomite rip-rap was put in place. However, this has not stopped erosion of this local segment of coast, but has only transferred the erosion from that point, to areas just South of it. It is significant to note that the entire harbour facility acts as a large groin. With dominant longshore currents to the South, any facility built perpendicular to the shore, like this one, will result in aggravated erosion of coastal areas to the South. This is exactly what has already happened, and resulted in the erosion previously described. In addition, waves approaching from the East also cause some diffraction of surf around the facility and therefore, to the North and to the South. Consequently, areas immediately North of the harbour has be affected by erosion and has lost beach sediments. Such diffraction

Eroding sections of the coastline need to be protected immediately, if erosion is to be arrested or reduced. If eroding coasts at the harbour site is left un-protected, it will cause further loss of coastal soils, beach sediments and damage to the adjacent road or other infrastructure. Protection strategies should be for the immediate and medium-long term.

A bio-engineering system should be employed. To prevent overtopping of coastal areas, a rip-rap system could be utilized along the edge of the coastline. Biological protection by planting locally coastal tree and shrub species would be best, to select flora which are adaptable to the existing micro-climate. The use of geotextile or bio-erosion mats, like coconut fibre mats, for scour control, is recommended and should be appropriate for the hydraulic and tropical UV conditions. The local dolomite is suitable for coastal protection, because of high density. Rip-rap should be sized based on actual wave hydraulics. All design should be performed by a competent professional. A coastal monitoring programme should be put in place to periodically assess any changes to the coastline at the harbour site. Monitoring will facilitate rapid repair to damaged infrastructure and eroding coasts. Monitoring should be beach profiling, beach sediment sampling and coastal littoral hydraulic assessment. Visual inspection of failure characteristics and wave run-up should be documented and photographed when they occur. This monitoring should be at least quarterly in the first 3 years, which can be decreased to twice yearly thereafter. The coastal monitoring data should be reviewed as soon after collection, and coastal management strategies modified/revised to reflect any changes or new developments Beach profiles and surveys should be levelled from Nauru's national surveying benchmarks. The data collected should be archived in a database for easy access and retrieval. Future coastal developments should be preceded by an environmental impact assessment (EIA), to minimize similar negative impacts.
