**WAITANGI
ESTUARY
ECOLOGICAL
MONITORING
2006**

**June 2007
EMI 0709
HBRC Plan No. 3948**

Environmental Management Group Technical Report

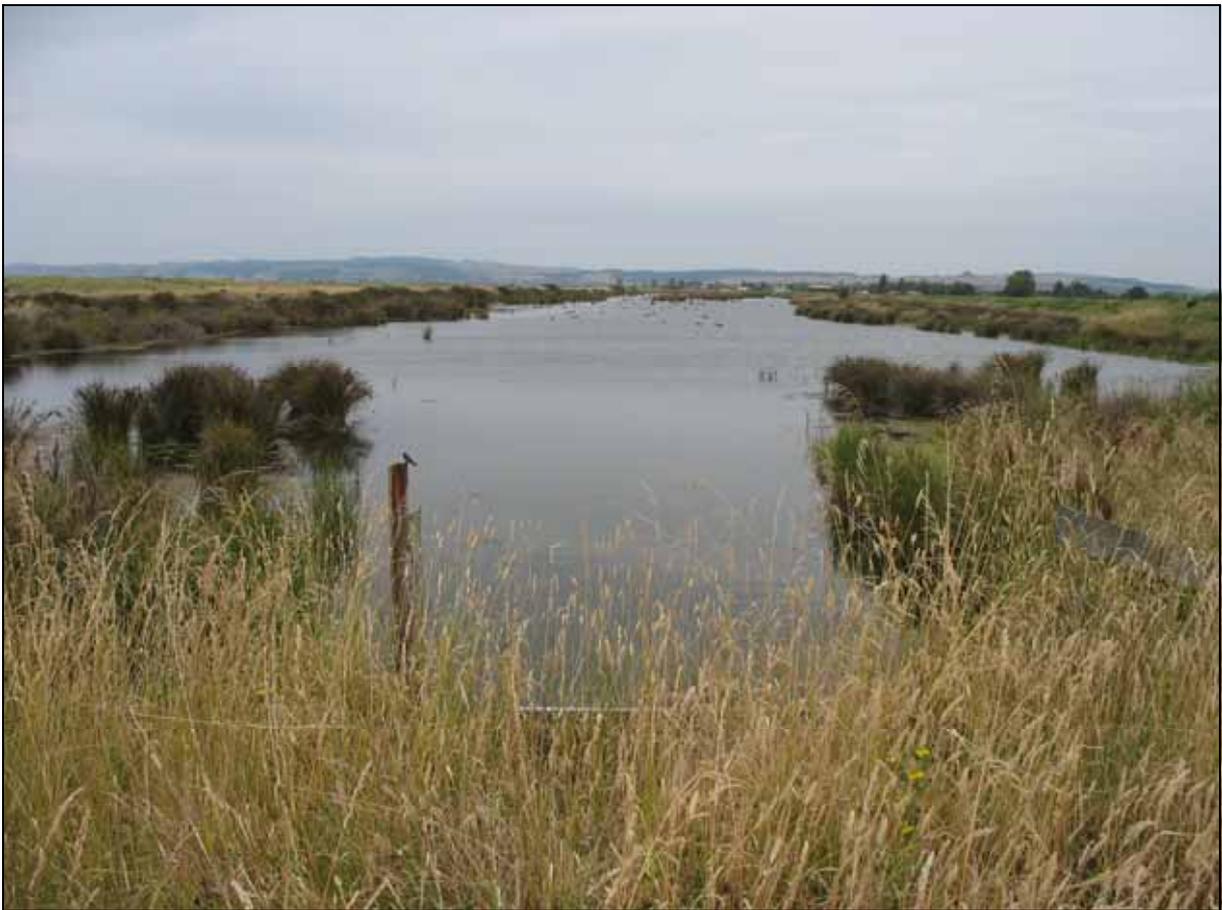
Cover photo: Muddy Creek on the south side of the causeway. A slow moving stretch of Muddy Creek above the flood gate on the causeway. The area is home to a great number of water birds and indigenous plants including a good population of the threatened plant *Mimulus repens*. The causeway culverts are barriers to inanga.
