## Identification of major sediment sources in the Motueka River

# **Identification of major sediment sources in the Motueka River**

Motueka Integrated Catchment Management  
(Motueka ICM) Programme Report Series

**Les Basher, Mike Marden, James Barringer,  
Heather North**

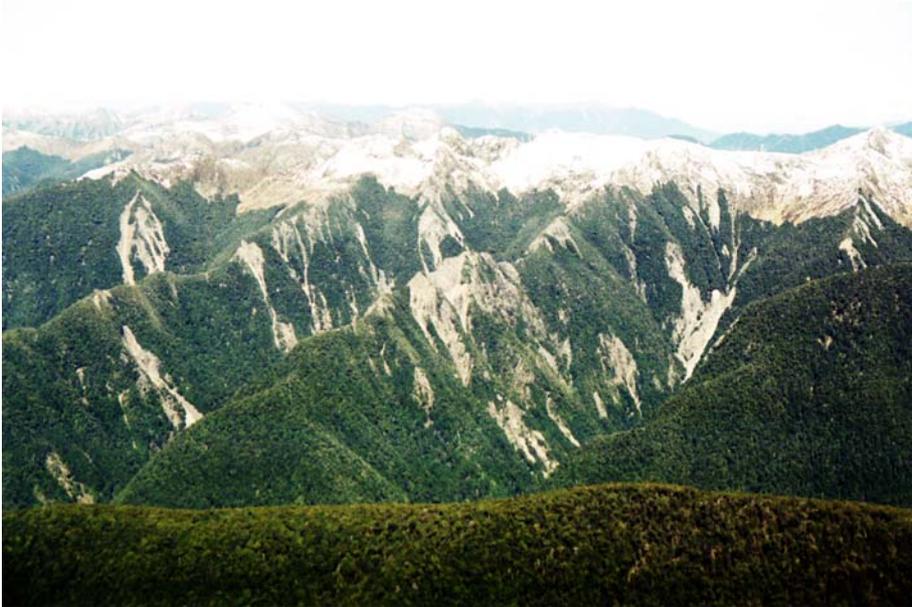
High areal density of landsliding is restricted to a very small area of the catchment in the north branch headwaters of the Wangapeka River (Fig. 1). Here there is a very high density of debris slides, often extending from ridge crest to valley bottom and characterised by complete failure of the

regolith and exposure of bedrock<sup>1</sup>. Rocks are mapped as Greenland Group sandstone, siltstone and mudstone. These landslides appear similar in form and age to the abundant landslides in the Matiri and Karamea Rivers formed during the 1929 Murchison earthquake (Pearce and O’Loughlin 1985; Pearce and Watson 1986).

Fig. 1 High density of landslides in the north branch headwaters of the Wangapeka River

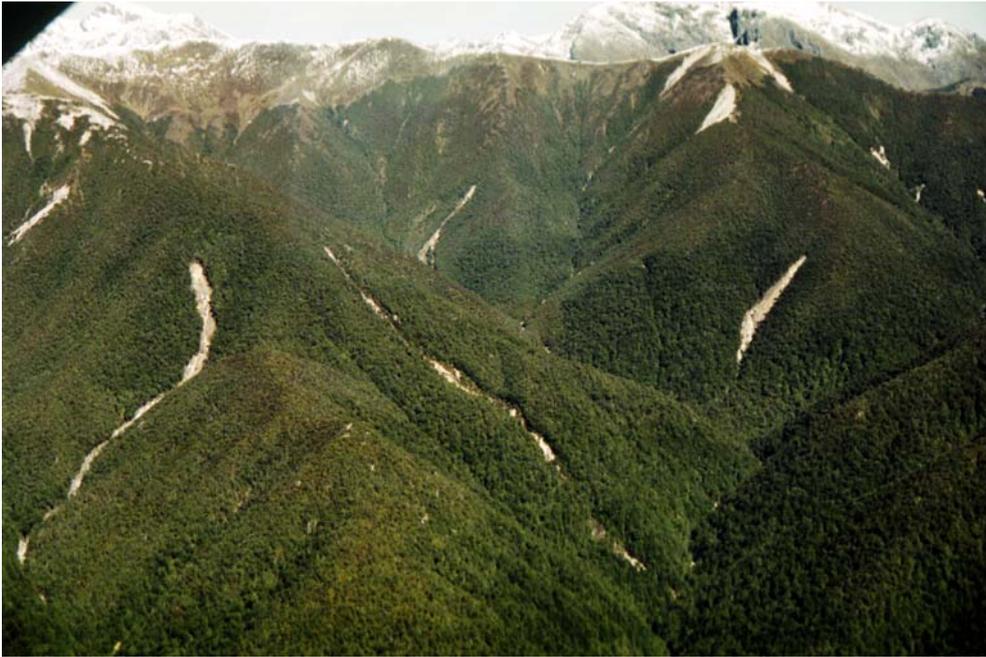
Throughout the rest of the Wangapeka there was a low density of landsliding, including the Dart catchment on Separation Point granite (Fig. 2), which has frequently been suggested as a major contributor of sediment. The landslides and riparian sources (Fig. 3) observed in the Dart catchment were dominantly in areas under native forest rather than pine. The Baton, Pearce, Graham and Pokororo catchments had an extremely low density of landslides (Fig. 4).

Fig. 2 Low density of landslides in upper Dart River in native forest

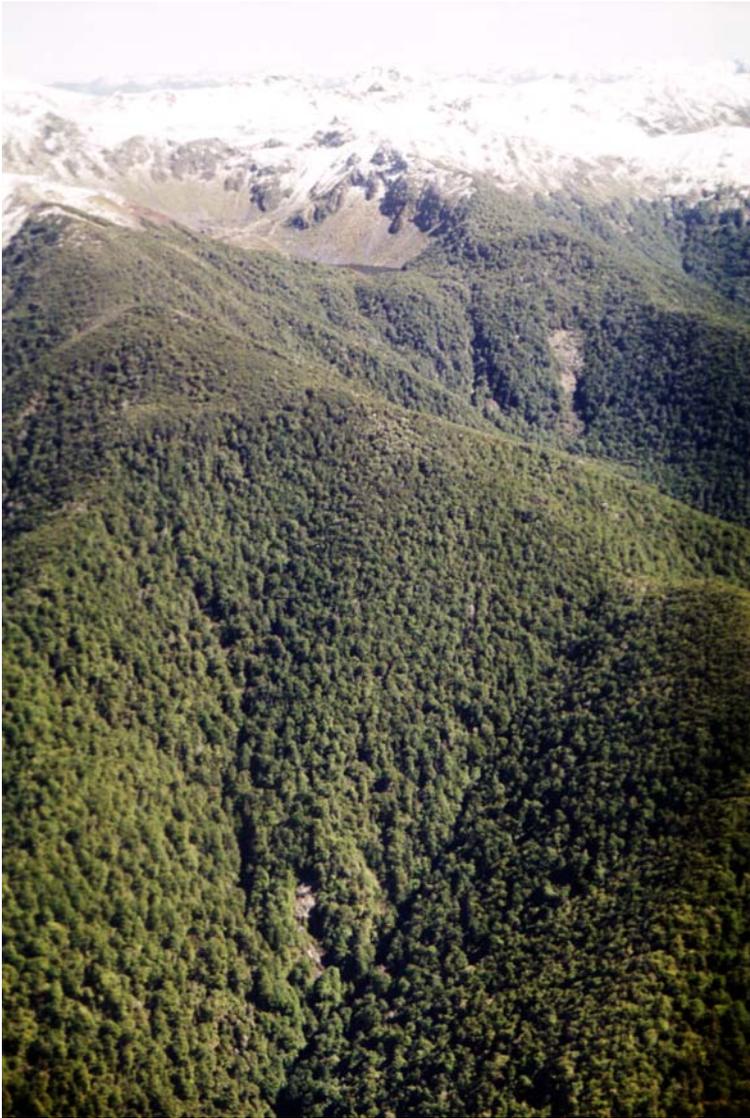
Fig. 4 Upper Baton River, very low density of landslides

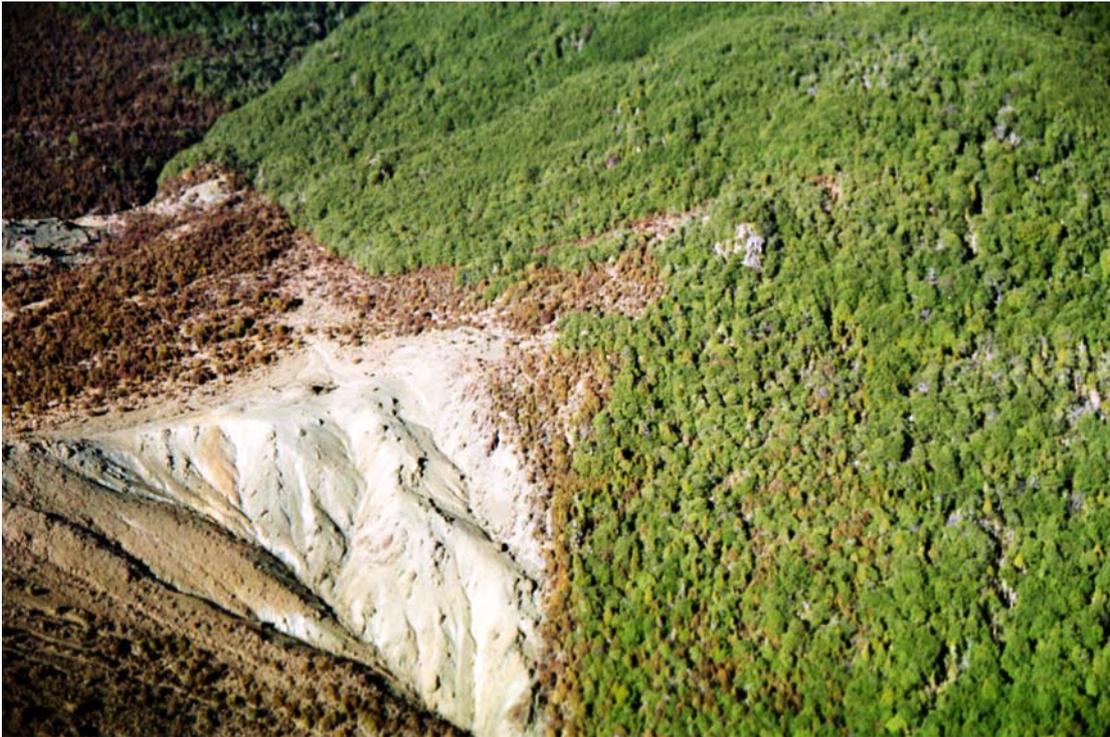
The upper Motueka River (above Blue Glen Creek) has considerable evidence of active erosion on ultramafic rocks, in the form of gullies, landslides, and extensive bare ground subject to surface erosion by wind and water (Figs. 5 and 6). Gullying is extensive and occasionally severe (Fig. 5). Areas underlain by Maitai Group sediments appear far more stable, are dominantly forested, lack gullying and have a low density of landslides. Recent active sedimentation of stream channels is prominent (Fig. 6).

Fig. 5 Severe gullying of ultramafic rocks in upper Motueka; note the contrast with forested Maitai Group sediments to right of the photo.

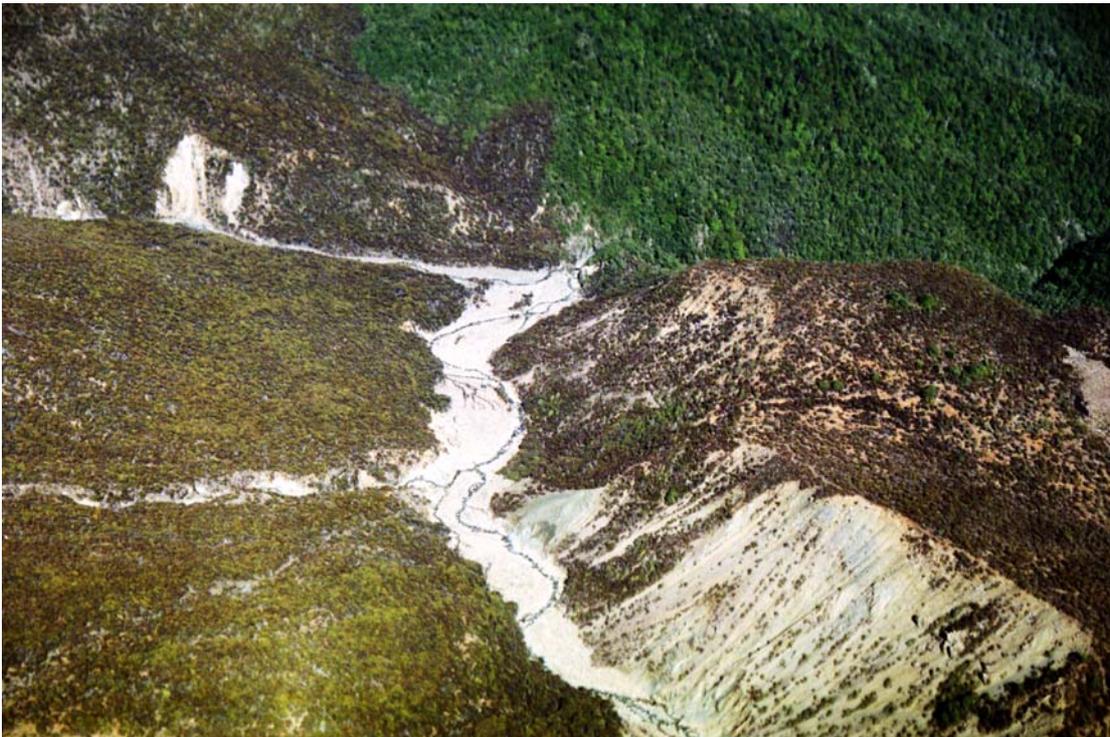
Fig. 6 Active gullying, bank erosion and surface erosion in upper Motueka. Note the active sedimentation of the stream channel and the contrast in vegetation cover and erosion with the Maitai Group sediments in the background of the photo.

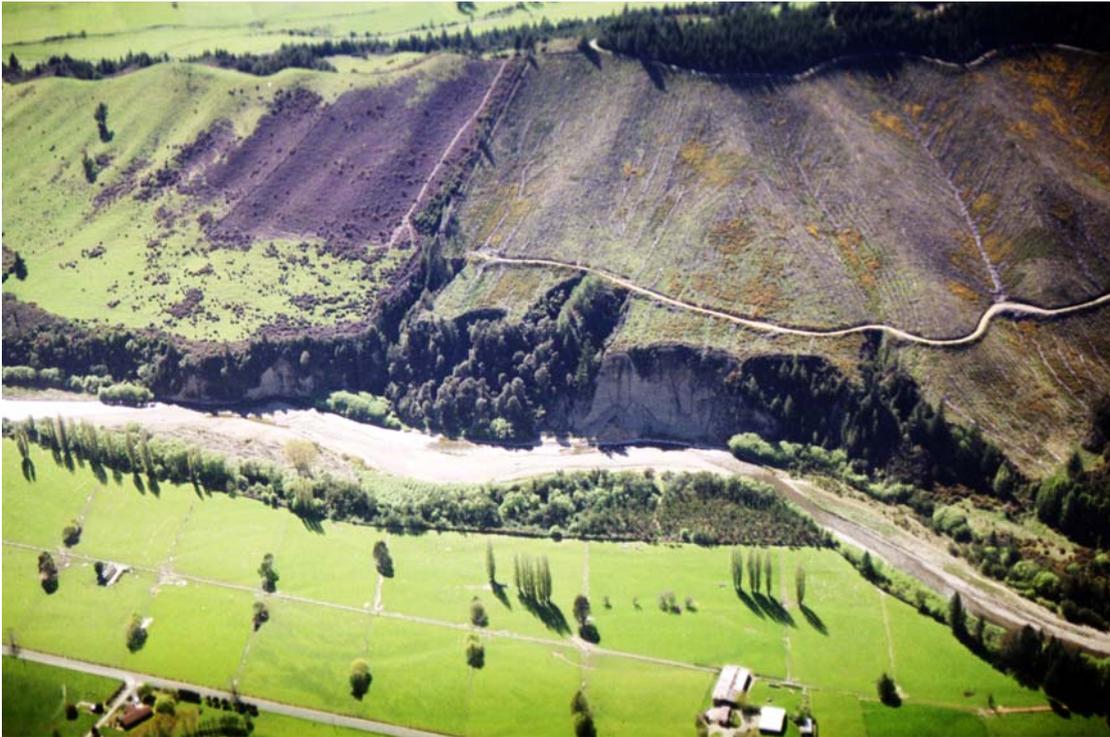
The large sources occur where the larger streams are incised into Moutere gravels, and often form cliffs 50–100m high (Fig. 7). They are probably old, natural landscape features that exhibit a range of activity. Some form vertical cliffs with little debris at the base and appear relatively stable. Others have gullied faces with debris cones at the base, indicating they are more active (Fig. 8).

Fig. 7 Severe bank erosion in the Motupiko River near Quinneys Bush

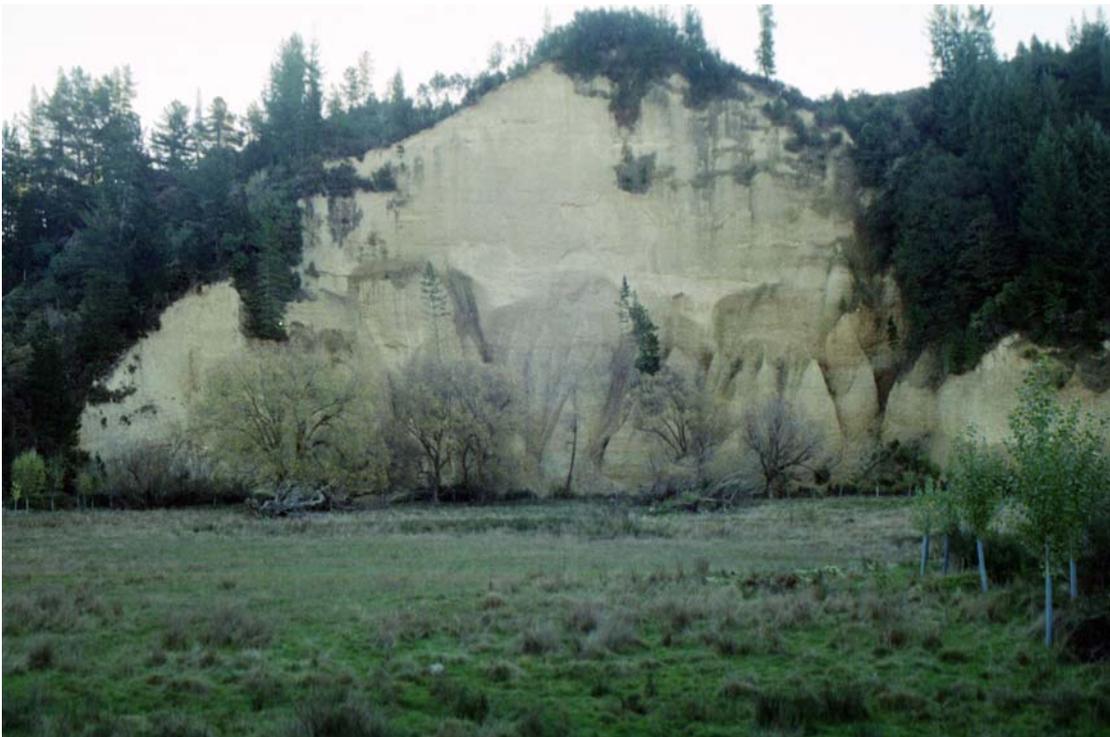
Fig. 8 Severe bank erosion in the Tadmor River near Tui. Note the gullying at the base of the cliff face.
