REPORT ON THE WAIMAKARIRI STREAM-BED
RESURVEY

R.M. Priest

June, 1967

Protection Forestry Branch,
Forest & Range Experiment Station,
P.O. Box 106,
Rangiora.

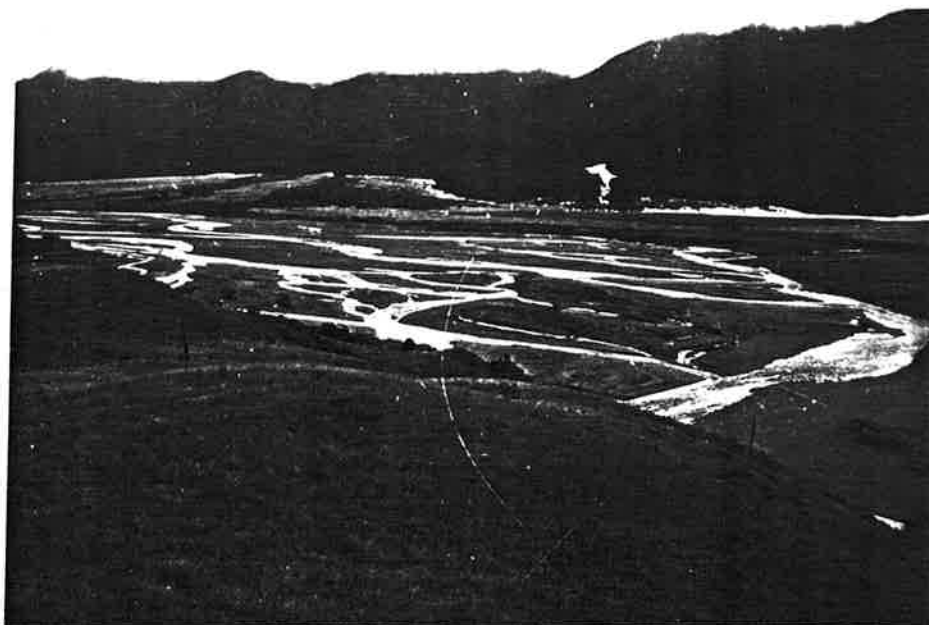
Fig. 8a: The broad anastomosing pattern of the middle reaches of the main Waimakariri River, upstream of the Hawdon River confluence.

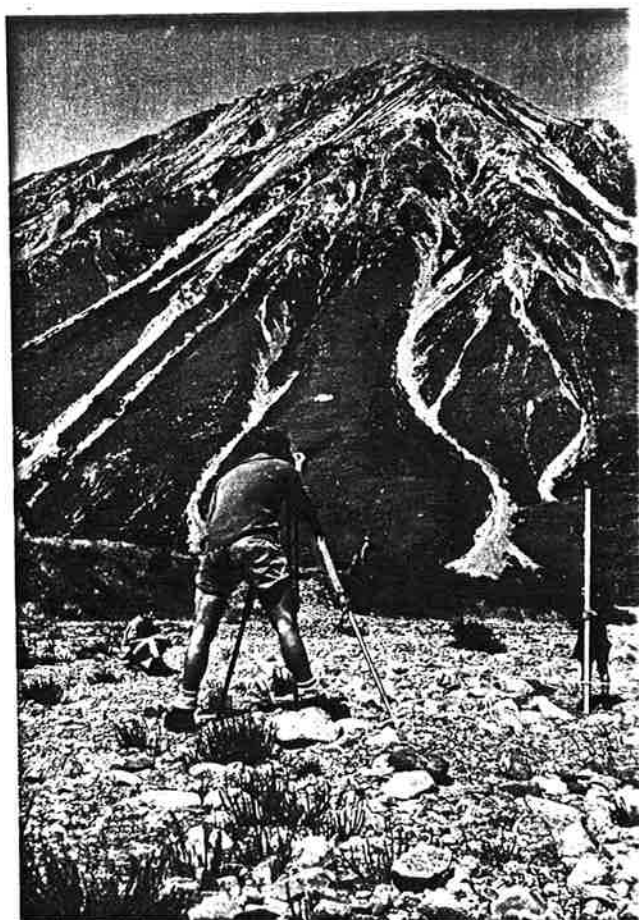
Fig. 8b: A 3 man party using a surveyor's level and staff to measure a stream-bed profile. Peveril Peak (Poulter Catchment) in background.

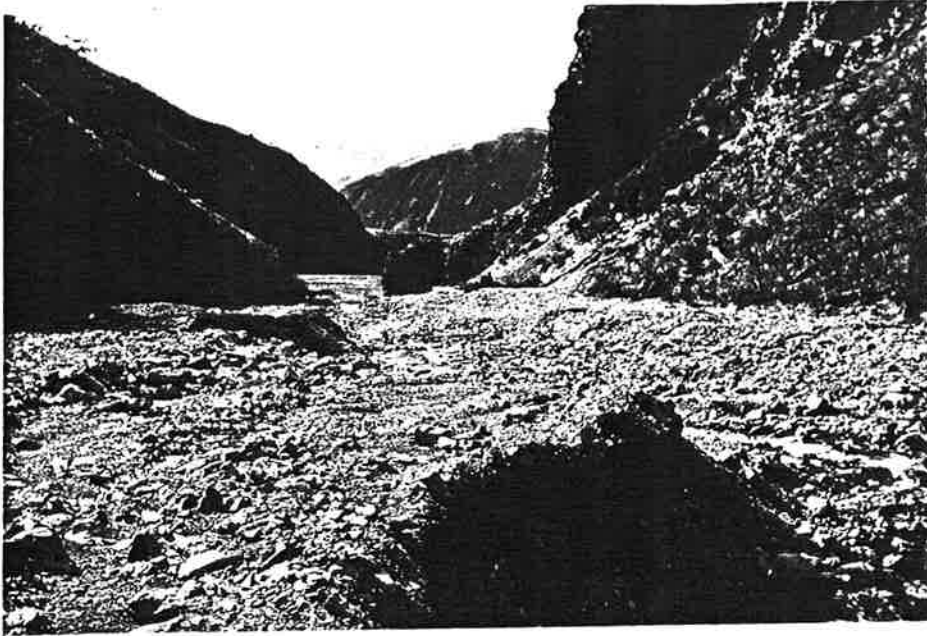
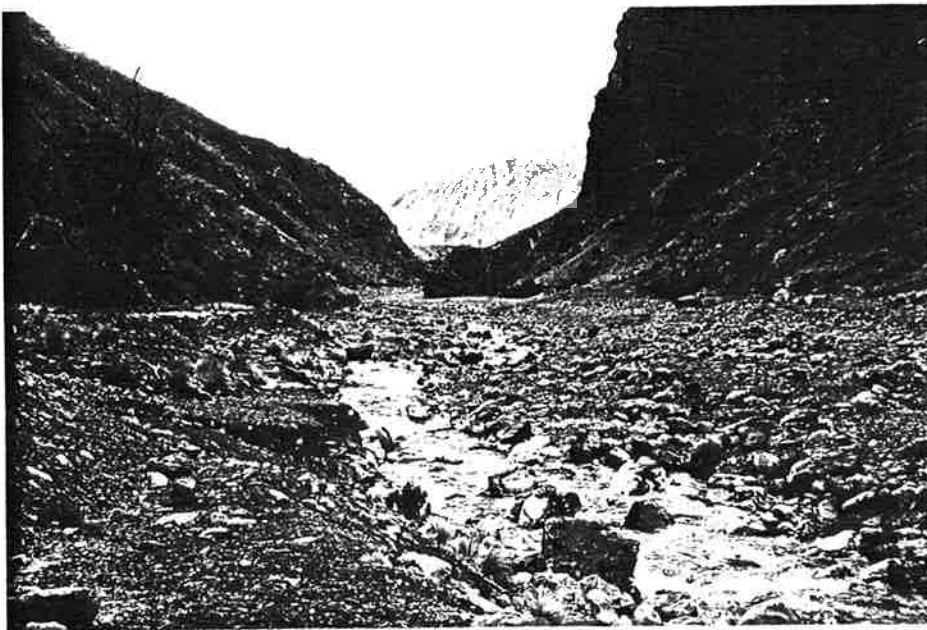
Although essentially qualitative, comparative photographs are a useful tool in assessing stream-bed change. The freshly deposited gravels of Fig. 9a have since been modified or removed. Stream-bed vegetation in the lower photograph comprises mainly hard and silver tussocks. Both photographs from the middle reaches of Ribbonwood Stream. (Broken River Catchment)

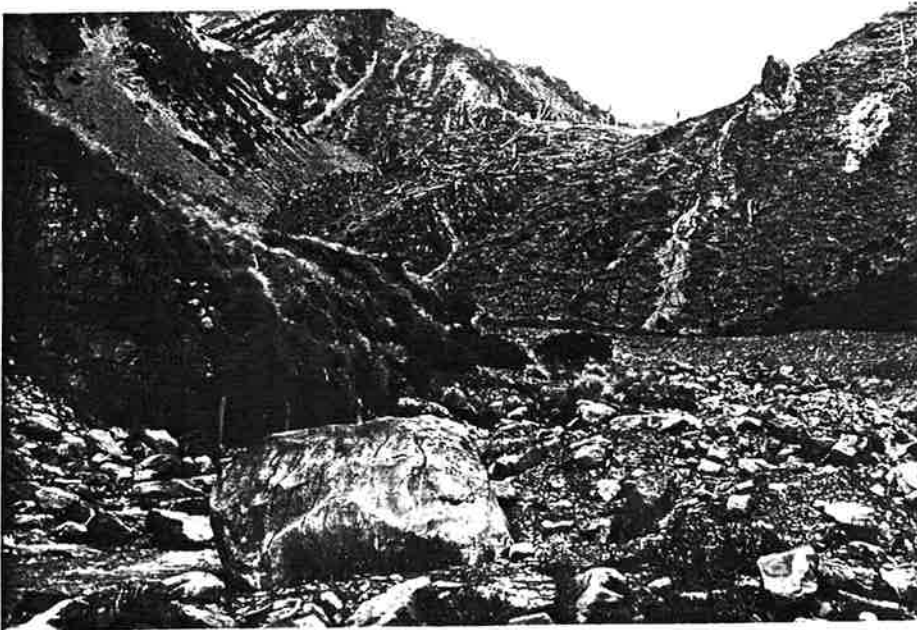
Fig. 10a

Comparative photos, again from Ribbonwood Stream.
The large stream-bed boulder in Fig. 10b can be recognised in Fig. 10a.
The transect line, some 15 chains downstream from this point, showed a level rise of 1.0 feet since the original survey.

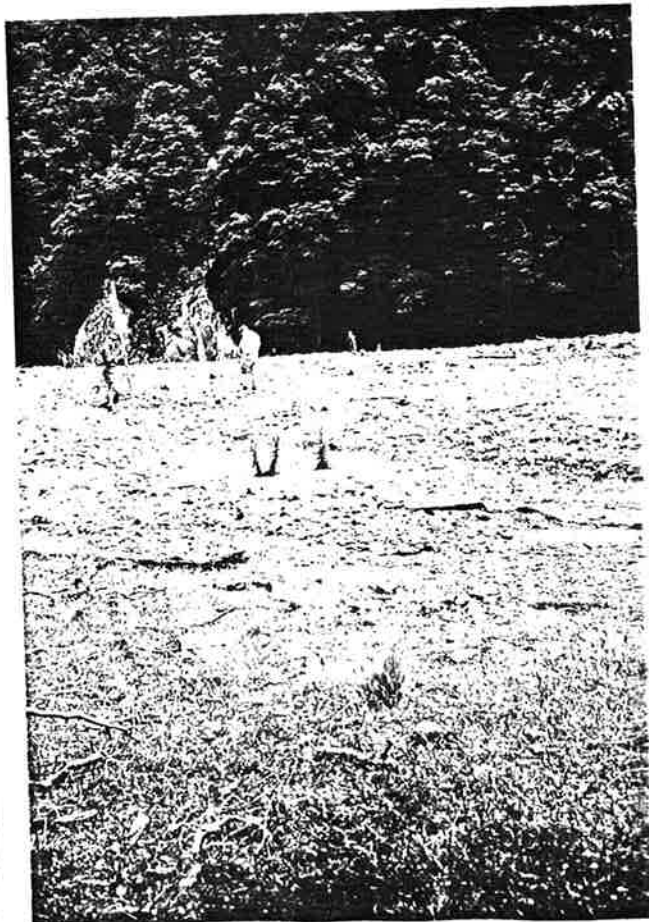
Fig. 11b: The Jordan Transect in January 1967. The profile showed no detectable change in level from that of the original survey.
