**THE EFFECTS OF RIPARIAN PROTECTION ON CHANNEL FORM AND
STABILITY OF 6 GRAZED STREAMS, SOUTHLAND, NEW ZEALAND**

R. Bruce Williamson, R. Keith Smith and John M. Quinn

September 1990

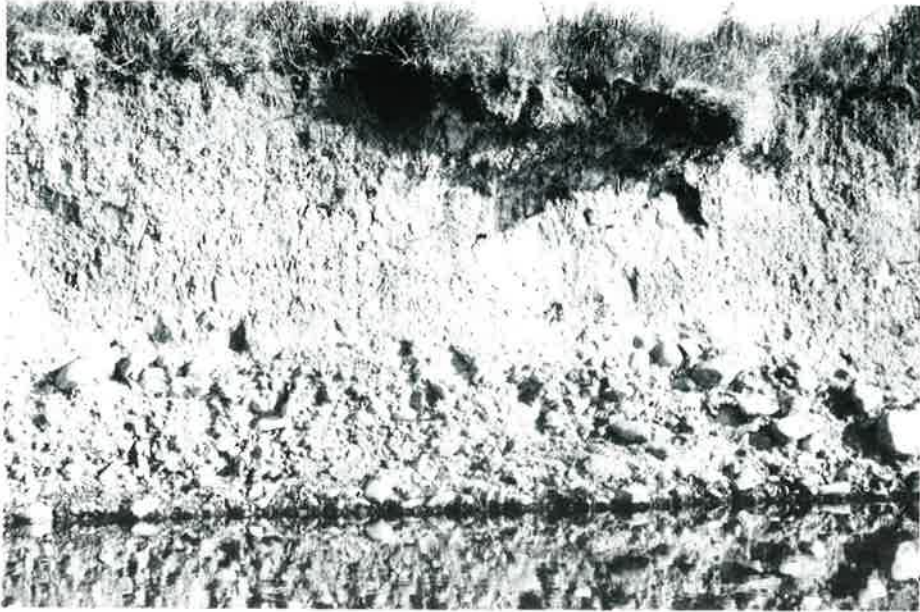
Fig. 2 Bank soil profile showing soils overlying coarse alluvium (Weydon Burn grazed site).

Profiles exposed on streambanks (Fig. 2) showed recent soils, mostly clay to silt loams, formed from coarse alluvium. In some cases, soils were stony or peaty. The underlying uncohesive alluvium varied widely in the amount of fine material and particle size, but most profiles contained at least one layer which disintegrated under mild abrasion. These layers normally occurred above the low flow water level in most streams except Reed Burn and Stag Stream. The overlying soils had enough cohesion to form overhangs of typically 0.5 m (and up to 1.2 m) when underlying alluvium had been removed through erosion.

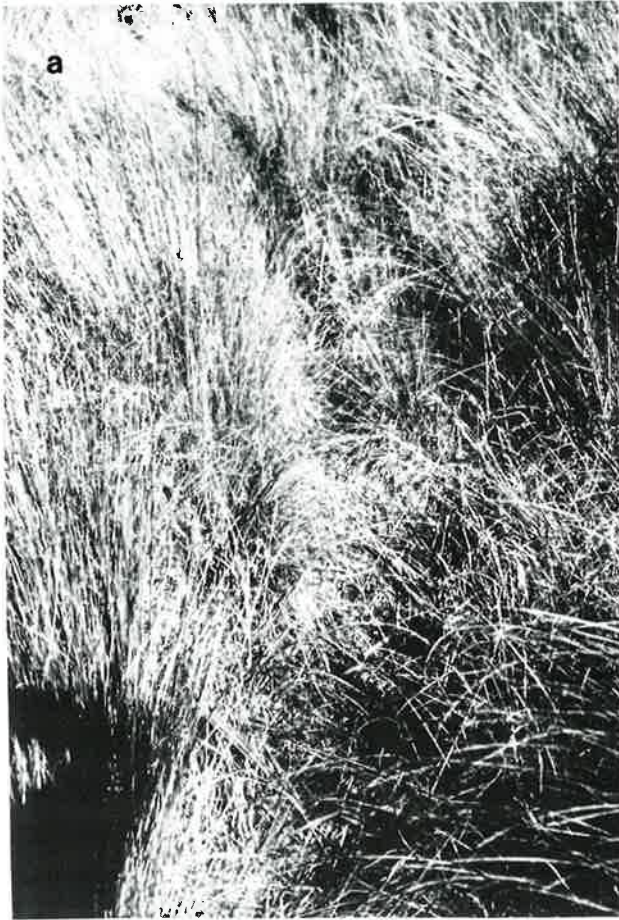
Fig. 5 (a) Reed Burn protected reach (RP), which is completely covered by overhanging vegetation (cocksfoot and tussock). (b). The grazed upper reaches of Stag Stream (SU1), which is well shaded by grass and sedges.

Our survey shows that there is little difference between the 2 streams. Both streams are small and stable, with vertical-sided or undercut, incised channels (Fig. 3, 5), that would be susceptible to stock trampling. None of the indices that measure channel shape (undercut, streambank angle, width) or stability (Table 3, Fig. 4) indicate stock damage has occurred in this part of Stag Stream. The vertical or overhung sides on both streams were sparsely covered with roots, moss and small ferns, and there was only slightly more freshly exposed soil in Stag Stream, perhaps indicating a slightly more erosive environment. The main difference between the 2 reaches was in vegetation growth on top of the bank, an obvious grazing effect (Fig. 4). Reed Burn was completely overhung by tall cocksfoot (1-2 m tall) and the occasional red tussock (2 m tall), whereas the Stag 1 reach had a mixed pasture/sedge/wire rush association (0.3 m tall) near the surveyed channel.

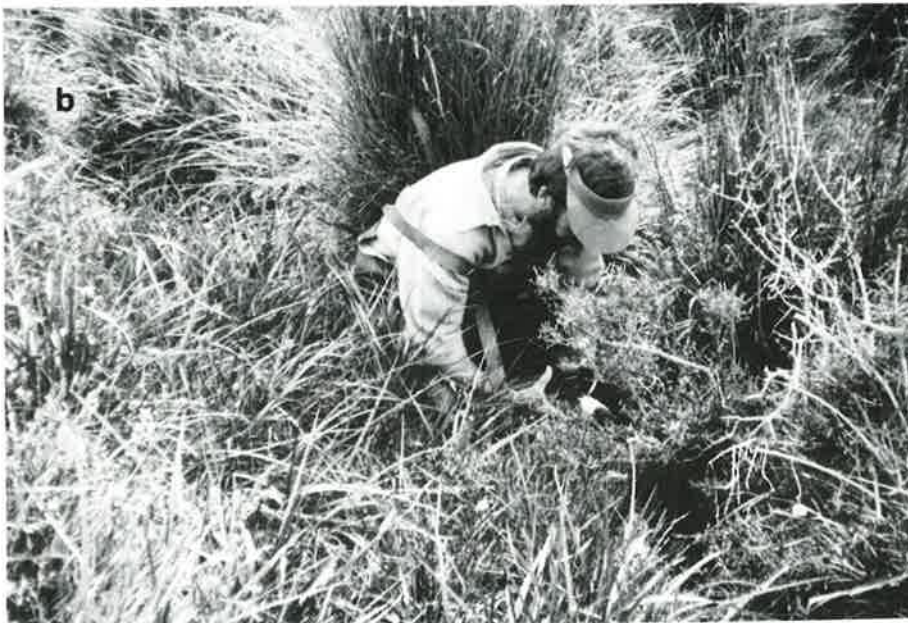
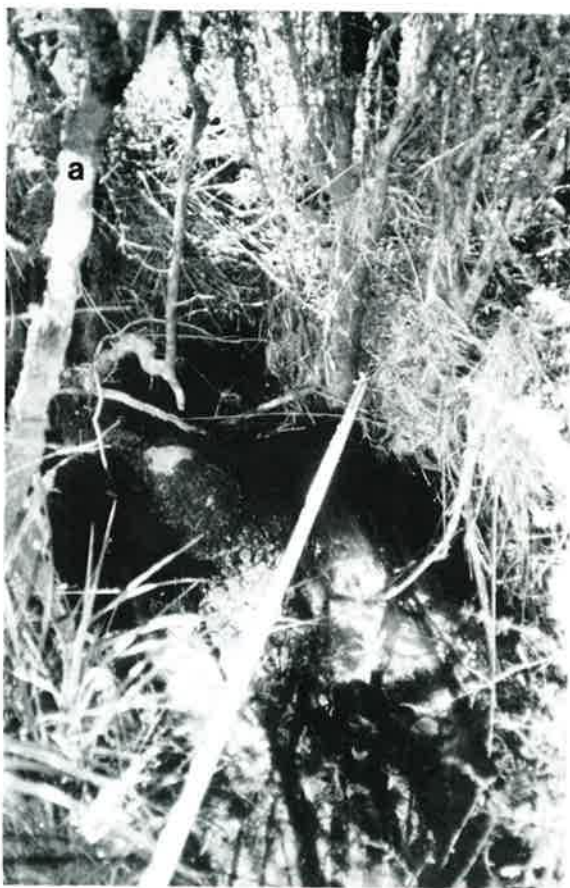
Fig. 6 Stock damaged and undamaged portions of the lower Stag Stream. (a) SU3. Note the significant bank cover by shrubs. (b) Stock crossing SU4. Note the wider, shallower channel and damaged shrubs.

Fig. 6 shows damaged and undamaged parts of the stream channel. The 400 m stretch SU4 is regularly used for stock crossing, or access along the stream channel, and this is reflected in soil alteration ratings (Fig. 4). A longitudinal survey (Table 3) showed stock crossings, stock-induced incipient bank collapse, and severe pugging damage had taken place along 25% of the banks. At major crossings the shrubs had been up-rooted, undermined or pushed into the stream channel. Downstream in the shrub protected reach, such damage was much lower (6%), while in SU3 it also occurred on 6% of the bank. As a result, the channel was significantly wider in SU4 compared to SU3 or SU5 (Table 3).

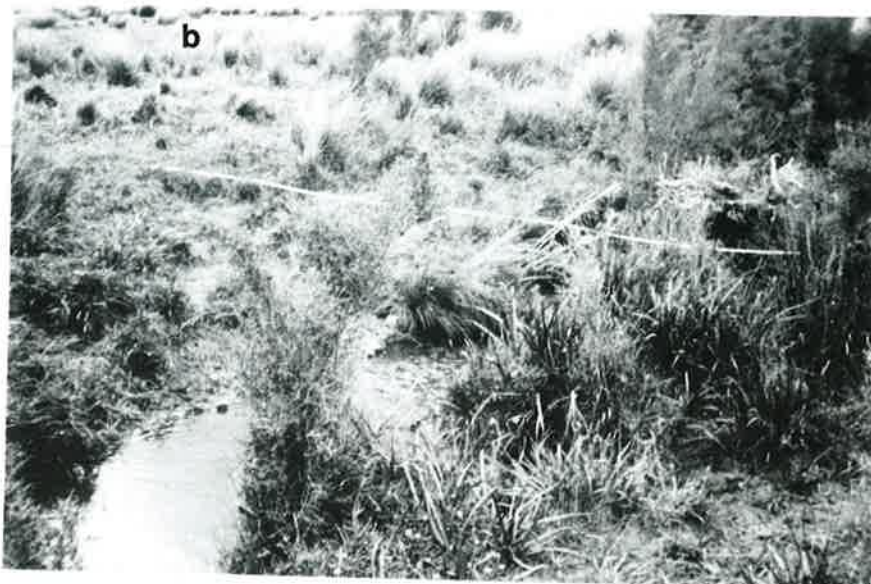
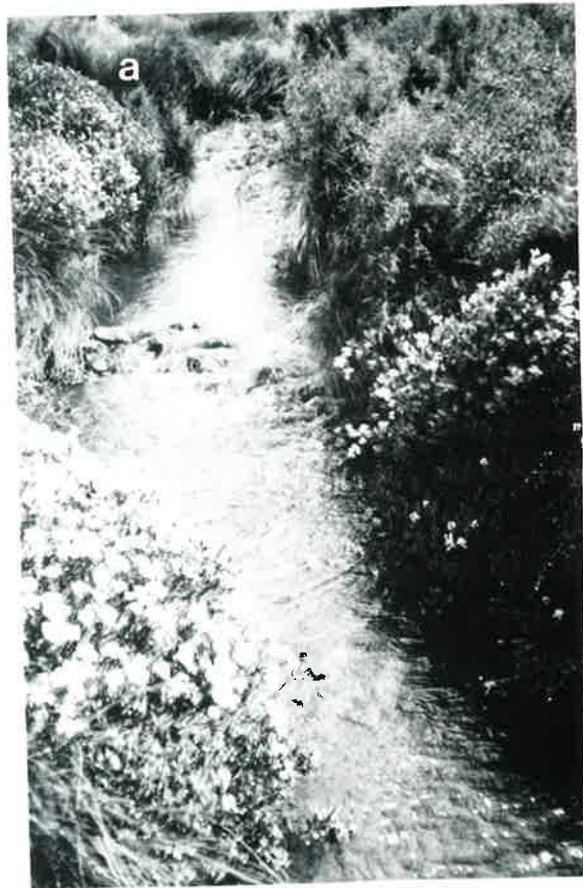
Fig. 7 (a) Ungrazed (CP) and (b) grazed (CU1) reaches of Centre Burn. The banks of both reaches were well covered with vegetation and were similar in size, but showed differences in the type of streamside vegetation cover.

Our surveys show that the 2 reaches (Fig. 7) were fairly similar in channel shape and fish habitat quality (Table 3), the ungrazed reach actually being wider than the grazed reach. There was no change in channel width between 1972 and 1988. Differences were found in channel stability (Table 3, Fig. 4) and vegetation (Table 4).

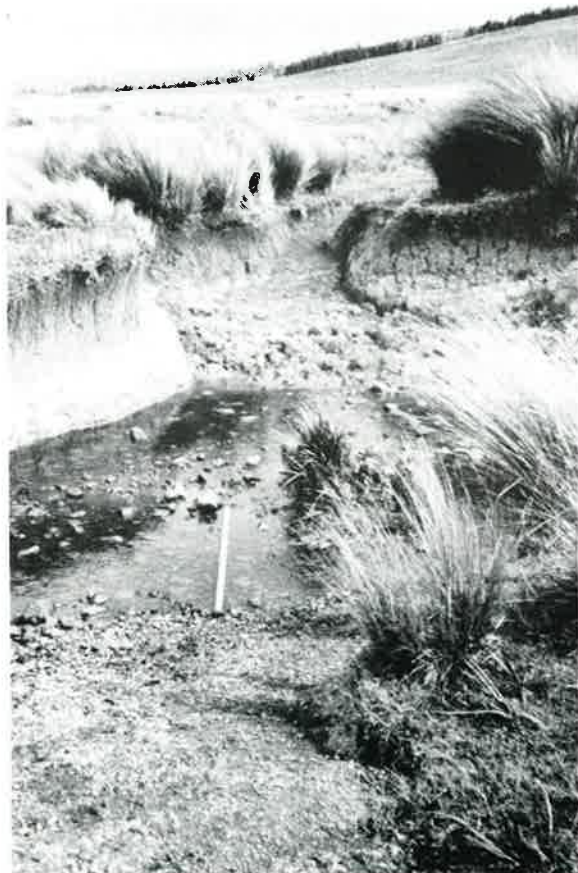
Fig. 9 Stock crossing on the Centre Burn (CU1).

Longitudinal surveys (Table 3) showed that about 12% of the unprotected streambank was suffering visible stock damage, mostly at well established stock crossings (Fig. 9). Other causes accounted for about 6%, which is more than observed in the protected reach ($\leq 3\%$). This difference due to stock damage was highly localised and easily visible. However, it has not (yet) been translated into significant change in the channel width (Table 3) or led to shifts in channel position.

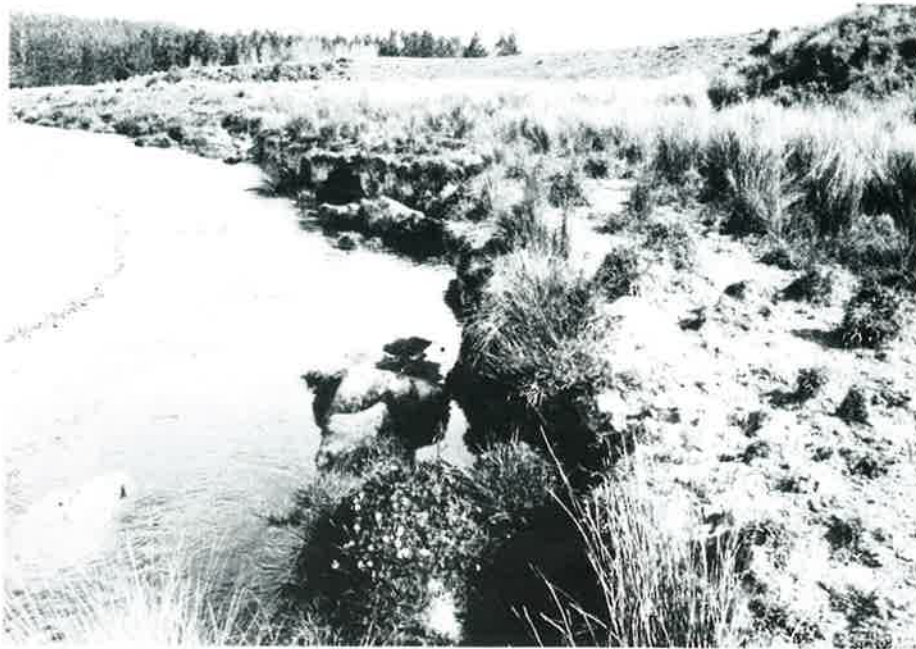
Fig. 13 Cattle accelerated collapse of overhangs on an outside bend on Hamilton Burn. Here cattle are constrained by the topography to walk close to the bank. The instability of this stretch is worsened by wet soils from a seepage (draining from the right of the photo).

The 3 upper reaches showed the typical pattern of an actively meandering river with steep eroding banks on the outside of bends and shallow shingle banks (point bars) on the inside of bends. The channel typically had deep pools at the meander points separated by long runs and riffles. There was very little noticeable difference in appearance between protected and unprotected reaches (Fig. 12). However, cattle damage in HU1 was particularly visible as trampled bare soil under false banks and accelerated collapse of undercut banks on the outside of active meanders (Fig. 13).

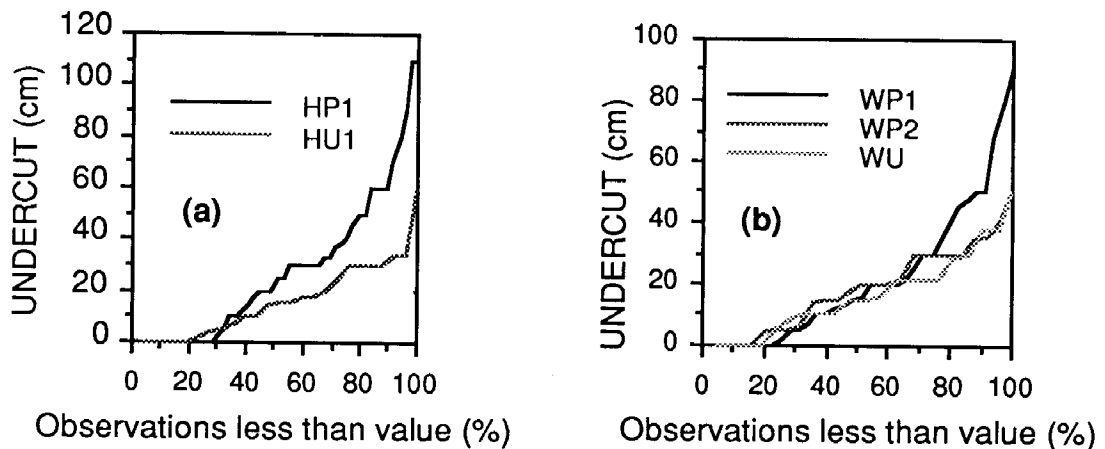
Fig. 14 Distribution of undercuts in actively eroding banks on the Hamilton Burn (a) and Weydon Burn (b). Undercuts are plotted with increasing size against cumulative observations.

The recent collapse of undercut streambanks was the most dramatic feature of active eroding banks (in both protected and grazed reaches of Hamilton and Weydon Burns) and is conceivably accelerated by animals walking along the streambank (Fig. 13). If this is a common result of grazing, then it should be reflected in a lower incidence of undercut banks in grazed paddocks. Therefore, the extent of undercut was examined in detail along the vertical eroding banks in HP1 and HU1. This survey (which was independent of the that reported in Fig. 4) showed some larger undercuts in HP1 but failed to detect a significant difference (Fig. 14).

As in Hamilton Burn, the extent of undercut was examined in detail along the vertical eroding banks. This survey (Fig. 14) found little difference between the protected and grazed reaches.

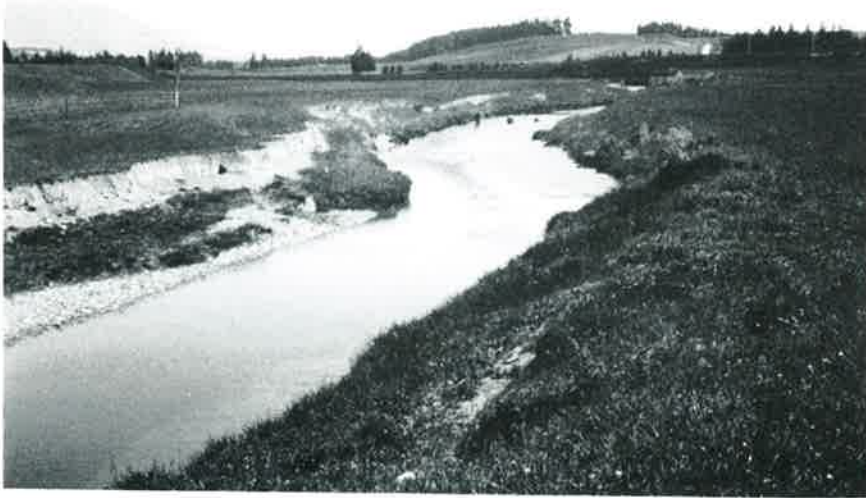
Fig. 15 Cattle grazed reach on the Hamilton Burn showing the bare false banks and relative stability of the channel and banks.

Visible stock damage was confined to trampling of gravel bars, the occasional stock crossing (which had minimal impact on streambank morphology or stability) and abrasion of false banks on the edge of the flood plain (Fig. 15). The latter phenomena were the most noticeable bank erosion, but as it occurred 3-6 m away from the waters edge, it was deemed to have little impact on streamside habitat or bank stability. It appeared to be caused by animals rubbing against or walking under the banks whilst seeking shelter.
