A preliminary assessment of potential barriers to fish migration in the Manawatu River catchment, North Island, New Zealand

A report prepared for Horizons Regional Council, June 2008

Dr Alex James and Dr Mike Joy

**Foundation of Research, Science & Technology
EnviroLink Contract Ref: 437-HZLC45**

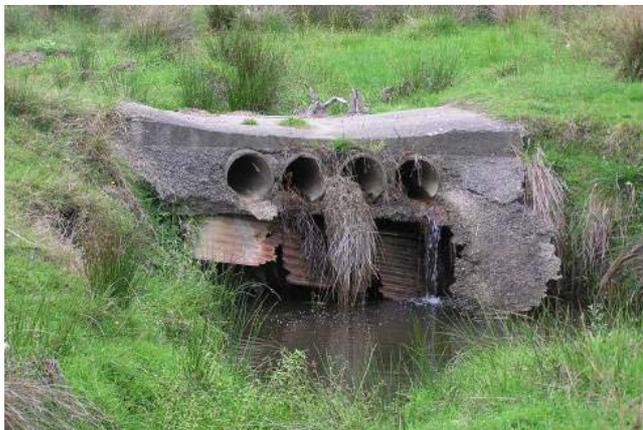
Figure 5. Unassessed culvert on private land near Levin. Note the ineffective fish ramp on the right.

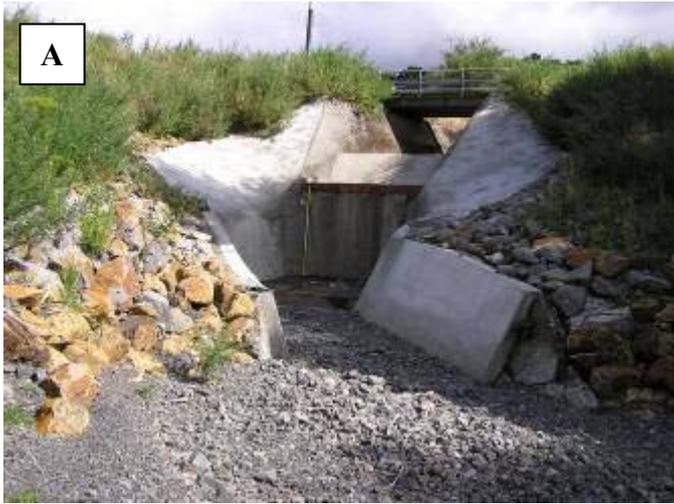
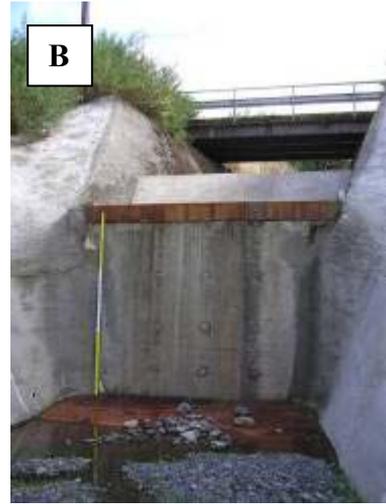
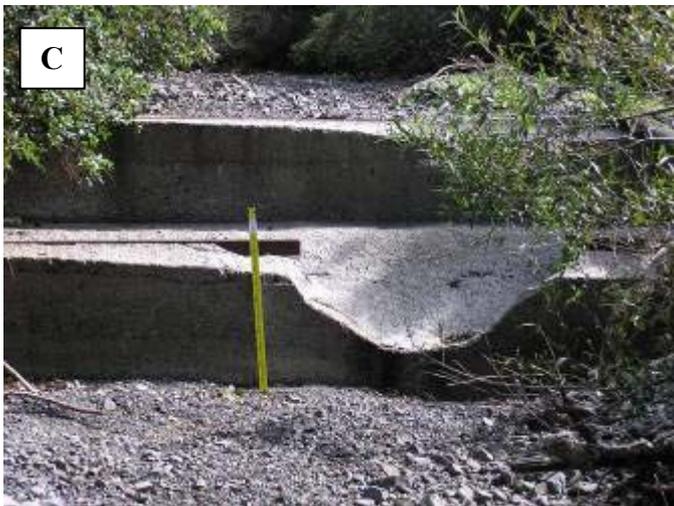
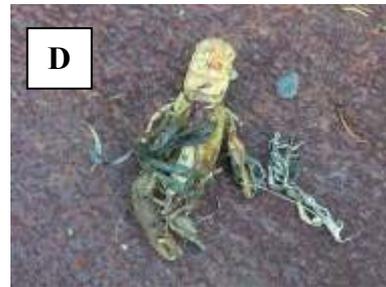
Figure 15. A: Massive structure on Mangapuaka Stream. B: The main drop is a 3 m vertical wall. C: Smaller weirs are present upstream. D: Desiccated koura at base of main drop.

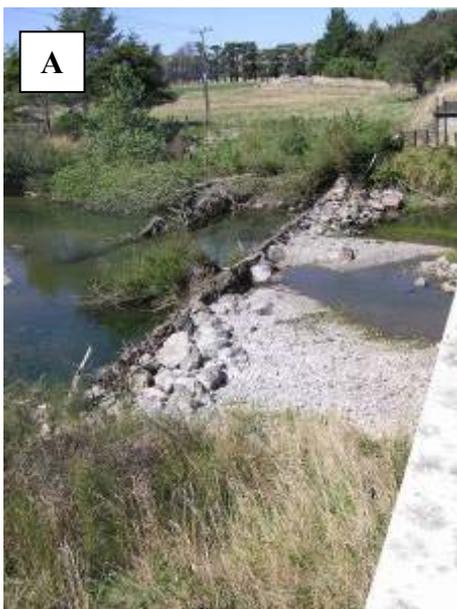
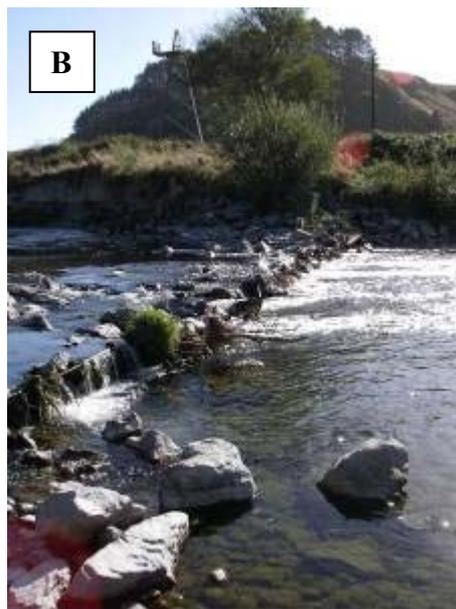
Figure 16. Two cable and boulder weir structures on the Mangatainoka River, A: below bridge on Bridge Rd and B: at the end of James Line.

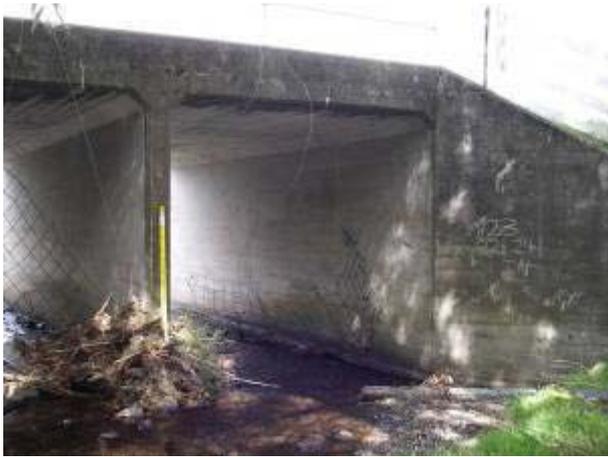
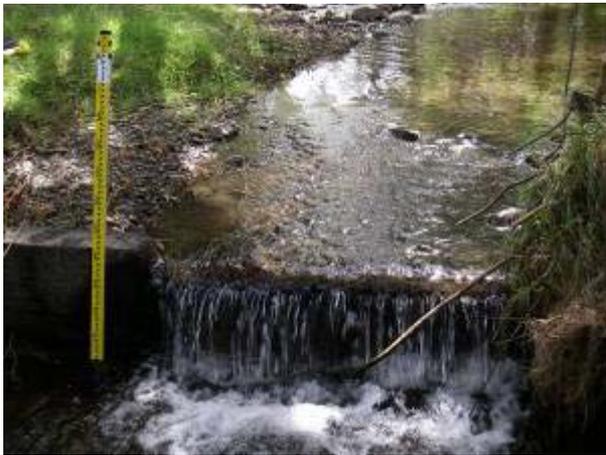
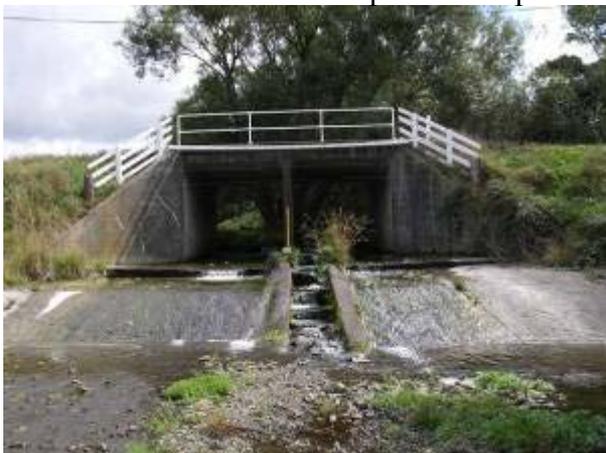
Figure 14. A: Useless ramp at Rokaiwhana Stream (T23:689102), B: Disfunctional ramp on unnamed stream (T23:437846), C: Eroded and unmaintained ramp on upper Manawatu River (U23:821241).

Above: Inlet looking downstream.

Below: Perched inlet

Below: Outlet. Note the very shallow water on ramps and central eroded fish pass structure that has a series of perched steps.

Potential as migratory barrier	High
Priority for remediation	High (existing pass, forested upstream)

The remaining two structures are perhaps both the most difficult and highest of priority. On the upper Manawatu River is a large ramp and weir structure with an eroded and unmaintained fish pass up the middle (see pg 28). Upstream of this structure are the high quality forested headwaters of the Manawatu River in the Ruahine Ranges. The repair/alteration of the existing fish pass here may improve the ability of fish to move upstream of this structure. The other difficult structure is the double concrete block weir below a bridge over the Rokaiwhana Stream (see pg 29). This structure forms a waterfall complex where formerly there was none and again there is a significant area of high quality forested catchment upstream. There is also evidence of some old fish pass structures on the upper weir that are no longer operational. Given these weirs were likely built to prevent scour around the base of the bridge, then serious consideration is required at this site to ascertain what can be done to improve fish passage.

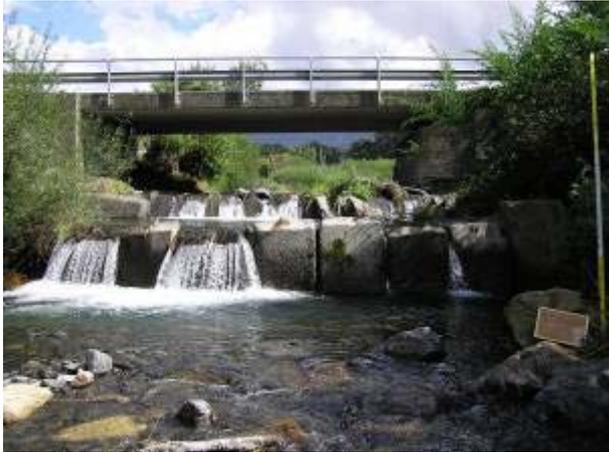
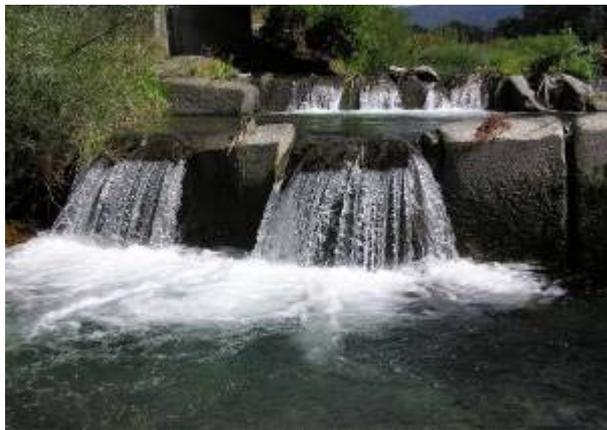
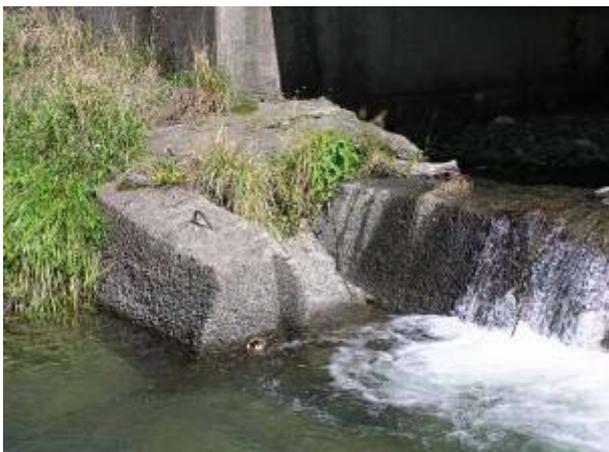
Above: Double weir structure below bridge.

Below: High water velocity over the concrete block weir.

Below: Useless fish ramp on upper weir.

Potential as migratory barrier	High
Priority for remediation	High (forested upstream)

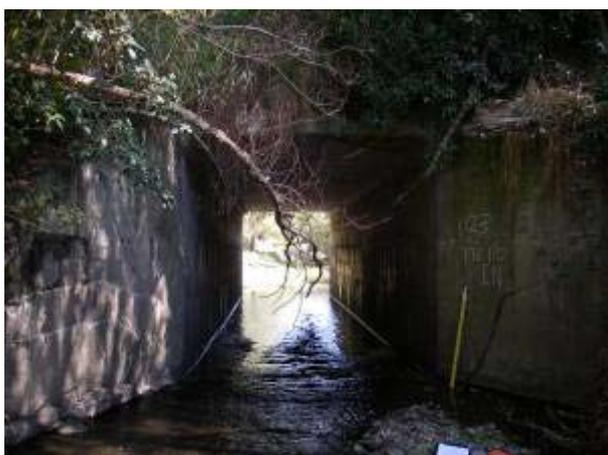
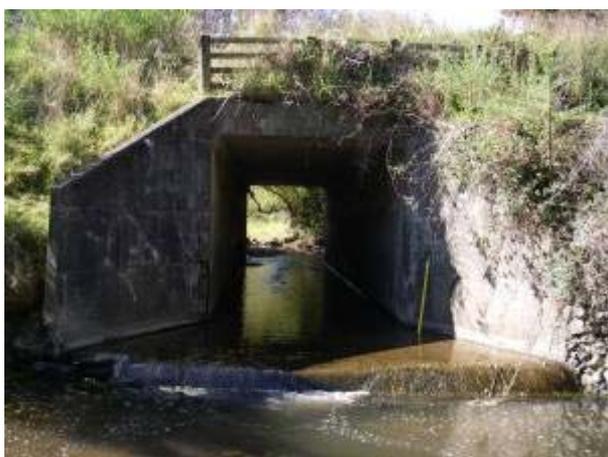
Above: Inlet.

Below: Outlet.

Potential as migratory barrier	High
Priority for remediation	High (easy fix)

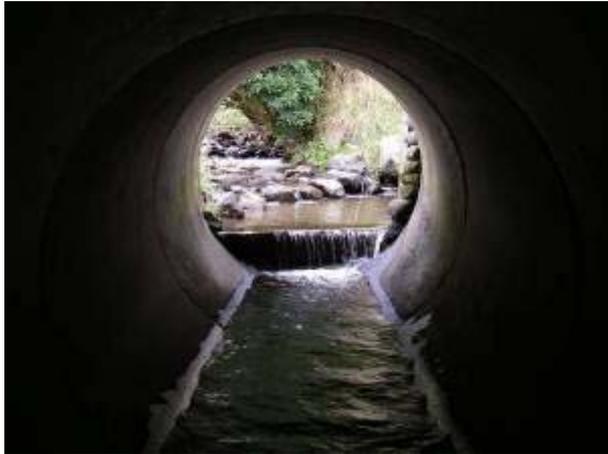
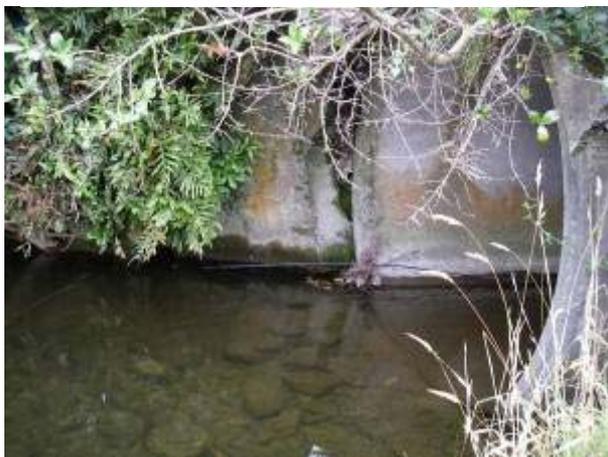
Above: Perched inlet.

Below: Outlet.

Potential as migratory barrier	High
Priority for remediation	High (easy fix)

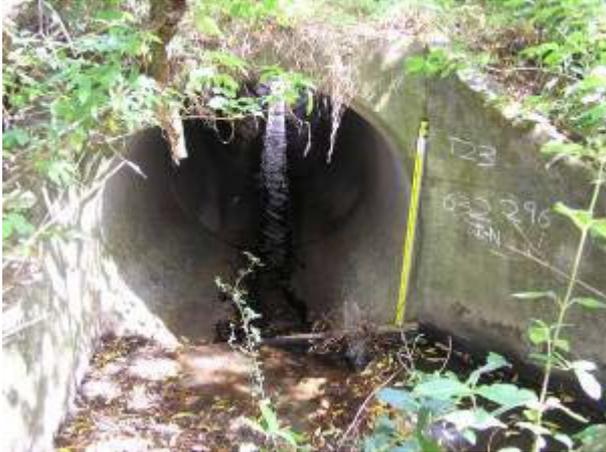
Above: Perched inlet.

Potential as migratory barrier	High
Priority for remediation	High (easy fix)

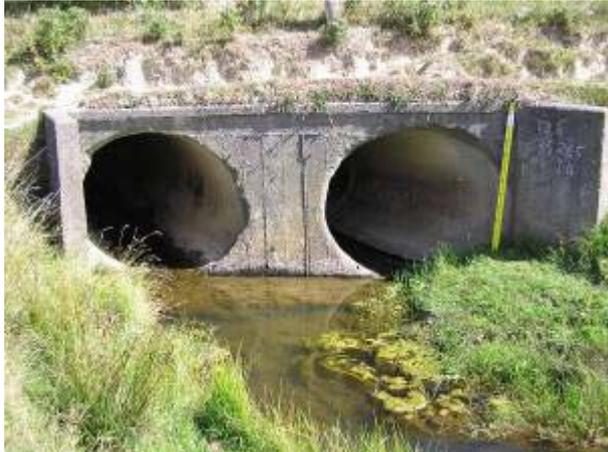
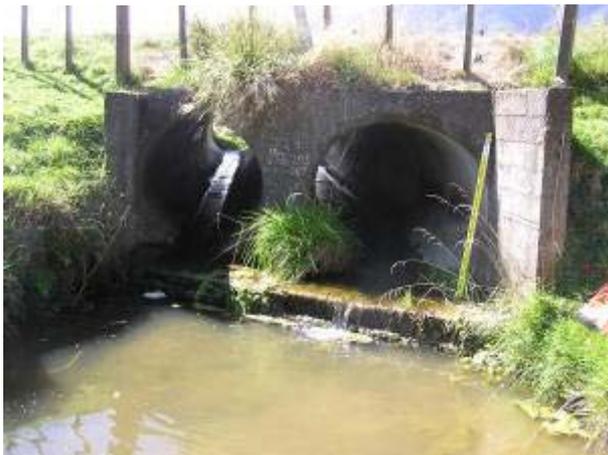
Above: Inlet.

Below: Perched outlet.

Potential as migratory barrier	High
Priority for remediation	High (easy fix)

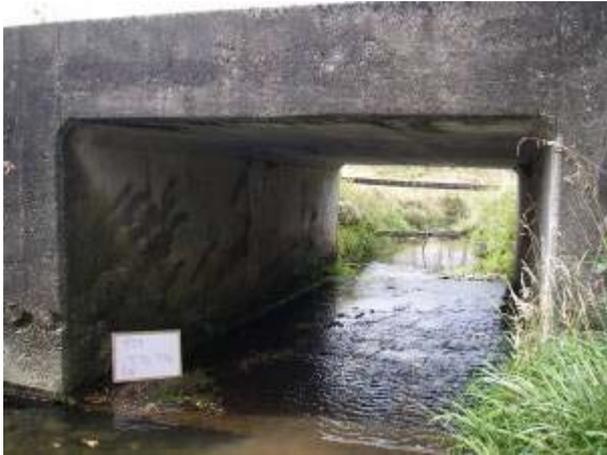
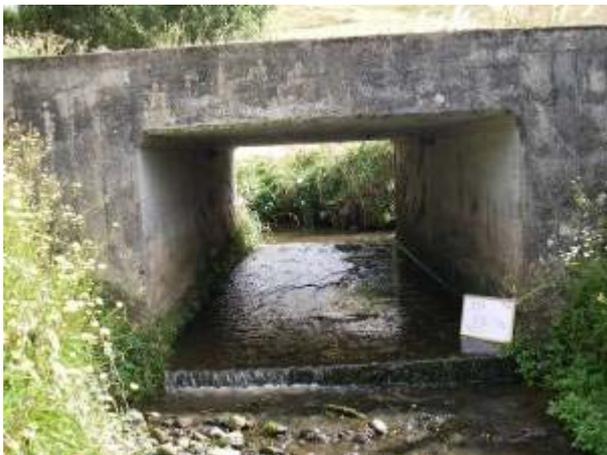
Above: Inlet

Below: Outlet

Potential as migratory barrier	Medium
Priority for remediation	High (easy fix)

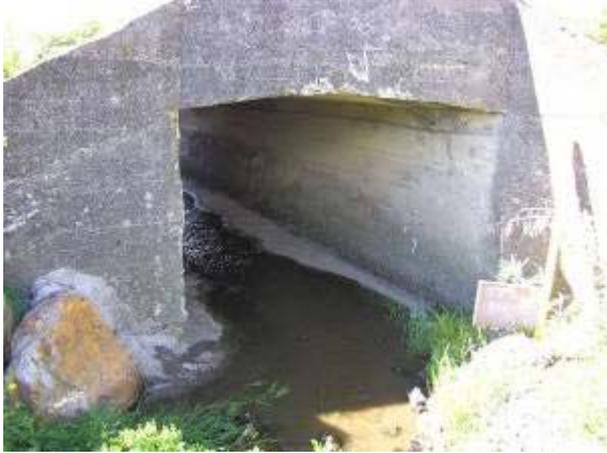
Above: Inlet

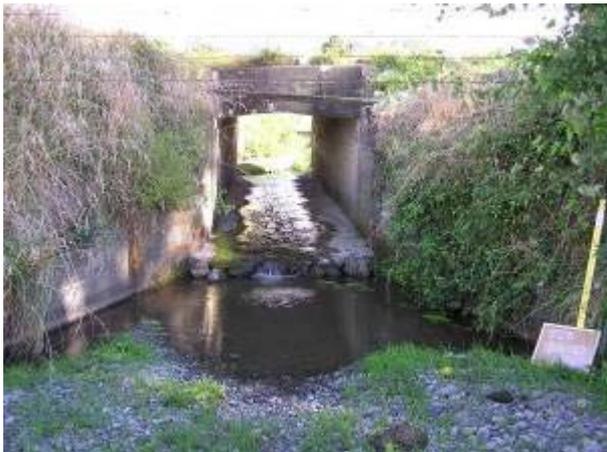
Below: Outlet

Site no.: T23:644067	
Location: Otamarahu Stream, Top Grass Rd	
Easting	2764409
Northing	6106702
Date assessed	7/03/2008
Structure	culvert
Type	box
Construction	concrete
Length	10.1 m
Diameter	1.85 m
Water depth (inlet)	0.04 m
Water depth (outlet)	0.02 m
Inlet cross section	flat
Outlet cross section	perched
If perched (height)	0.13 m
If perched (undercut)	0.09 m
Likely severity of barrier	Low flows
Potential barriers known upstream	0
Potential barriers known downstream	0

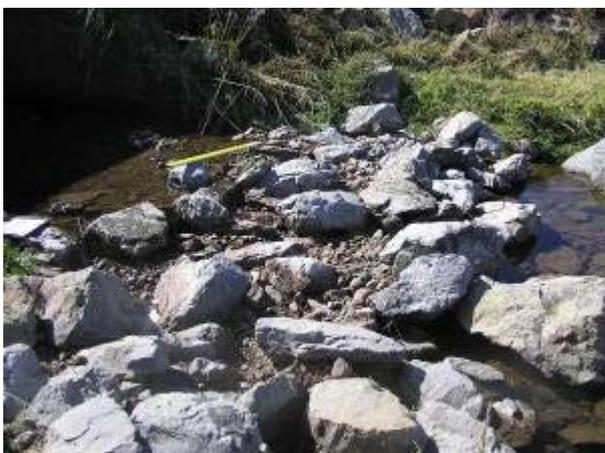
Below: Outlet showing how a dam has been created during low flow period.

Site no.: T24:410791	
Location: Unnamed stream, Inglis Rd	
Easting	2741052
Northing	6079111
Date assessed	18/03/2008
Structure	culvert
Type	box
Construction	concrete
Length	6.73 m
Diameter	3.1 m
Water depth (inlet)	0.12 m
Water depth (outlet)	0.05 m
Inlet cross section	flat
Outlet cross section	perched/ dammed
If perched (height)	-
If perched (undercut)	-
Likely severity of barrier	Low flows
Potential barriers known upstream	0
Potential barriers known downstream	0

Potential as migratory barrier	Medium
Priority for remediation	High (easy fix)

dam during low flow periods and prevents the passage of fish under such conditions (e.g. see pg 36).

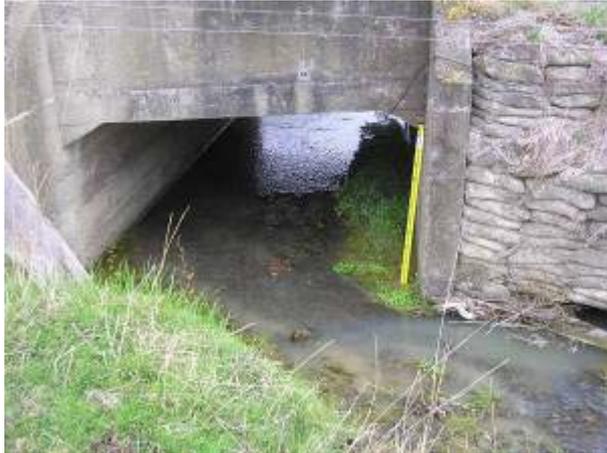
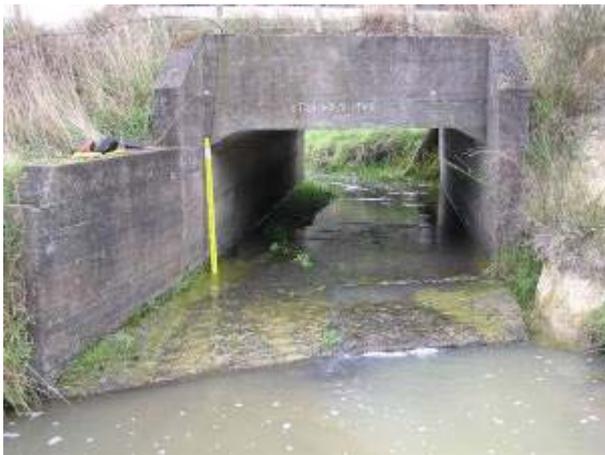
Above: Inlet

Below: Outlet

Site no.: T24:435946	
Location: Unnamed stream, Centre Rd (off Fitzherbert East Rd)	
Easting	2743501
Northing	6094671
Date assessed	7/04/2008
Structure	culvert
Type	box
Construction	concrete
Length	9.6 m
Diameter	2.5 m
Water depth (inlet)	0.05 m
Water depth (outlet)	0.02 m
Inlet cross section	flat
Outlet cross section	perched
If perched (height)	0.04 m
If perched (undercut)	0 m
Likely severity of barrier	Low flows
Potential barriers known upstream	0
Potential barriers known downstream	0

Potential as migratory barrier	Medium
Priority for remediation	High (easy fix)

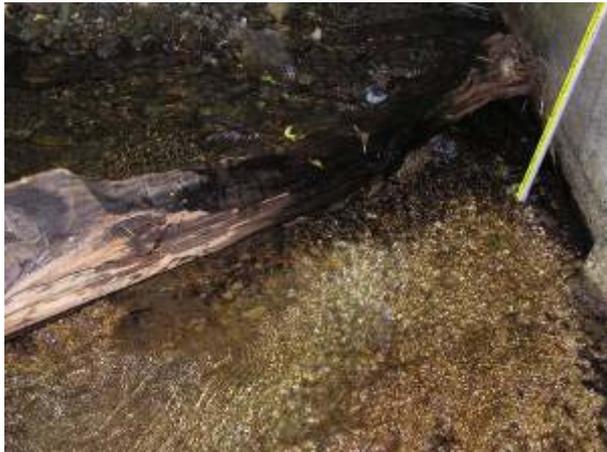
Above: Log creating perched inlet but water flow beneath end of log at time of assessment.

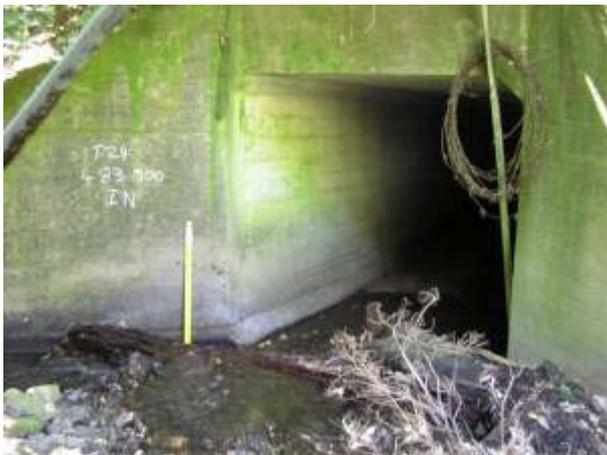
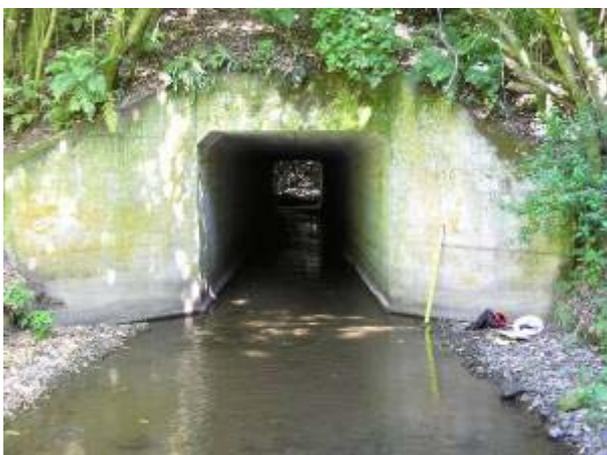
Above: Inlet

Above: Outlet

Site no.: T24:483900	
Location: Unnamed stream, Gorge Rd, ~3 km south of Ballance Bridge	
Easting	2748364
Northing	6090041
Date assessed	18/03/2008
Structure	culvert
Type	box
Construction	concrete
Length	29.3 m
Diameter	2.4 m
Water depth (inlet)	0.03 m
Water depth (outlet)	0.13 m
Inlet cross section	Perched
Outlet cross section	Flat
If perched (height)	0.33
If perched (undercut)	0.20
Likely severity of barrier (visual assessment)	High flows
Known barriers upstream	0
Known barriers downstream	0

Potential as migratory barrier	Medium
Priority for remediation	High (easy fix)

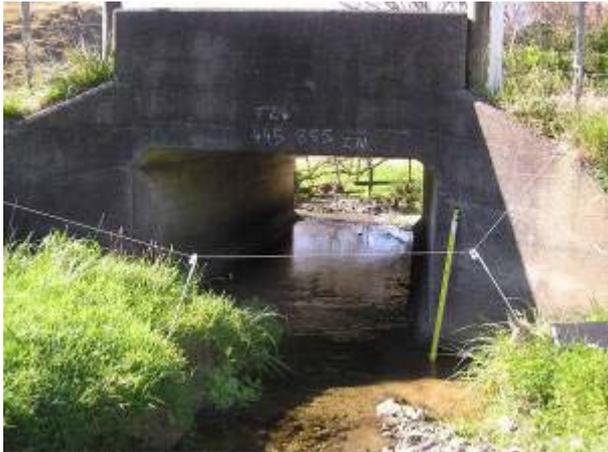
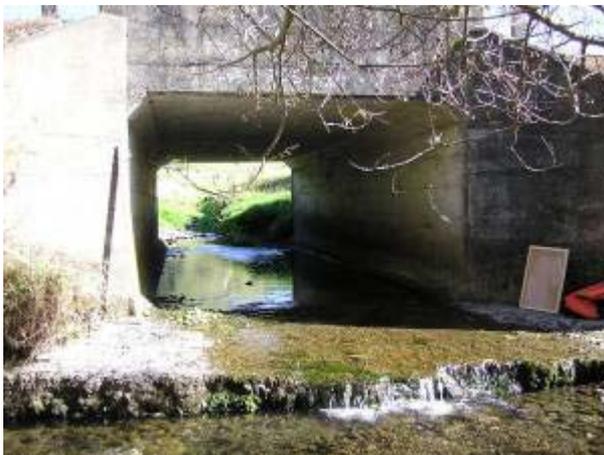
Above: Inlet.

Site no.: T24:445855	
Location: unnamed stream, Ballance Valley Rd	
Easting	2744527
Northing	6085551
Date assessed	18/03/2008
Structure	culvert
Type	box
Construction	concrete
Length	7.95 m
Diameter	2.42 m
Water depth (inlet)	0.06 m
Water depth (outlet)	0.03 m
Inlet cross section	flat
Outlet cross section	perched
If perched (height)	0.12 m
If perched (undercut)	~0.9 m
Likely severity of barrier	Most flows
Potential barriers known upstream	0
Potential barriers known downstream	0

Below: Perched outlet.

Potential as migratory barrier	Medium
Priority for remediation	High (easy fix)

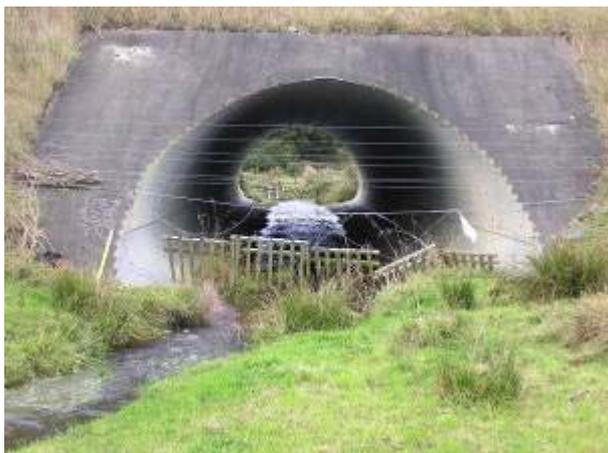
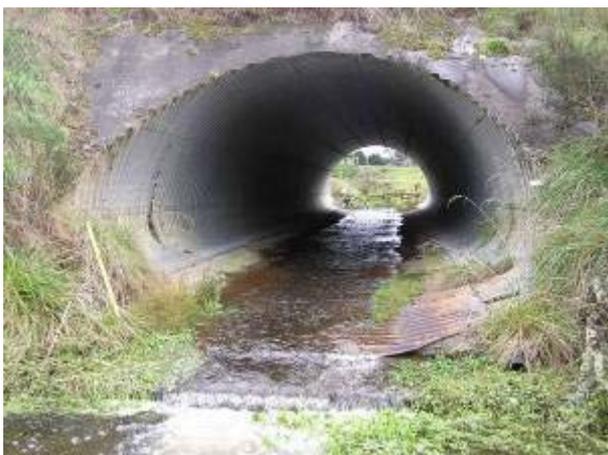
Above: Inlet.

Below: Perched outlet.

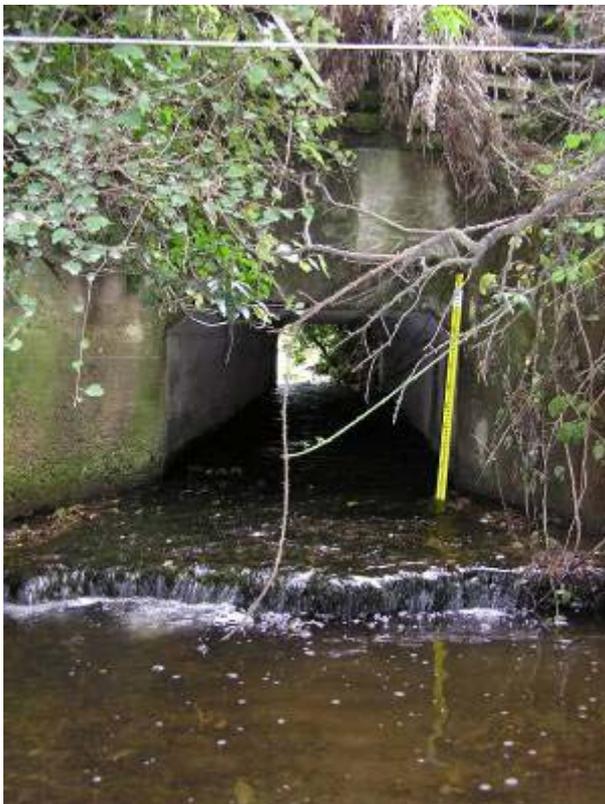
Site no.: U23:815273	
Location: Mahuraiti Stream, Ellison Rd, near Norsewood	
Easting	2781515
Northing	6127367
Date assessed	8/04/2008
Structure	culvert
Type	box
Construction	concrete
Length	12.6 m
Diameter	1.44 m
Water depth (inlet)	0.04 m
Water depth (outlet)	0.04 m
Inlet cross section	flat
Outlet cross section	perched
If perched (height)	0.1 m
If perched (undercut)	0 m
Likely severity of barrier	Most flows
Potential barriers known upstream	0
Potential barriers known downstream	0

Below: Perched outlet.

Potential as migratory barrier	Medium
Priority for remediation	High (easy fix)

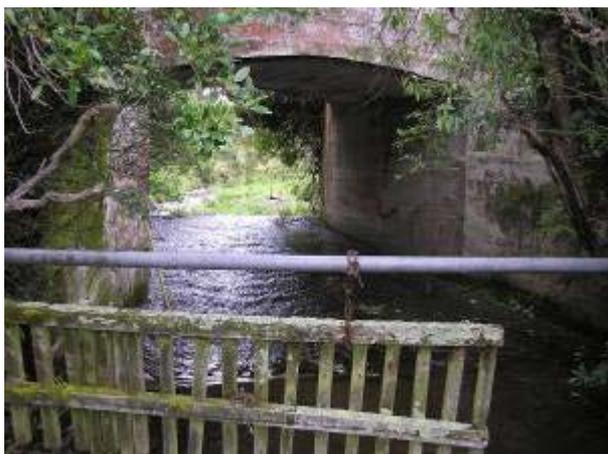
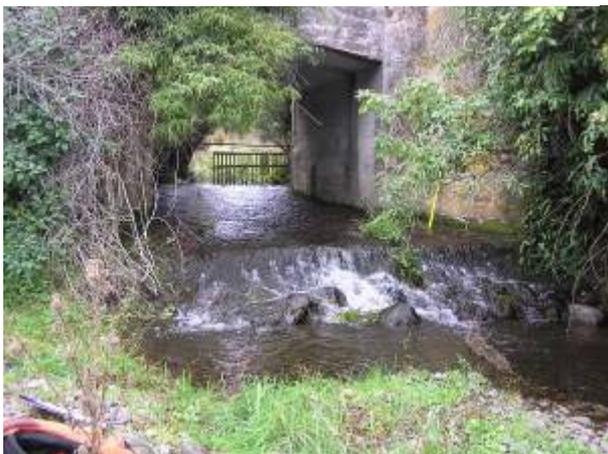
Above: Inlet.

Below: Perched outlet with ramp and boulders that may reduce effect.

Site no.: U23:815266	
Location: Mahuraunui Stream/Stoney Creek, Ellison Rd, near Norsewood	
Easting	2781572
Northing	6126608
Date assessed	8/04/2008
Structure	culvert/bridge
Type	box
Construction	concrete
Length	14 m
Diameter	3.7 m
Water depth (inlet)	0.04 m
Water depth (outlet)	0.04 m
Inlet cross section	flat
Outlet cross section	perched
If perched (height)	0.5 m
If perched (undercut)	0 m
Likely severity of barrier	Most flows
Potential barriers known upstream	0
Potential barriers known downstream	0

Potential as migratory barrier	Medium
Priority for remediation	High (easy fix)

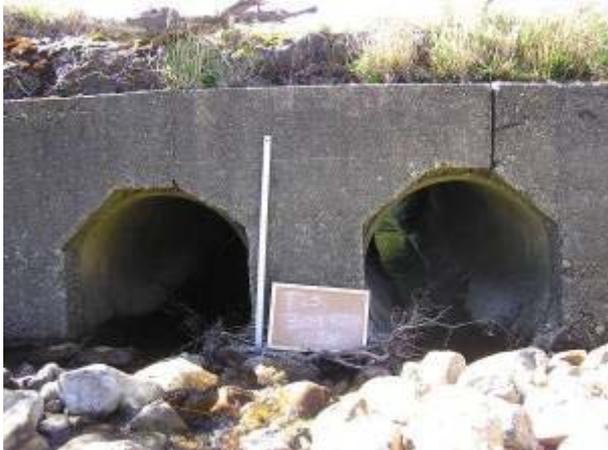
Above: Inlet.

Below: Perched and undercut outlet.

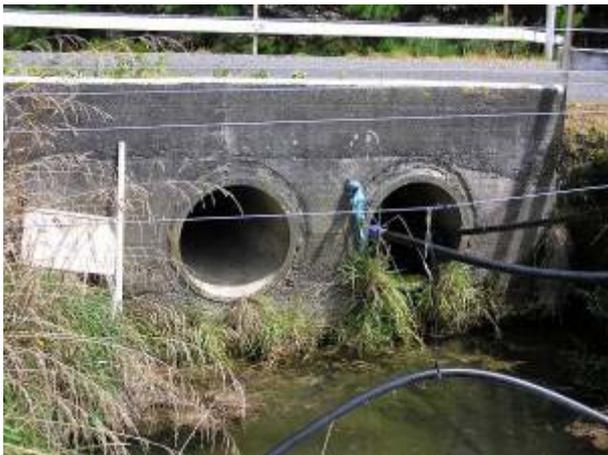
Site no.: T25:330667	
Location: unnamed stream, Mangaraupiu Rd, near Eketahuna	
Easting	2733013
Northing	6066773
Date assessed	26/02/2008
Structure	culvert
Type	double pipe
Construction	concrete
Length	4.9 m
Diameter	0.6 m
Water depth (inlet)	0 m
Water depth (outlet)	0 m
Inlet cross section	perched
Outlet cross section	perched
If perched (height)	0.32 m
If perched (undercut)	0 m
Likely severity of barrier	Most flows
Potential barriers known upstream	0
Potential barriers known downstream	0

Below: Perched outlet.

Potential as migratory barrier	High
Priority for remediation	Medium (difficult fix, forested upstream)

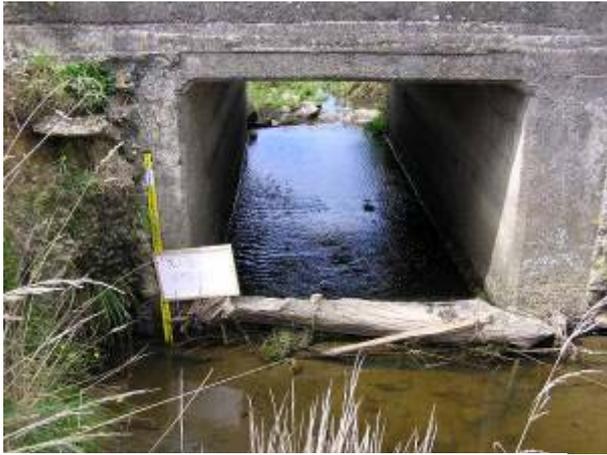
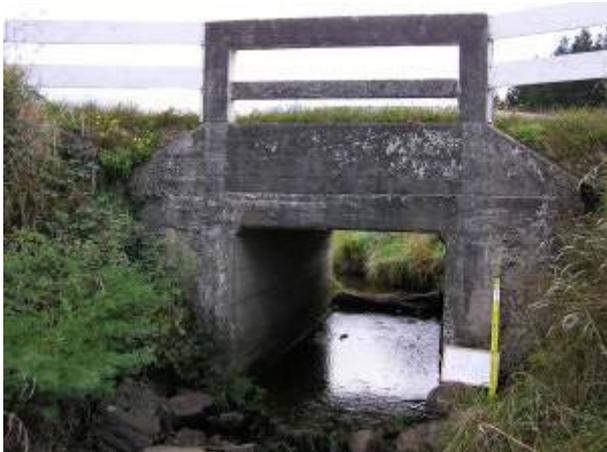
Above: Inlet.

Below: Outlet.

Site no.: T23:695112	
Location: unnamed stream, Top Grass Rd	
Easting	2769592
Northing	6111250
Date assessed	7/03/2008
Structure	culvert
Type	box
Construction	concrete
Length	5.5 m
Diameter	1.8 m
Water depth (inlet)	0.03 m
Water depth (outlet)	0.03 m
Inlet cross section	pooled
Outlet cross section	perched
If perched (height)	0.27 m
If perched (undercut)	0.12 m
Likely severity of barrier	Most flows
Potential barriers known upstream	0
Potential barriers known downstream	0

Potential as migratory barrier	High
Priority for remediation	Medium (easy fix , degraded upstream)

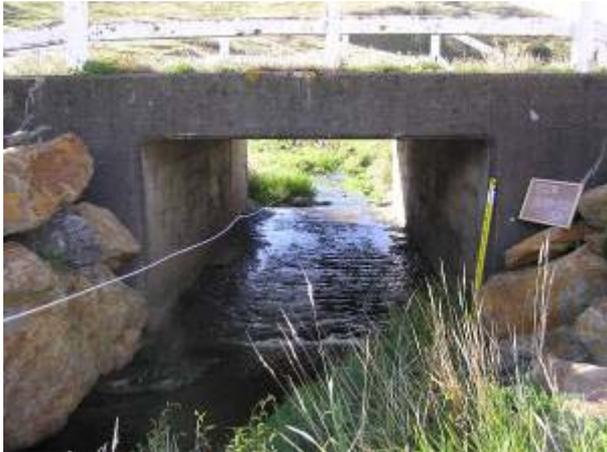
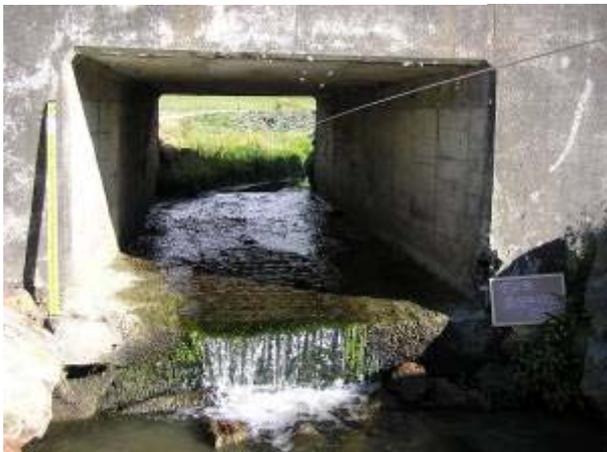
Above: Inlet.

Site no.: T23:584020	
Location: unnamed stream, Top Grass Rd	
Easting	2758414
Northing	6102089
Date assessed	7/03/2008
Structure	culvert
Type	box
Construction	concrete
Length	7 m
Diameter	2.45 m
Water depth (inlet)	0.03 m
Water depth (outlet)	0.04 m
Inlet cross section	pooled
Outlet cross section	perched
If perched (height)	0.37 m
If perched (undercut)	0 m
Likely severity of barrier	Most flows
Potential barriers known upstream	0
Potential barriers known downstream	0

Below: Outlet.

Potential as migratory barrier	High
Priority for remediation	Medium (degraded upstream)

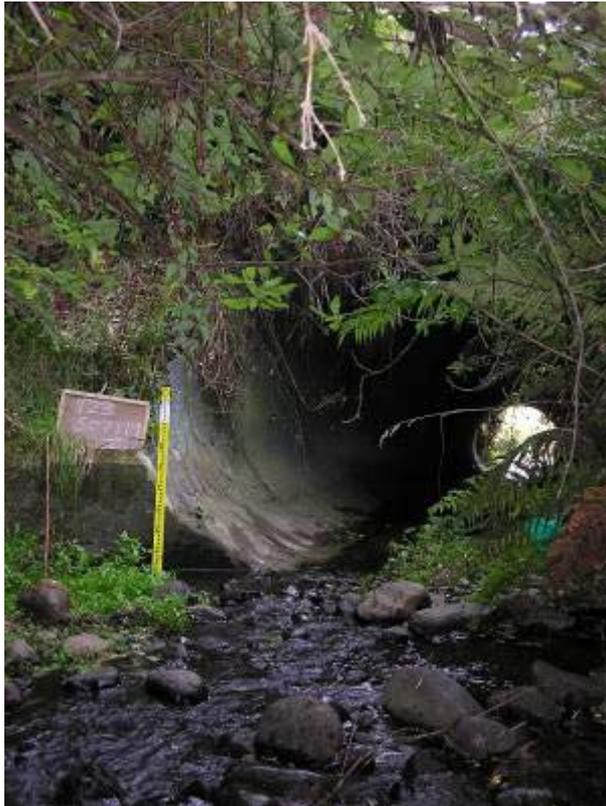
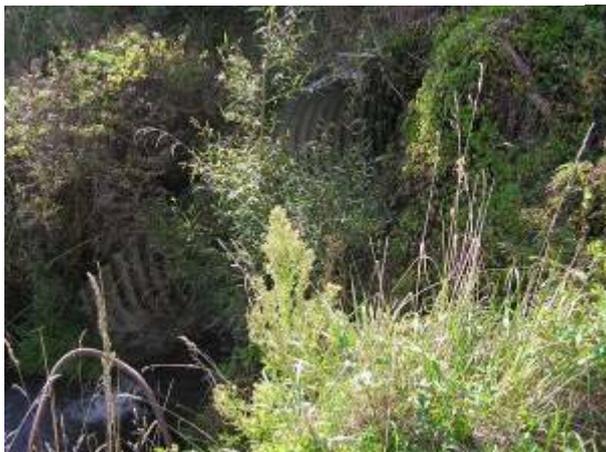
Above: Inlet.

Site no.: T23:507119	
Location: unnamed stream, Pohangina Valley East Rd	
Easting	2750795
Northing	6111966
Date assessed	27/03/2008
Structure	culvert
Type	pipe
Construction	corrugated iron
Length	24.6 m
Diameter	2.4 m
Water depth (inlet)	0.05 m
Water depth (outlet)	0.02 m
Inlet cross section	flat
Outlet cross section	perched
If perched (height)	0.23 m
If perched (undercut)	0 m
Likely severity of barrier	Most flows
Potential barriers known upstream	0
Potential barriers known downstream	0

Below: The outlet is difficult to access because of deep pool.

Potential as migratory barrier	High
Priority for remediation	Medium (difficult fix)

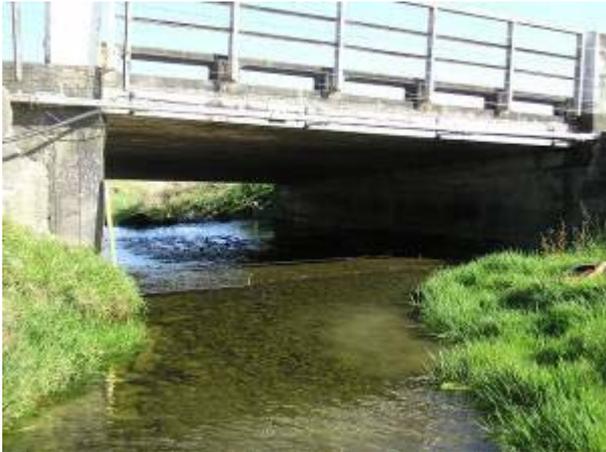
Above: Inlet.

Below: Perched outlet.

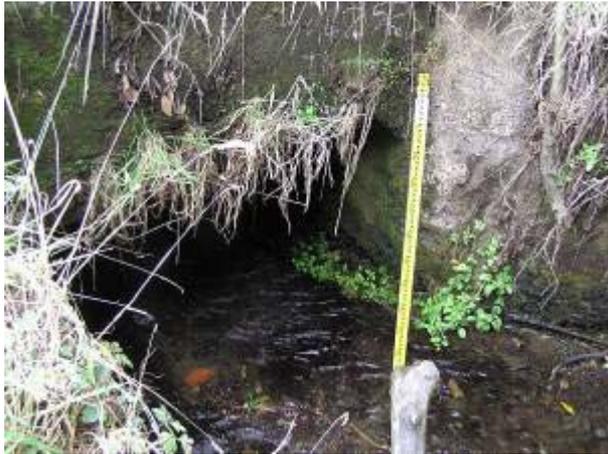
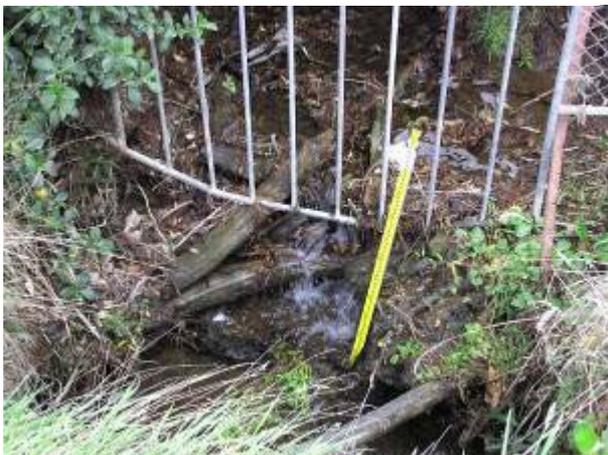
Potential as migratory barrier	High
Priority for remediation	Medium (difficult fix)

Above: Inlet.

Below: Debris dam just upstream of inlet.

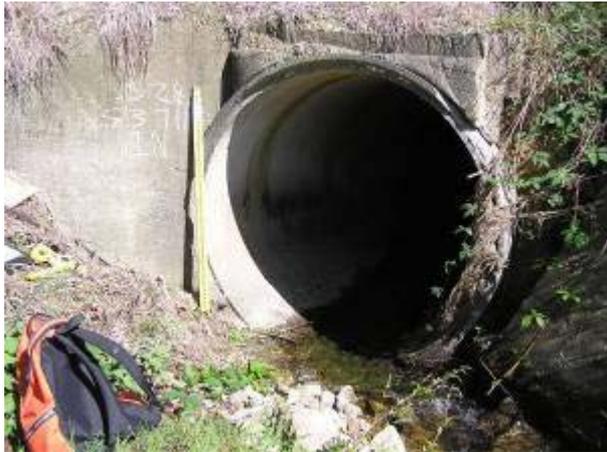
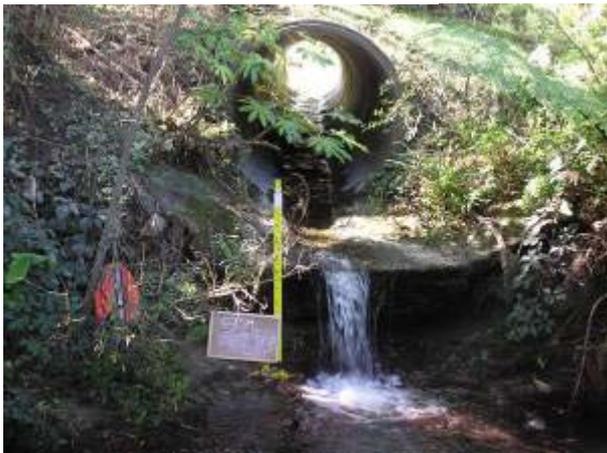
Above: Inlet.

Below: Perched outlet.

Site no.: S24:183711	
Location: unnamed stream, Kingston Rd, north of Shannon	
Easting	2718383
Northing	6071185
Date assessed	3/04/2008
Structure	culvert
Type	pipe
Construction	concrete
Length	22.7 m
Diameter	1.5 m
Water depth (inlet)	0.08 m
Water depth (outlet)	0.06 m
Inlet cross section	flat
Outlet cross section	perched
If perched (height)	0.70 m
If perched (undercut)	0.45 m
Likely severity of barrier	Most flows
Potential barriers known upstream	0
Potential barriers known downstream	0 (S24:182713, S24:182712)

Potential as migratory barrier	High
Priority for remediation	Medium (difficult fix, degraded upstream)

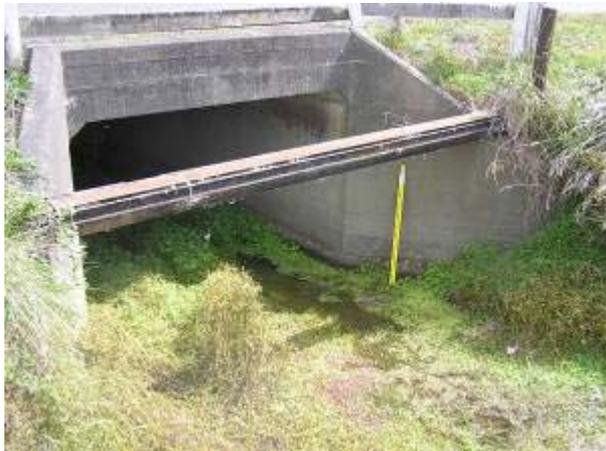
Above: Inlet that is above the level of water flow at low flows.

Below: Outlet

Site no.: T24:532912	
Location: Unnamed stream, SH2, just south of Woodville	
Easting	2753205
Northing	6091255
Date assessed	20/03/2008
Structure	culvert
Type	box
Construction	concrete
Length	10.8 m
Diameter	2.7 m
Water depth (inlet)	0 m
Water depth (outlet)	0.03 m
Inlet cross section	perched
Outlet cross section	flat
If perched (height)	0.3 m
If perched (undercut)	0 m
Likely severity of barrier	Low flows
Potential barriers known upstream	0
Potential barriers known downstream	0

Potential as migratory barrier	High
Priority for remediation	Low (degraded upstream)

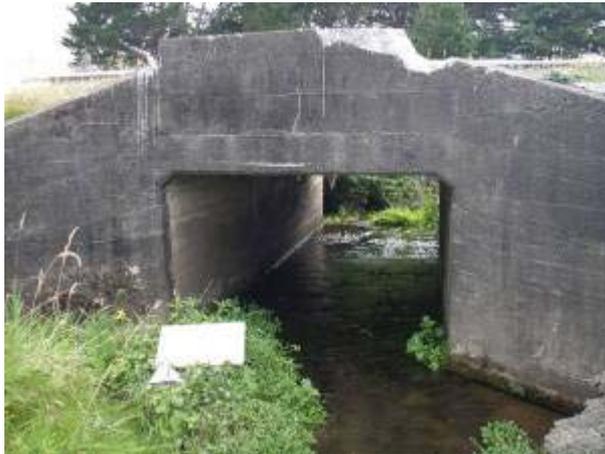
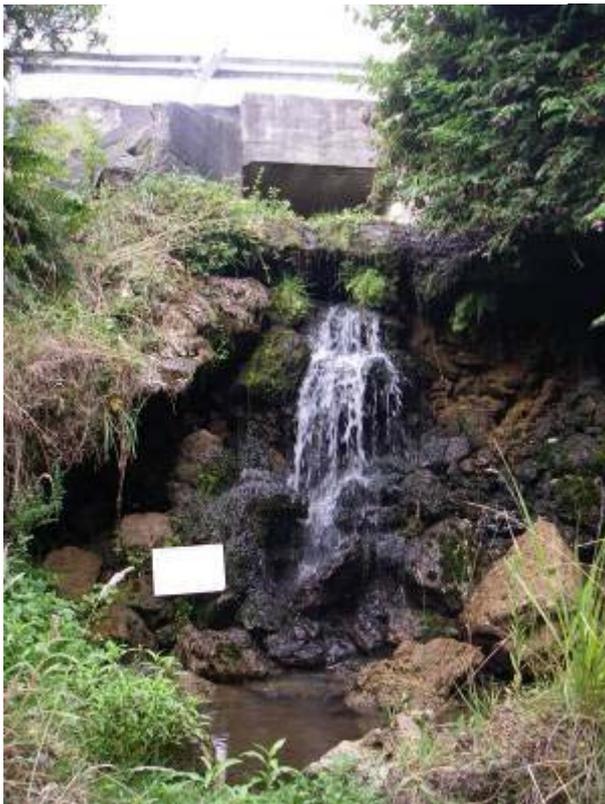
Above: Inlet.

Below: Perched outlet with remnants of a fish ramp.

Site no.: T24:422785	
Location: unnamed stream, Nikau Rd, near Pahiatua Track	
Easting	2742177
Northing	6078701
Date assessed	1/02/2008
Structure	culvert
Type	box
Construction	concrete
Length	6.7 m
Diameter	1.9 m
Water depth (inlet)	0.05 m
Water depth (outlet)	0.04 m
Inlet cross section	flat
Outlet cross section	perched
If perched (height)	4 m
If perched (undercut)	1.5 - 2 m
Likely severity of barrier	Most flows
Potential barriers known upstream	0
Potential barriers known downstream	0

Potential as migratory barrier	High
Priority for remediation	Low (difficult fix, degraded upstream)

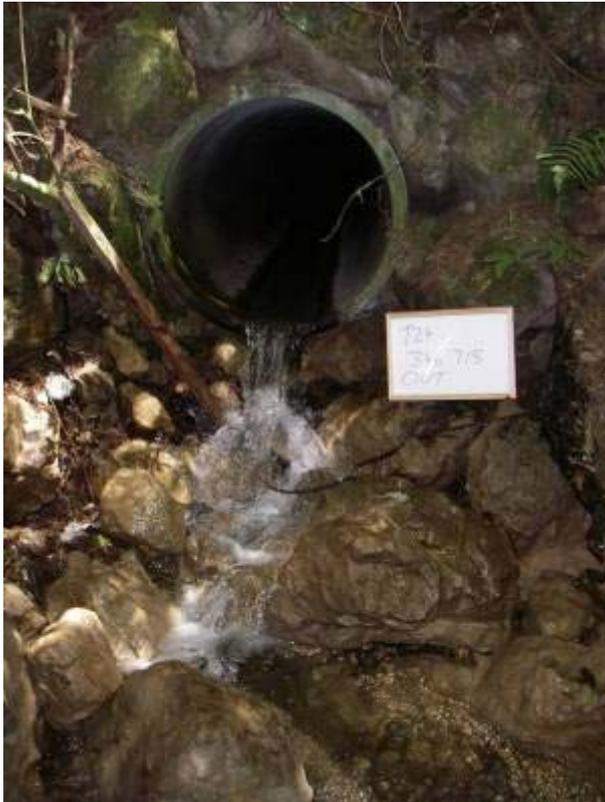
Above: Inlet concealed by debris.

Below: Perched outlet.

Potential as migratory barrier	High
Priority for remediation	Low

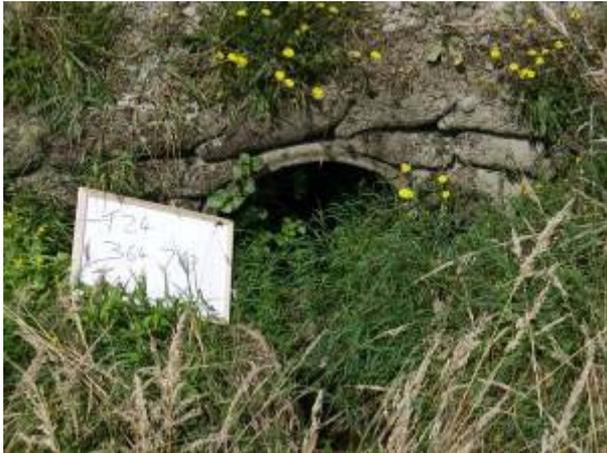
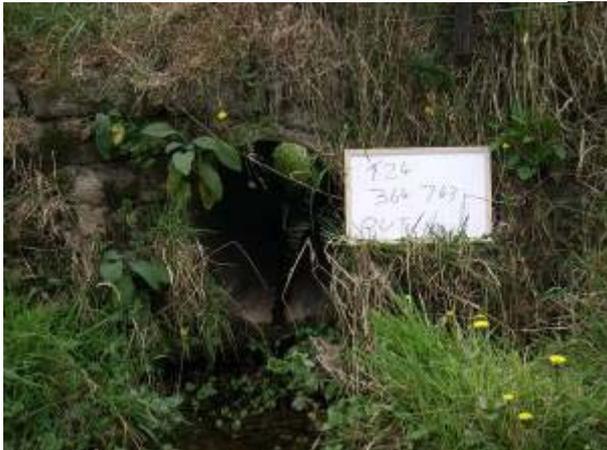
Above: Inlet.

Below: Outlet with only a dribble going through pipe. Most flow was under the pipe.

Site no.: T24:364743	
Location: unnamed stream, Naenae Rd, near road end	
Easting	2736384
Northing	6074507
Date assessed	1/02/2008
Structure	culvert
Type	pipe
Construction	concrete
Length	4.7 m
Diameter	0.6 m
Water depth (inlet)	0.02 m
Water depth (outlet)	0.002 m
Inlet cross section	flat
Outlet cross section	perched
If perched (height)	0.28 m
If perched (undercut)	0.25 m
Likely severity of barrier	Most flows
Potential barriers known upstream	0
Potential barriers known downstream	0

Potential as migratory barrier	High
Priority for remediation	Low (tiny stream, limited upstream)

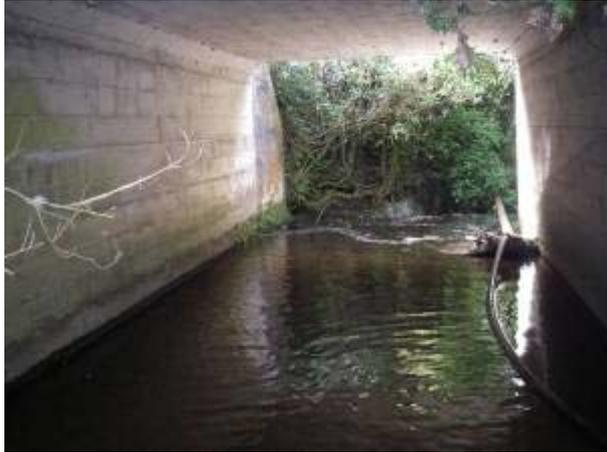
Above: Inlet. Note that a fence and deep pool prevented full photo of inlet.

Below: Perched outlet. Note this photo is incorrectly labelled on whiteboard.

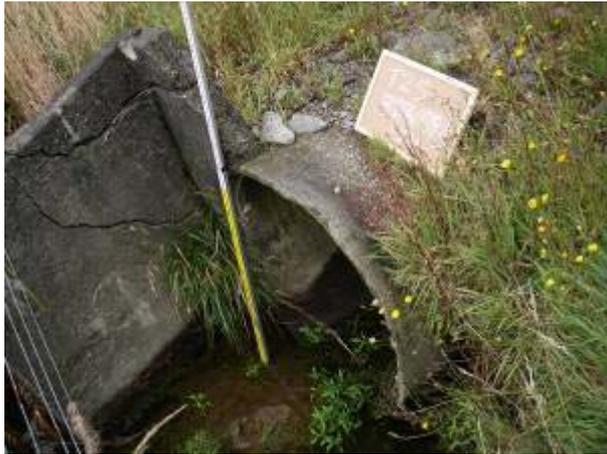
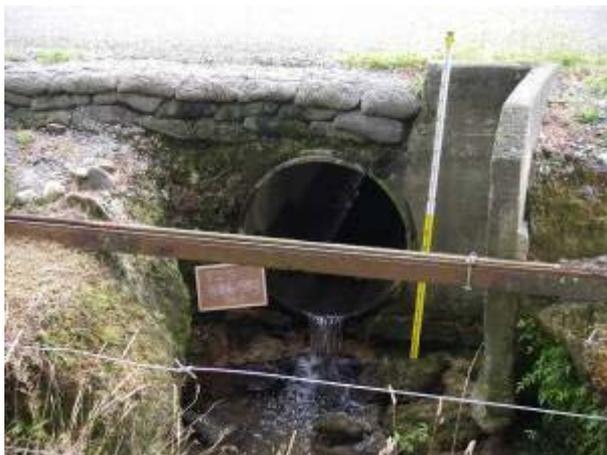
Above: Inlet.

Below: Outlet.

Site no.: T25:336593	
Location: unnamed stream, Priests Rd, near Eketahuna	
Easting	2733621
Northing	6059317
Date assessed	18/02/2008
Structure	culvert
Type	pipe
Construction	concrete
Length	8.55 m
Diameter	1.05 m
Water depth (inlet)	0.06 m
Water depth (outlet)	0.04 m
Inlet cross section	flat
Outlet cross section	perched
If perched (height)	0.3 m
If perched (undercut)	0.35 m
Likely severity of barrier	Most flows
Potential barriers known upstream	0
Potential barriers known downstream	0

Potential as migratory barrier	High
Priority for remediation	Low (limited and degraded upstream)

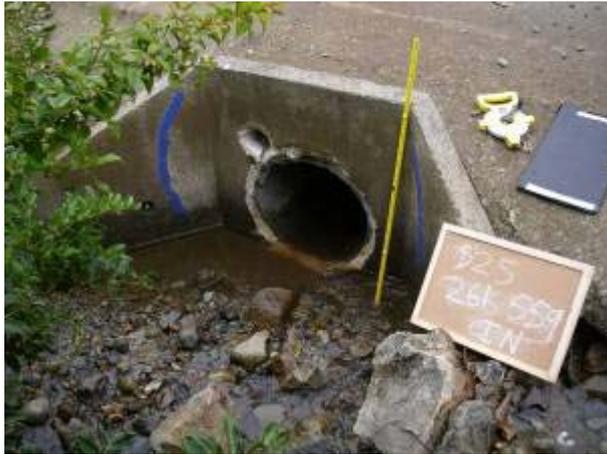
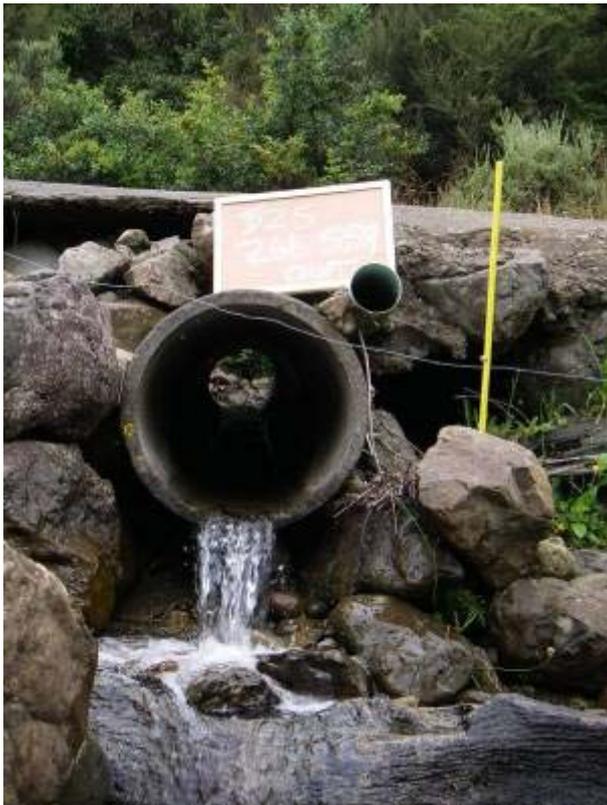
Above: Inlet.

Below: Outlet.

Site no.: S25:261559	
Location: unnamed stream, Putara Rd, near Eketahuna	
Easting	2733621
Northing	6059317
Date assessed	18/02/2008
Structure	ford
Type	pipe
Construction	concrete
Length	6.05 m
Diameter	0.44 m
Water depth (inlet)	0.05 m
Water depth (outlet)	0.03 m
Inlet cross section	flat
Outlet cross section	perched
If perched (height)	0.25 m
If perched (undercut)	>1 m
Likely severity of barrier	Most flows
Potential barriers known upstream	0
Potential barriers known downstream	0

Potential as migratory barrier	High
Priority for remediation	Low (difficult fix, limited upstream)

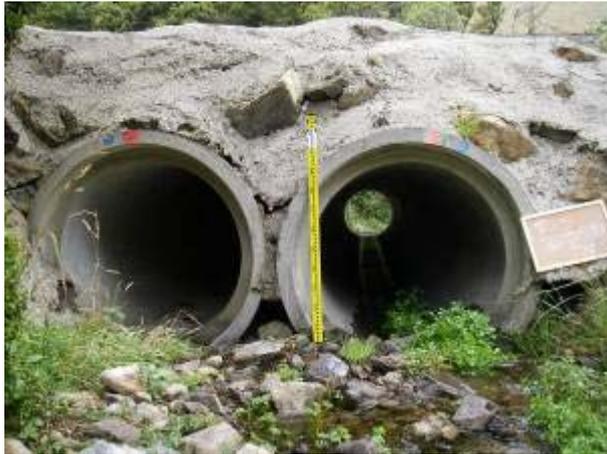
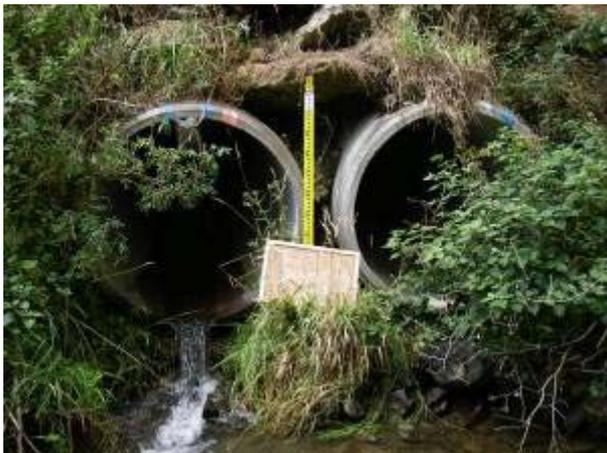
Above: Inlet. The left pipe is dry.

Below: Outlet.

Site no.: T25:310591	
Location: unnamed stream, Putara Rd, near Eketahuna	
Easting	2731052
Northing	6059173
Date assessed	18/02/2008
Structure	culvert
Type	double pipe
Construction	concrete
Length	12.3 m
Diameter	1.05 m
Water depth (inlet)	0.05 m
Water depth (outlet)	0.15 m
Inlet cross section	flat
Outlet cross section	perched
If perched (height)	0.25 m
If perched (undercut)	0.13 m
Likely severity of barrier	Most flows
Potential barriers known upstream	0
Potential barriers known downstream	0

Potential as migratory barrier	High
Priority for remediation	Low (limited upstream)

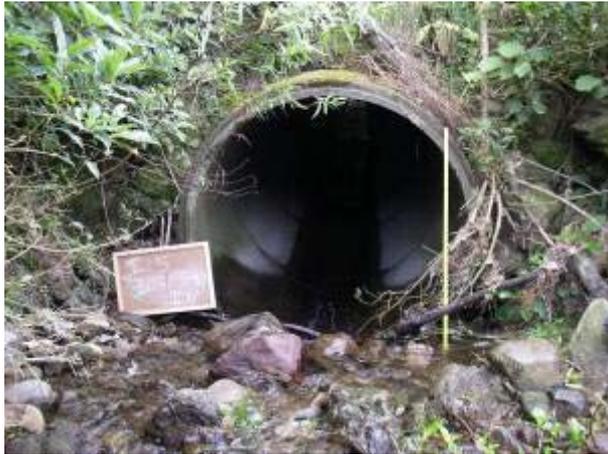
Above: Inlet.

Below: Perched outlet.
