A preliminary assessment of potential barriers to fish migration in the Manawatu River catchment, North Island, New Zealand

A report prepared for Horizons Regional Council, June 2008

Dr Alex James and Dr Mike Joy

**Foundation of Research, Science & Technology
EnviroLink Contract Ref: 437-HZLC45**

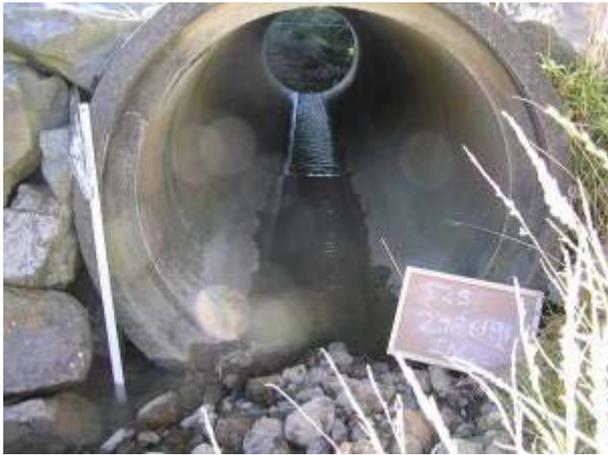
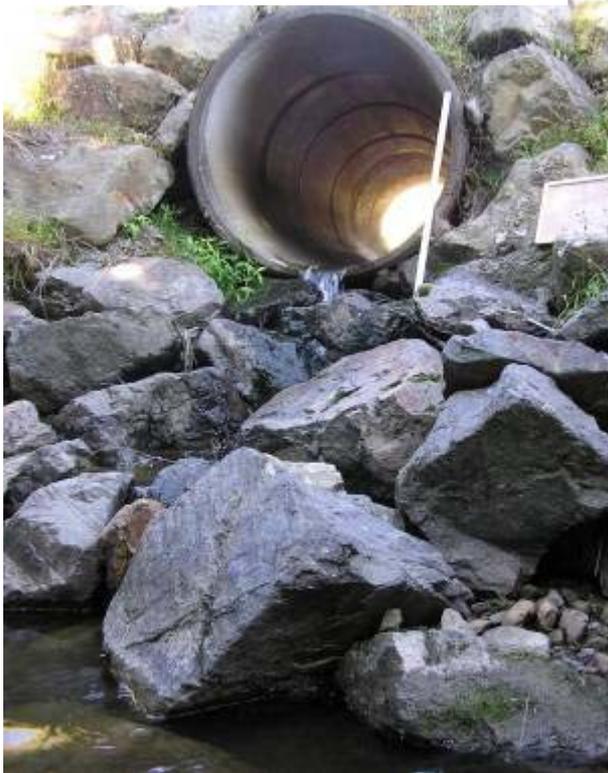
Above: Inlet.

Below: Perched outlet.

Site no.: S25:298619	
Location: unnamed stream, Mangaroa Rd, near Eketahuna	
Easting	2729852
Northing	6061985
Date assessed	26/02/2008
Structure	culvert
Type	pipe
Construction	concrete
Length	7.5 m
Diameter	2.5 m
Water depth (inlet)	0.05 m
Water depth (outlet)	0.03 m
Inlet cross section	flat
Outlet cross section	perched
If perched (height)	0.12 m
If perched (undercut)	0.38 m
Likely severity of barrier	Most flows
Potential barriers known upstream	0
Potential barriers known downstream	0

Potential as migratory barrier	High
Priority for remediation	Low (limited upstream)

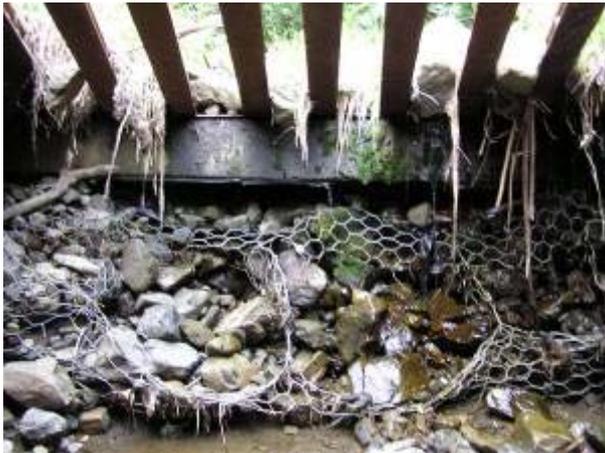
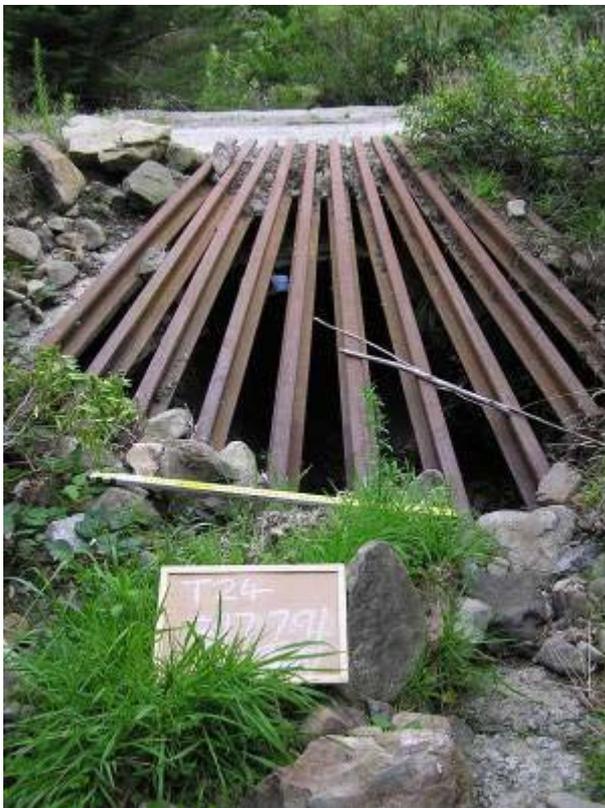
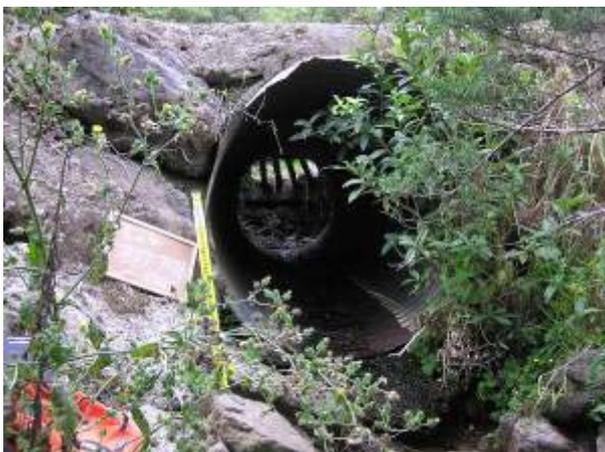
Above: Inlet facing upstream below iron boulder screen.
 Below: Inlet boulder screen from above.

Site no.: T24:317791	
Location: unnamed stream, Kahuterawa Rd	
Easting	2731759
Northing	6079104
Date assessed	11/03/2008
Structure	culvert
Type	pipe
Construction	corrugated iron
Length	8.1 m
Diameter	1.4 m
Water depth (inlet)	0.01 m
Water depth (outlet)	0.01 m
Inlet cross section	perched
Outlet cross section	perched
If perched (height)	0.35 m
If perched (undercut)	0 m
Likely severity of barrier	Most flows
Potential barriers known upstream	0
Potential barriers known downstream	0

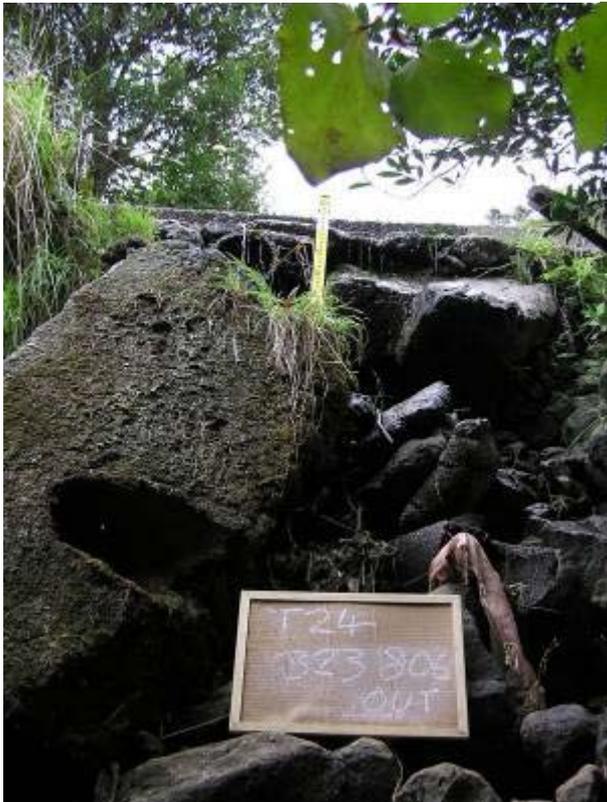
Above: Inlet with culvert totally buried by sediment.

Below: Outlet. The pipe is just to the left of the surveyor's staff.

Site no.: T24:323806	
Location: unnamed stream, Kahuterawa Rd	
Easting	2732311
Northing	6080625
Date assessed	11/03/2008
Structure	ford
Type	single culvert
Construction	concrete
Length	5.3 m
Diameter	0.23 m
Water depth (inlet)	0.01 m
Water depth (outlet)	0.005 m
Inlet cross section	flat
Outlet cross section	perched
If perched (height)	1.17 m
If perched (undercut)	>1 m
Likely severity of barrier	Most flows
Potential barriers known upstream	0
Potential barriers known downstream	0

Potential as migratory barrier	High
Priority for remediation	Low (difficult fix)

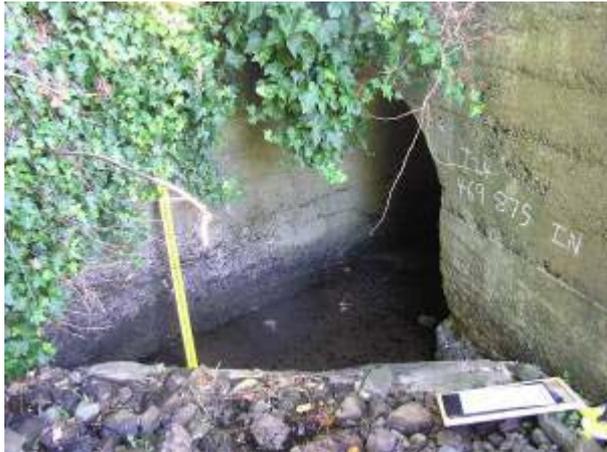
Above: Perched inlet.

Below: Perched outlet.

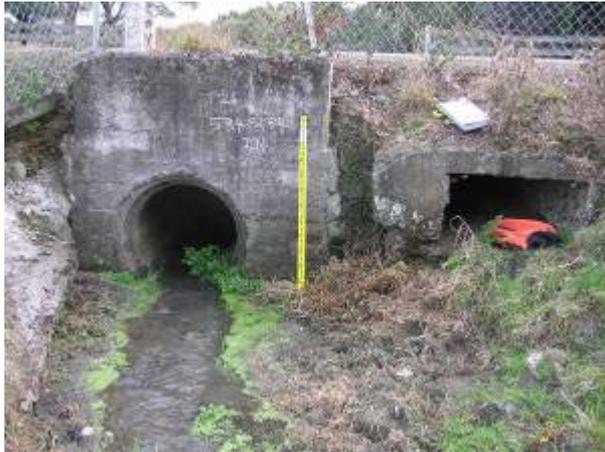
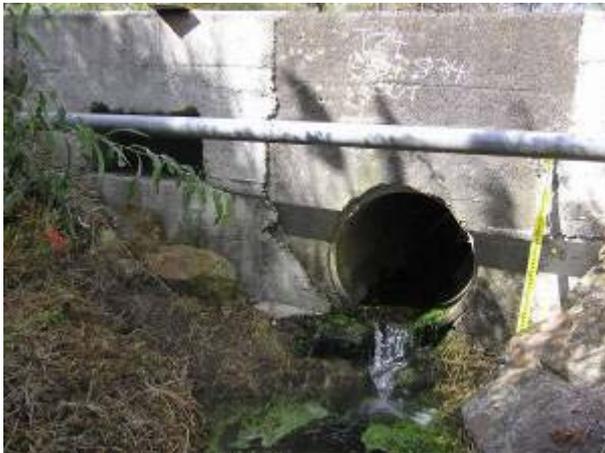
Above: Inlet.

Below: Perched outlet.

Site no.: T24:534834	
Location: unnamed stream, Mangatainoka, near Brewery	
Easting	2753450
Northing	6083416
Date assessed	20/03/2008
Structure	culvert
Type	pipe
Construction	concrete
Length	10.1 m
Diameter	0.75 m
Water depth (inlet)	0.08 m
Water depth (outlet)	0.05 m
Inlet cross section	flat
Outlet cross section	perched
If perched (height)	0.18 m
If perched (undercut)	0.3 m
Likely severity of barrier	Most flows
Potential barriers known upstream	0
Potential barriers known downstream	0

Potential as migratory barrier	High
Priority for remediation	Low (degraded upstream)

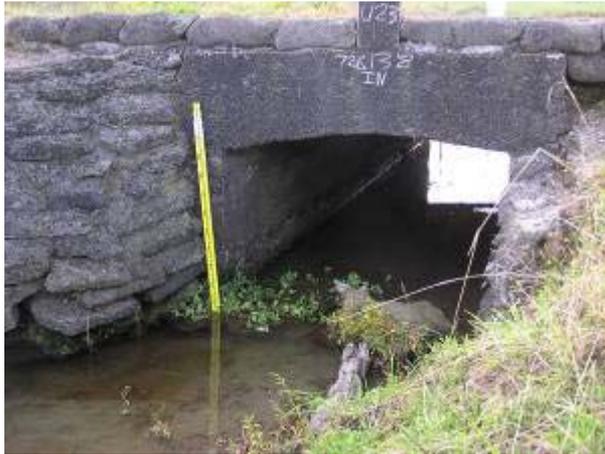
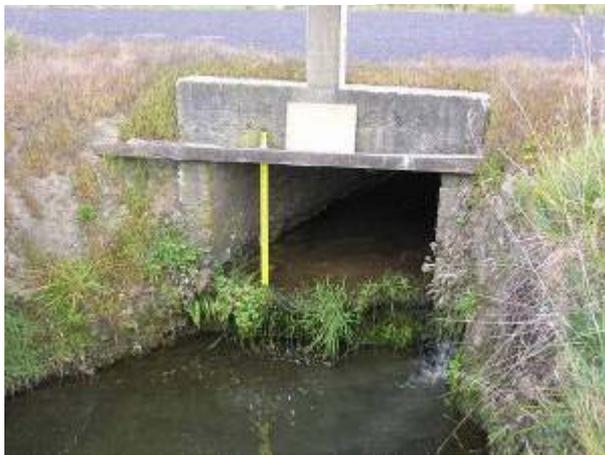
Above: Inlet.

Below: Perched outlet.

Site no.: U23:726138	
Location: unnamed stream, Umutaoroa Rd, near Dannevirke	
Easting	2772624
Northing	6113887
Date assessed	26/03/2008
Structure	culvert
Type	box
Construction	concrete
Length	6.32 m
Diameter	1.52 m
Water depth (inlet)	0.05 m
Water depth (outlet)	0.02 m
Inlet cross section	pooled
Outlet cross section	perched
If perched (height)	0.44 m
If perched (undercut)	0.45 m
Likely severity of barrier	Most flows
Potential barriers known upstream	1 (U23:722139)
Potential barriers known downstream	1 (U23:735133)

Potential as migratory barrier	High
Priority for remediation	Low (degraded upstream)

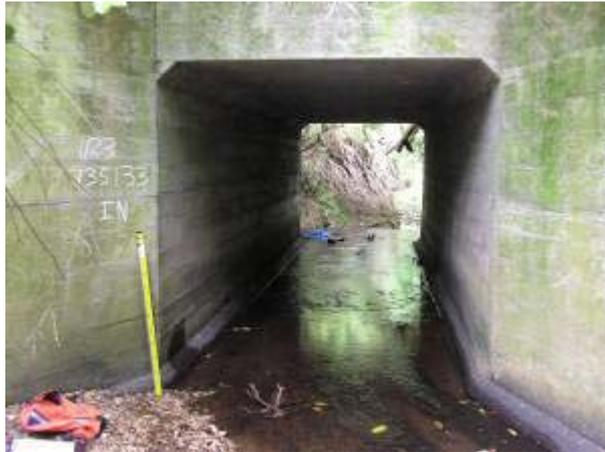
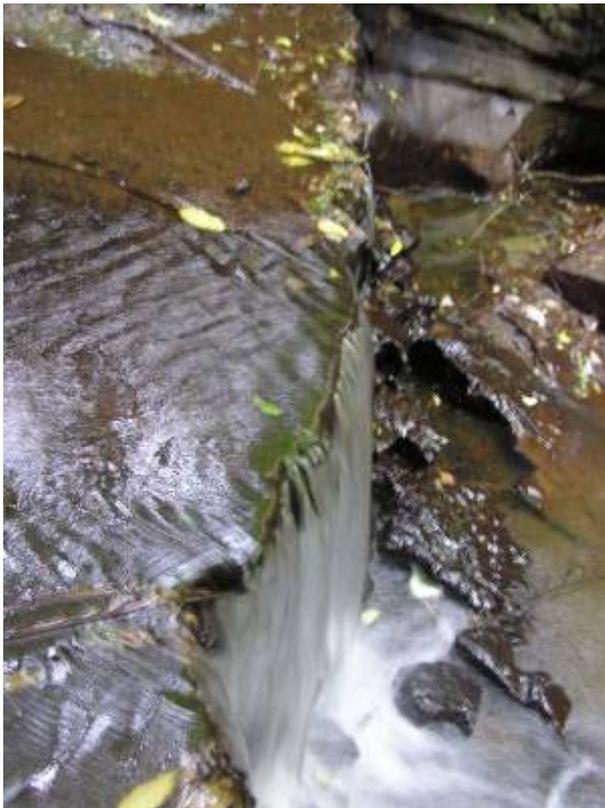
Above: Inlet.

Below: Perched outlet. Access to below culvert was difficult.

Site no.: U23:735133	
Location: unnamed stream, Dangen Rd, near Dannevirke	
Easting	2773578
Northing	6113398
Date assessed	26/03/2008
Structure	culvert
Type	box
Construction	concrete
Length	12.5 m
Diameter	2.42 m
Water depth (inlet)	0.05 m
Water depth (outlet)	0.02 m
Inlet cross section	flat
Outlet cross section	perched
If perched (height)	1.45 m
If perched (undercut)	~0.5 m
Likely severity of barrier	Most flows
Potential barriers known upstream	2 (U23:735133, U23:726138)
Potential barriers known downstream	0

Potential as migratory barrier	High
Priority for remediation	Low (difficult fix, degraded upstream)

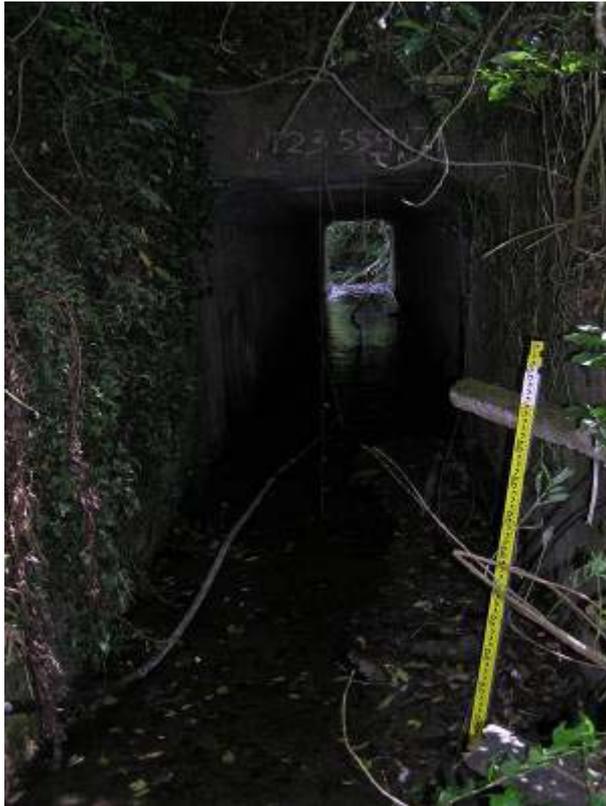
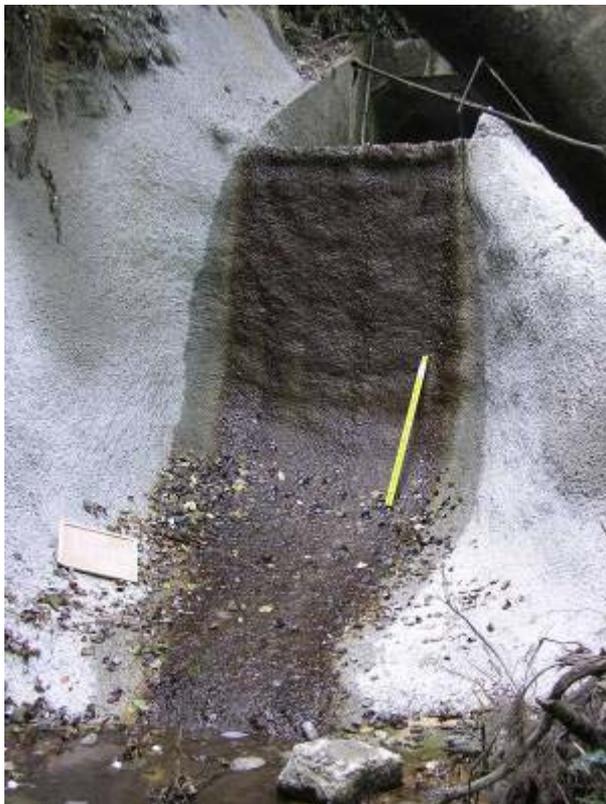
Above: Inlet.

Below: Extremely perched outlet.
Evidence of very recent erosion prevention works.

Site no.: T23:559171	
Location: unnamed stream, Pohangina Valley East Rd	
Easting	2755944
Northing	6117197
Date assessed	27/03/2008
Structure	culvert
Type	box
Construction	concrete
Length	26.5 m
Diameter	1.74 m
Water depth (inlet)	0.02 m
Water depth (outlet)	0.01 m
Inlet cross section	flat
Outlet cross section	perched
If perched (height)	~3 m
If perched (undercut)	0 m
Likely severity of barrier	Most flows
Potential barriers known upstream	0
Potential barriers known downstream	0

Potential as migratory barrier	High
Priority for remediation	Low (difficult fix, limited upstream)

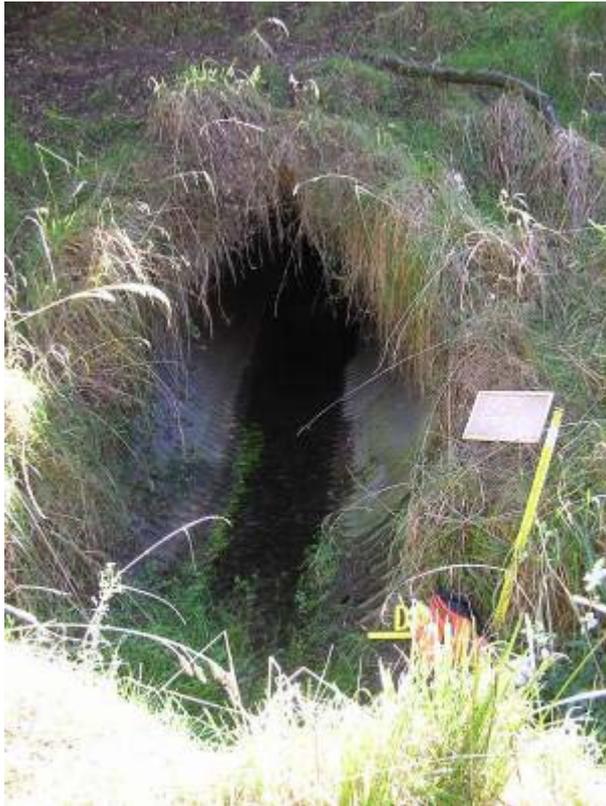
Above: Inlet.

Site no.: U23:775011	
Location: Kotarenu Stream, Weber Rd, near Dannevirke	
Easting	2777563
Northing	6101123
Date assessed	8/04/2008
Structure	culvert
Type	pipe
Construction	corrugated iron
Length	41 m
Diameter	2.4 m
Water depth (inlet)	0.09 m
Water depth (outlet)	0.10 m
Inlet cross section	flat
Outlet cross section	perched
If perched (height)	1.36 m
If perched (undercut)	2 m+
Likely severity of barrier	Most flows
Potential barriers known upstream	0
Potential barriers known downstream	0

Potential as migratory barrier	High
Priority for remediation	Low (difficult fix, degraded upstream)

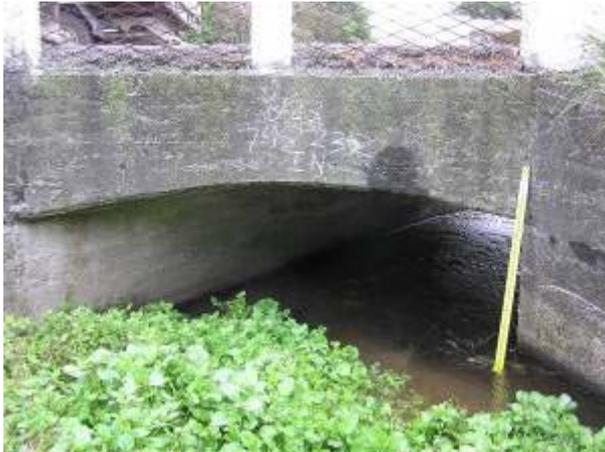
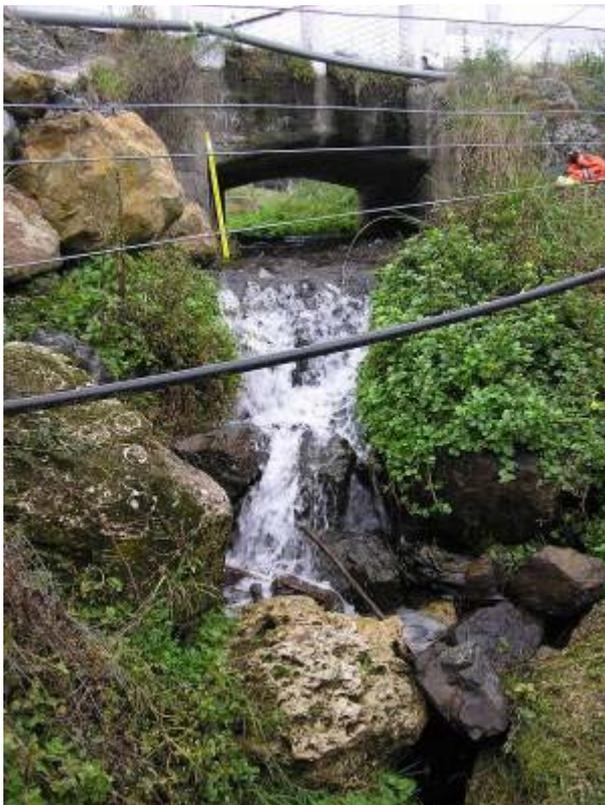
Above: Inlet.

Site no.: U23:798232	
Location: Unnamed stream, Ngamoko Rd, near Norsewood	
Easting	2779828
Northing	6123276
Date assessed	8/04/2008
Structure	culvert/bridge
Type	box
Construction	concrete
Length	12.6 m
Diameter	2.7 m
Water depth (inlet)	0.16 m
Water depth (outlet)	0.05 m
Inlet cross section	flat
Outlet cross section	perched
If perched (height)	1.6 m
If perched (undercut)	0 m
Likely severity of barrier	Most flows
Potential barriers known upstream	0
Potential barriers known downstream	1 (U23:856230)

Below: Perched outlet.

Potential as migratory barrier	High
Priority for remediation	Low (difficult fix, degraded upstream)

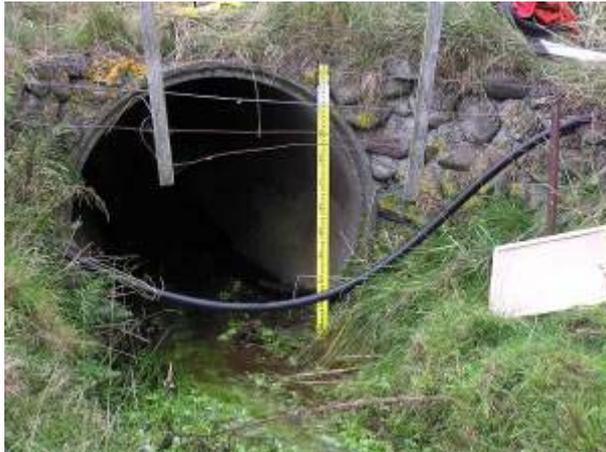
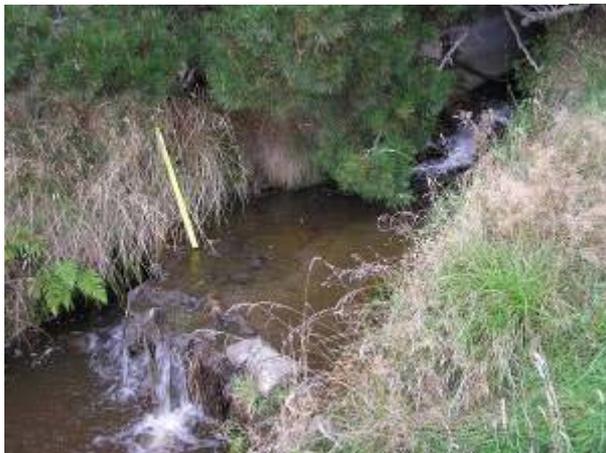
Above: Inlet.

Below: The outlet is at the top right with a perched drop around 3 m downstream.

Site no.: U23:803241	
Location: Unnamed stream, Manawatu River Rd, near Norsewood	
Easting	2780376
Northing	6124118
Date assessed	8/04/2008
Structure	culvert
Type	pipe
Construction	concrete
Length	19.66 m
Diameter	1.17 m
Water depth (inlet)	0.12 m
Water depth (outlet)	0.06 m
Inlet cross section	flat
Outlet cross section	perched
If perched (height)	0.3 m
If perched (undercut)	0.5 m
Likely severity of barrier	Most flows
Potential barriers known upstream	0
Potential barriers known downstream	1 (U23:856230)

Potential as migratory barrier	High
Priority for remediation	Low (difficult fix, degraded upstream)

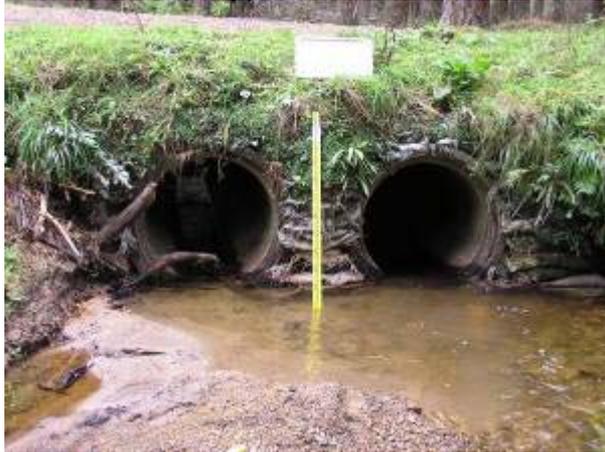
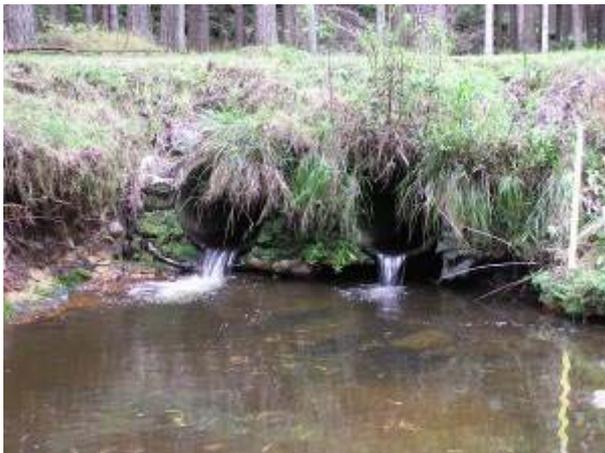
Above: Inlet.

Below: Perched outlet.

Site no.: S24:284745 (GPS coords from clearing 50m away)	
Location: Unnamed stream, Scotts Rd, Gordon Kear Forest	
Easting	2728433
Northing	6074540
Date assessed	20/04/2008
Structure	culvert
Type	double pipe
Construction	concrete
Length	7.7 m
Diameter	0.75 m
Water depth (inlet)	0.05/0.06 m
Water depth (outlet)	0.04/0.04 m
Inlet cross section	flat
Outlet cross section	perched
If perched (height)	0.27 m
If perched (undercut)	0.55 m
Likely severity of barrier	Most flows
Potential barriers known upstream	3 (S24:284745, S24:282744, S24:280740)
Potential barriers known downstream	2 (S24:287748, S24:589749)

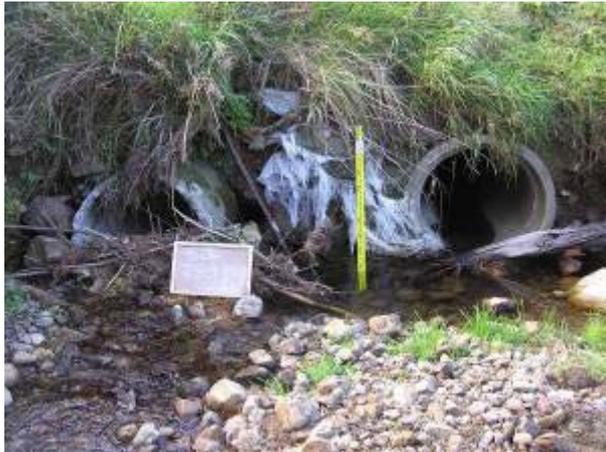
Above: Inlet.

Potential as migratory barrier	High
Priority for remediation	Low (difficult fix)

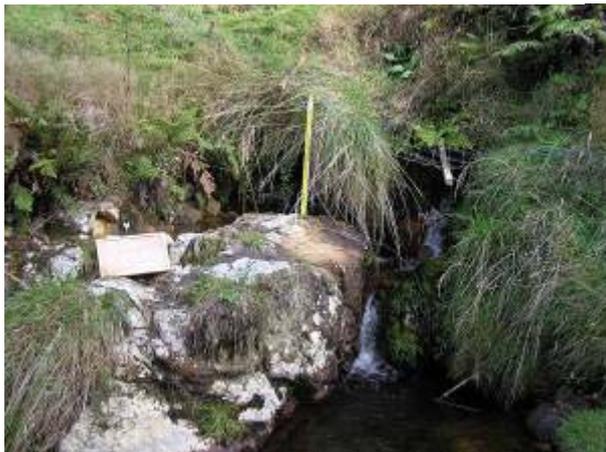
Below: Perched outlet with drop over bedrock outcrop.

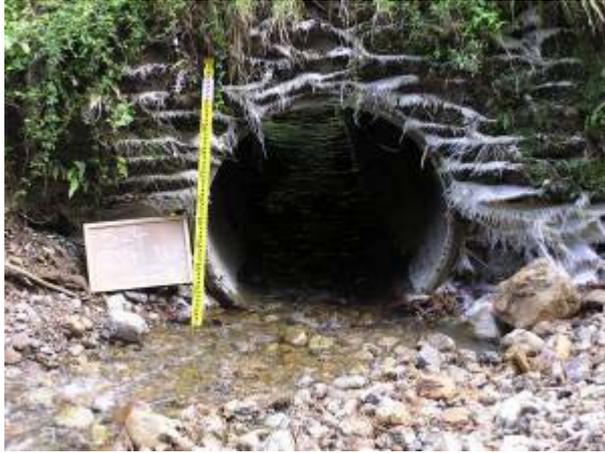
Above: Inlet.

Potential as migratory barrier	High
Priority for remediation	Low (difficult fix, limited upstream)

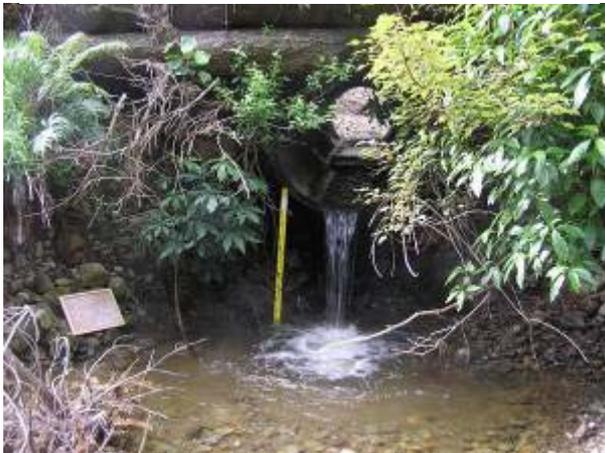
Below: Perched outlet with significant undercutting.

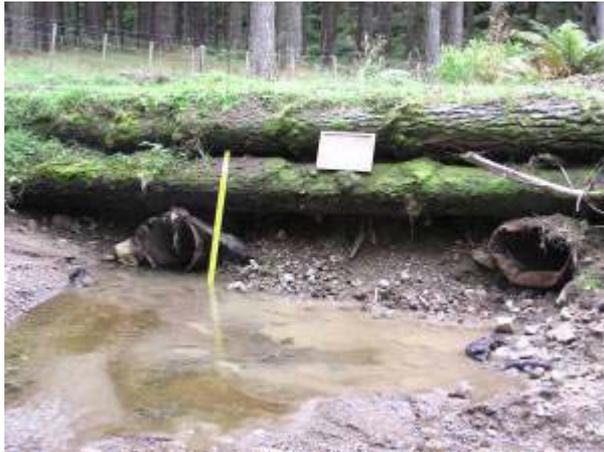
Above: Inlet. No water flows through the righthand pipe.

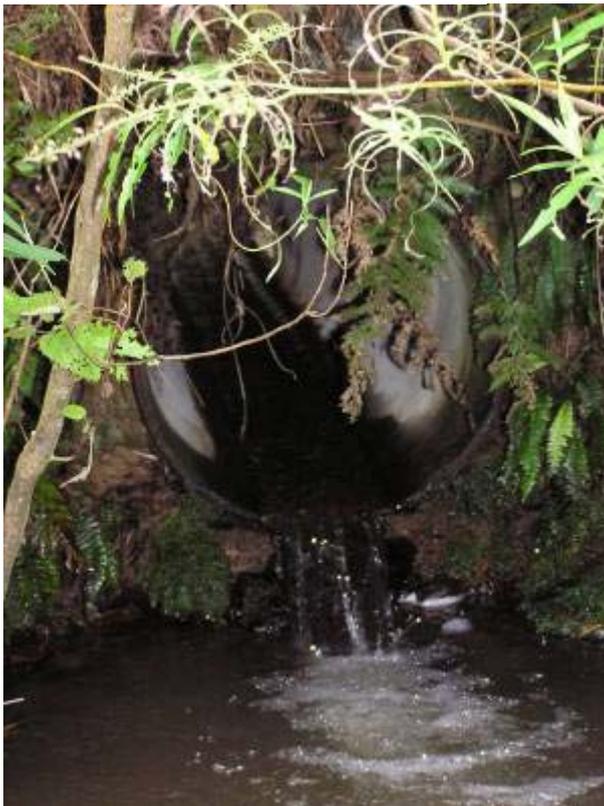
Below: Perched outlet.

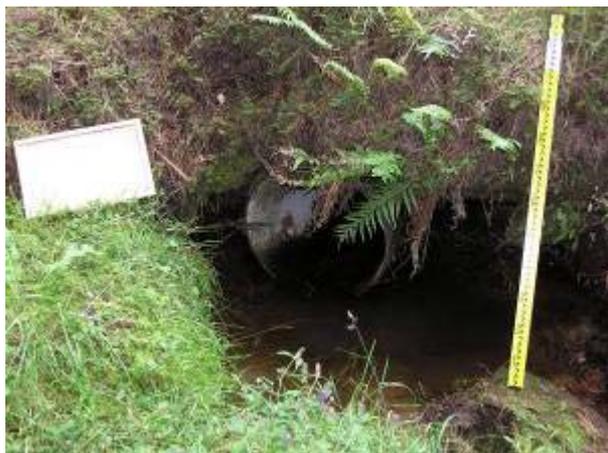
Above: Inlet.

Potential as migratory barrier	High
Priority for remediation	Low (difficult fix, limited upstream)

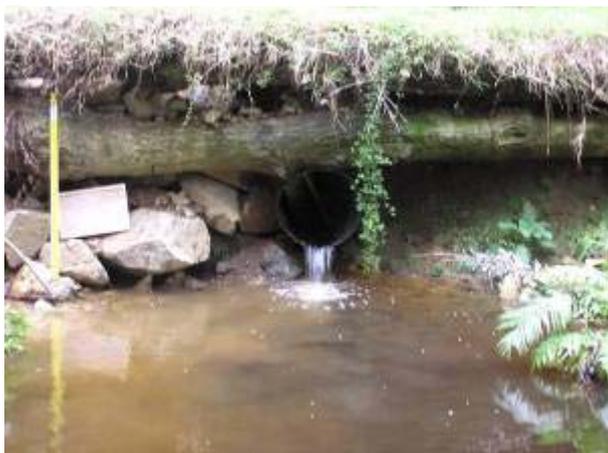
Below: Perched outlet. There is flow outside of culvert here and the road is being undermined.

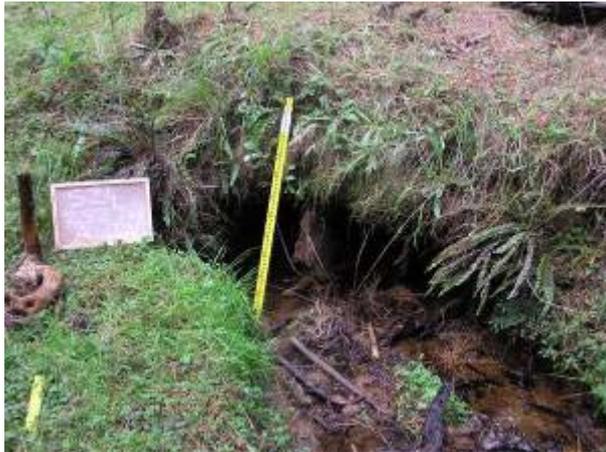
Above: Inlet.

Potential as migratory barrier	High
Priority for remediation	Low (difficult fix, limited upstream)

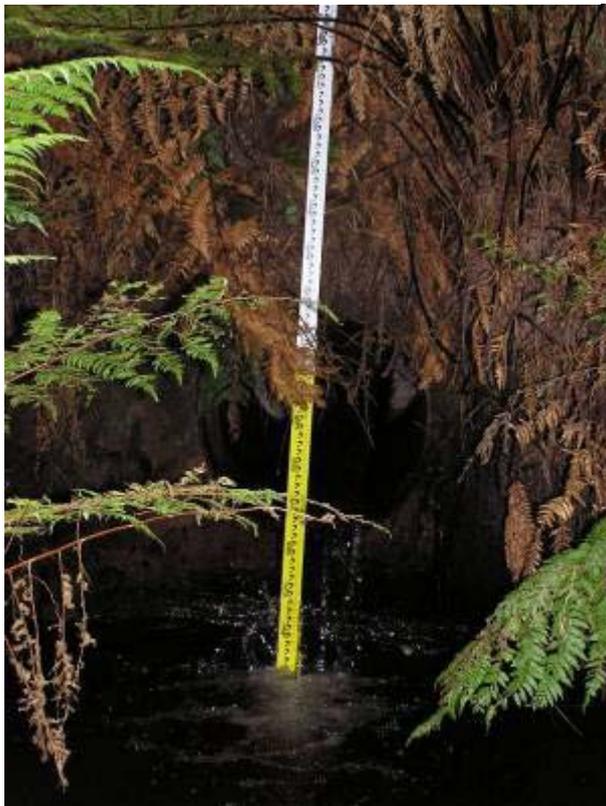
Below: Perched outlet. A deep (>1 m) plunge pool made access difficult.

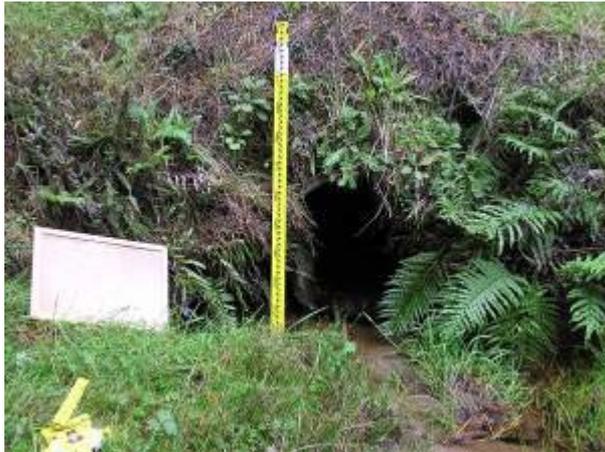
Above: Inlet.

Potential as migratory barrier	High
Priority for remediation	Low (difficult fix, limited upstream)

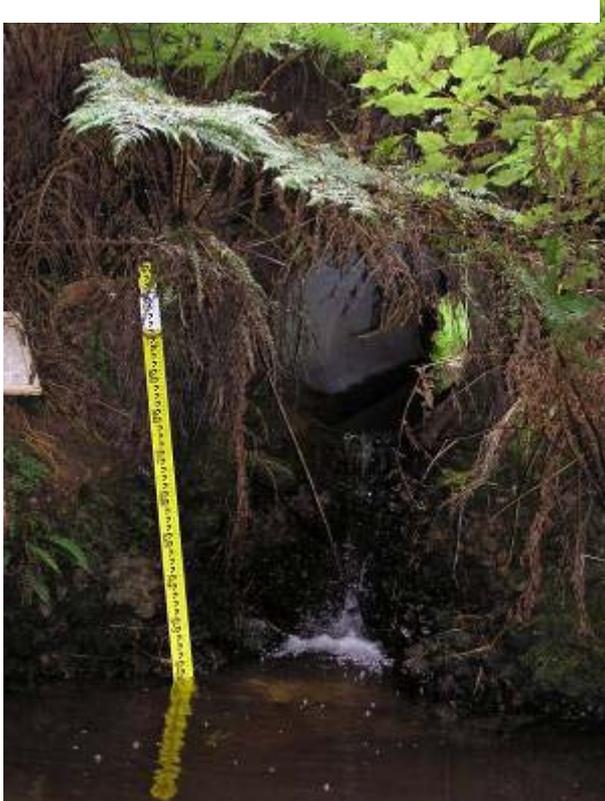
Below: Perched outlet.

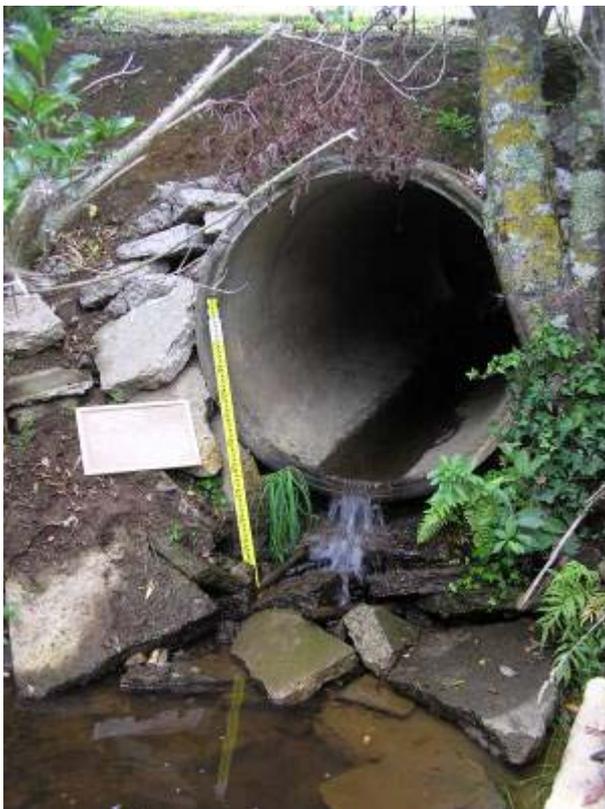
Below: Perched outlet.

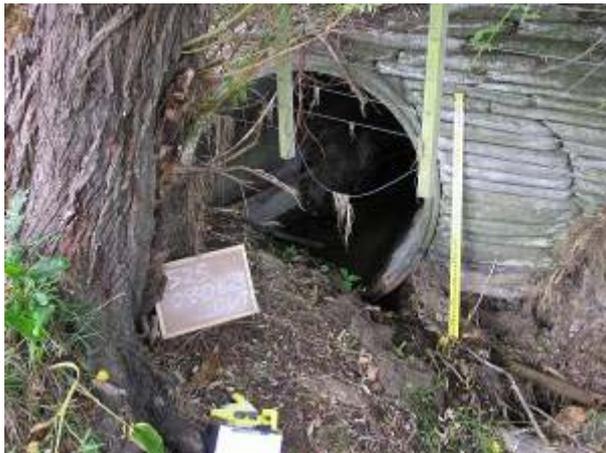
Below: Perched outlet.

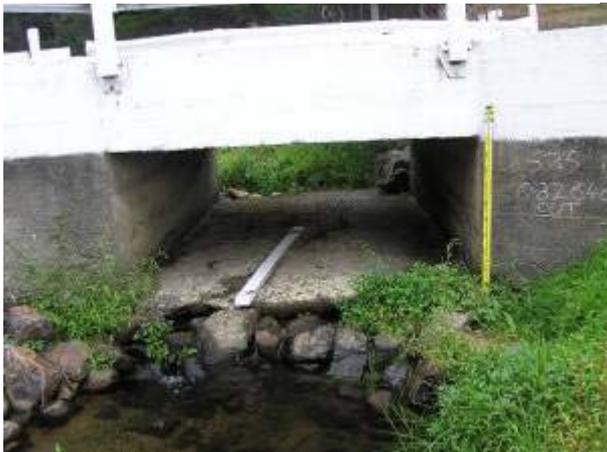
Below: The outlet with the entire flow beneath the concrete base of the culvert.

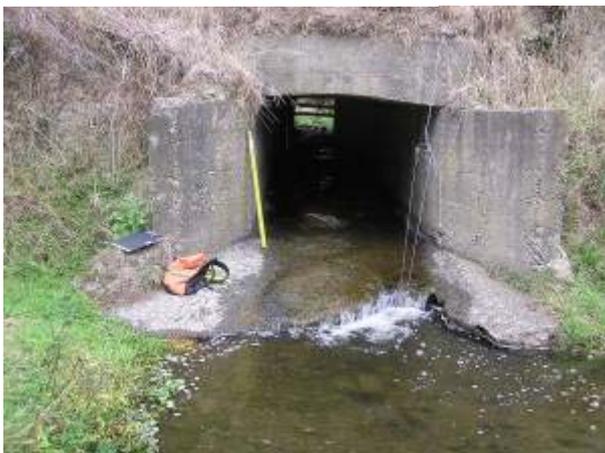
Below: Perched outlet.

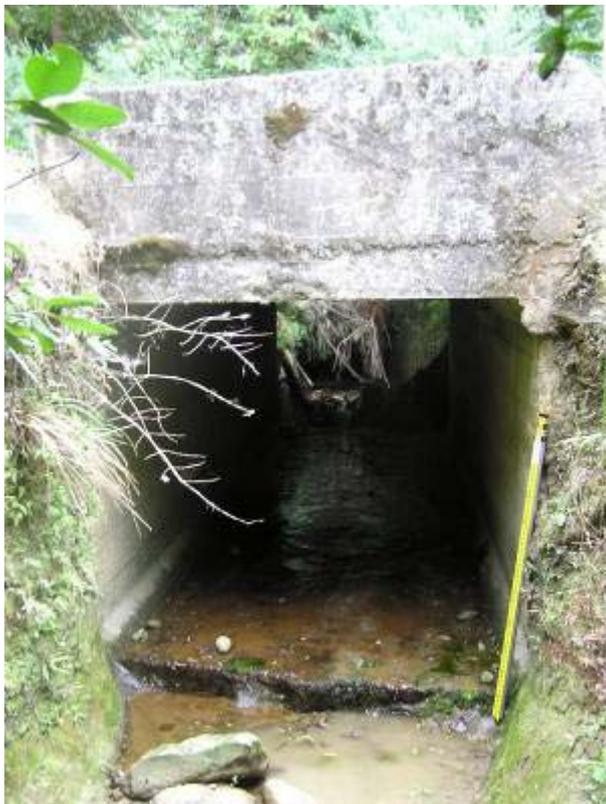
Below: Perched outlet.

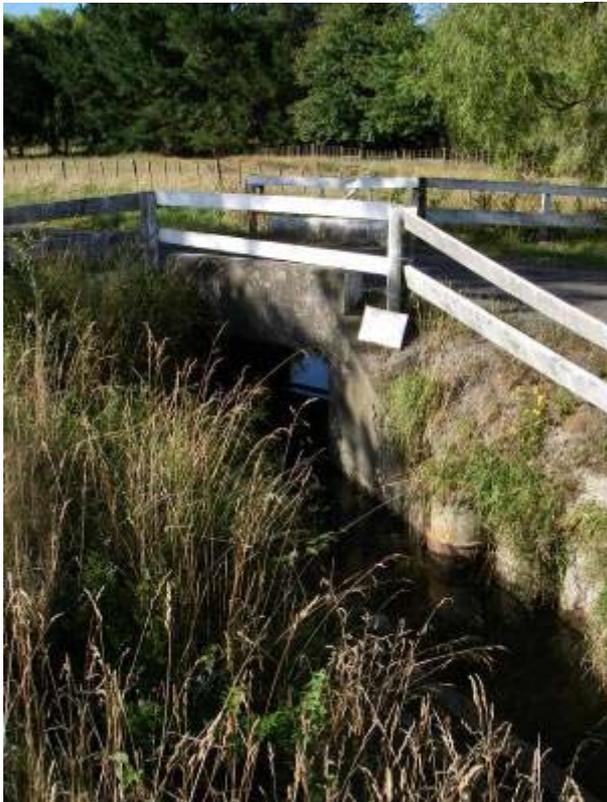
Below: Outlet. This stream is barely moving at this site and smells anoxic.

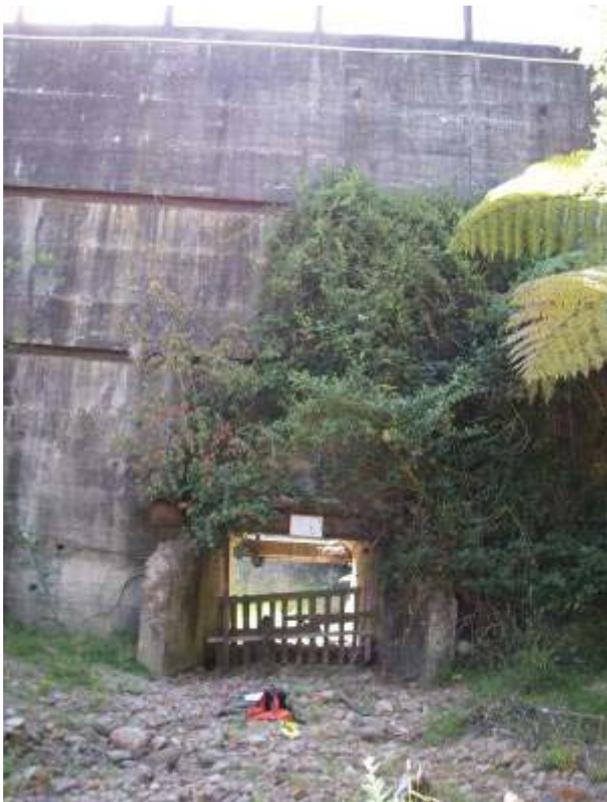
Below: Outlet. This site was dry at the time of assessment.

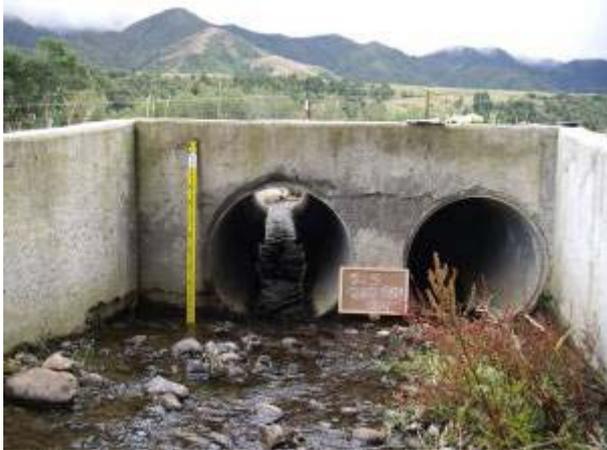
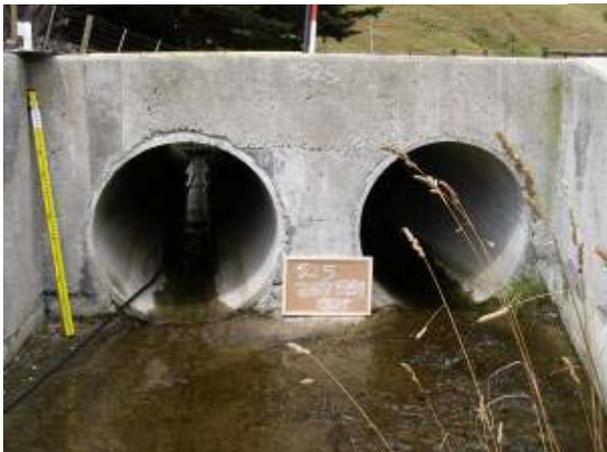
Above: Inlet.

Below: Outlet.

Potential as migratory barrier	Low
Priority for remediation	Low

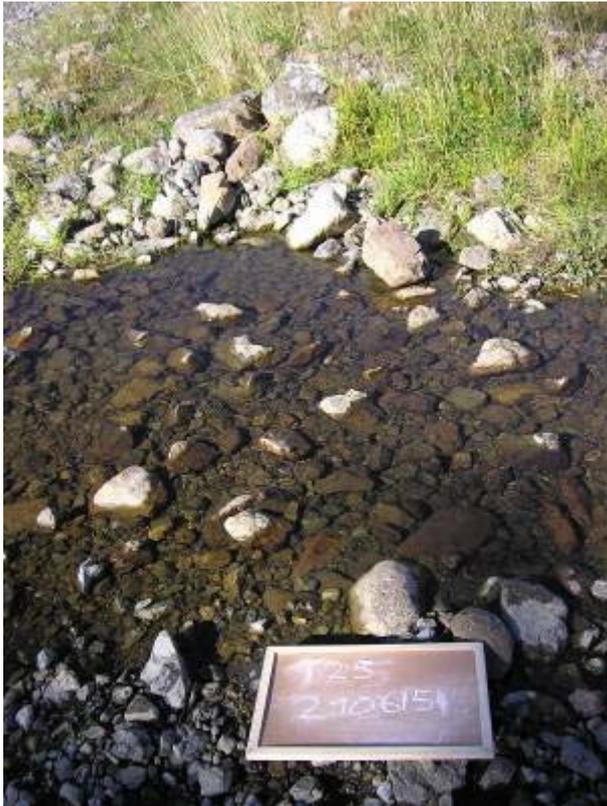
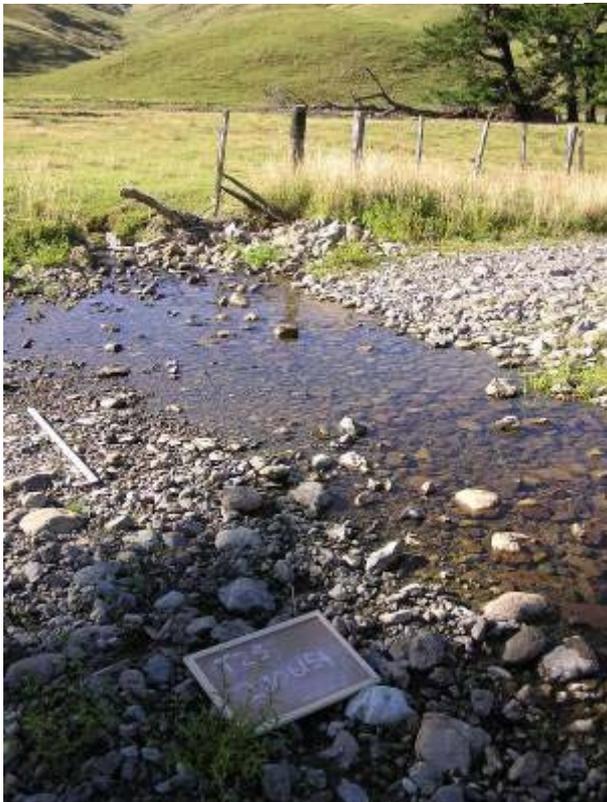
Above: Inlet. Label should be S25 not T25.

Below: The ford.

Potential as migratory barrier	Low
Priority for remediation	Low

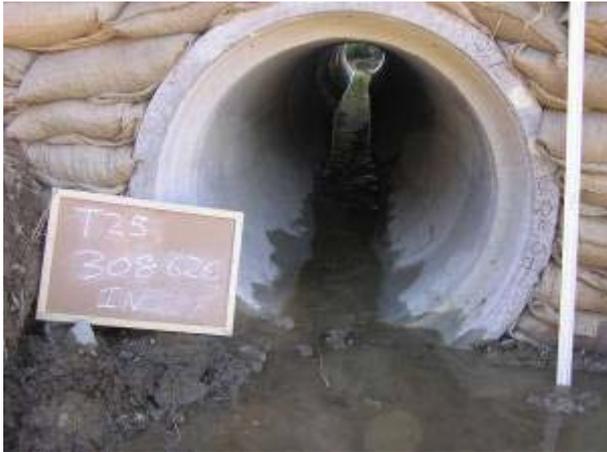
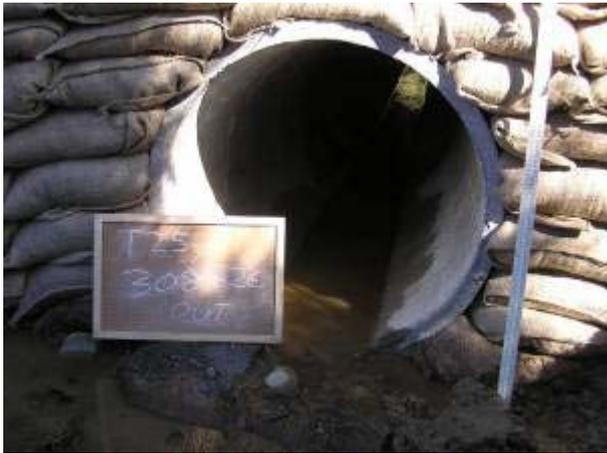
Above: Inlet. This culvert was installed just before site visit.

Below: Outlet.

Potential as migratory barrier	Low
Priority for remediation	Low

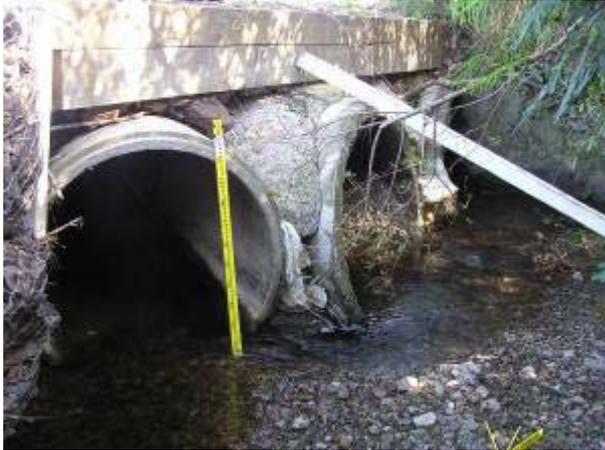
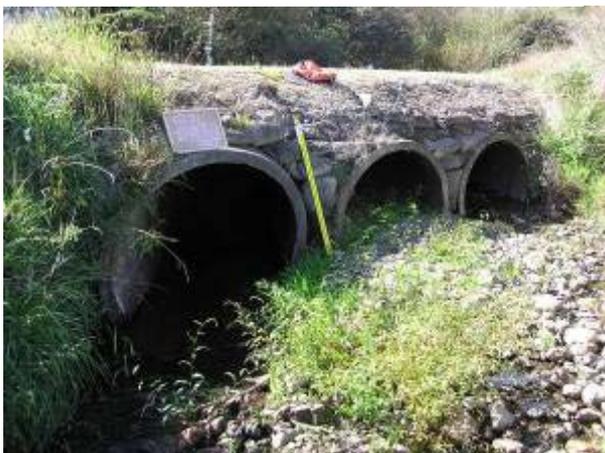
Below: Outlet. The middle pipe is half filled with sediment.

Potential as migratory barrier	Low
Priority for remediation	Low

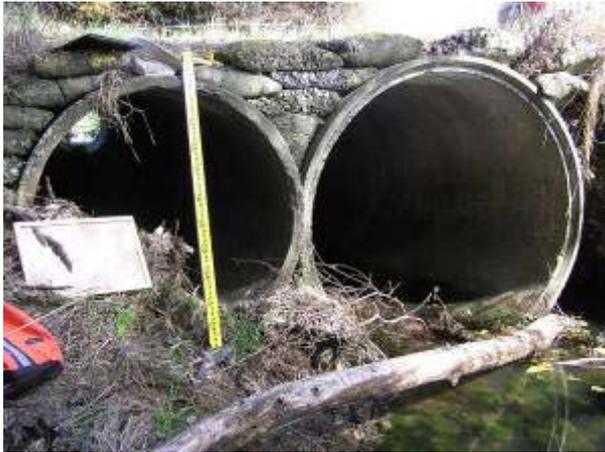
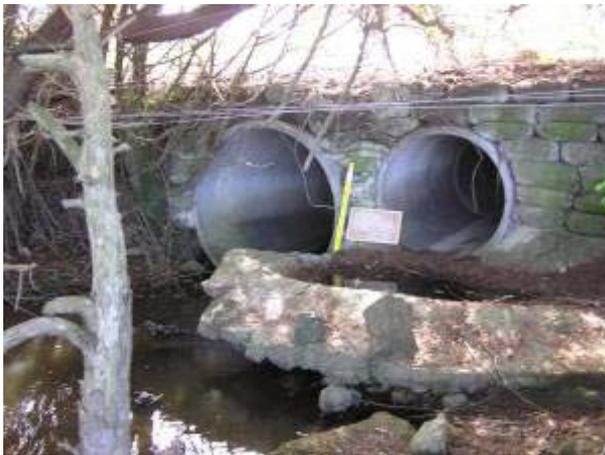
Below: Outlet. The righthand pipe was well above the water level at the time of assessment. This dry pipe has a severely undercut and perched fish pass structure.

Potential as migratory barrier	Low
Priority for remediation	Low

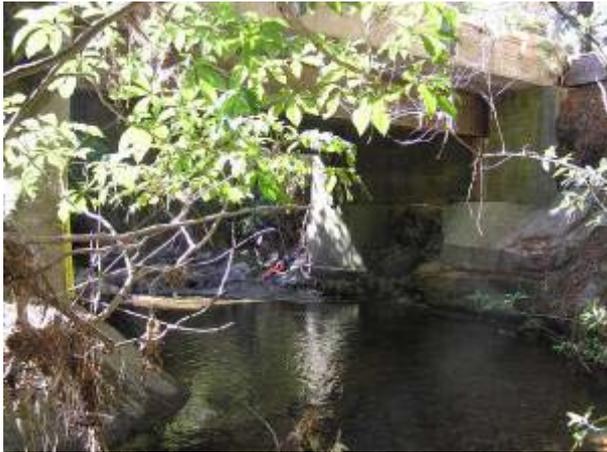
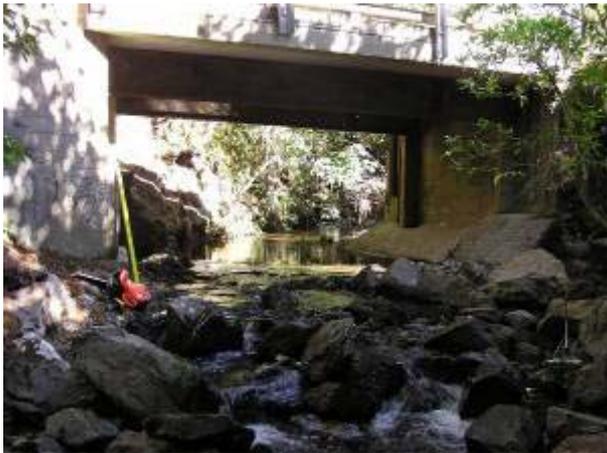
Below: Outlet. The drop through the boulders is no greater than any natural features visible nearby.

Potential as migratory barrier	Low
Priority for remediation	Low

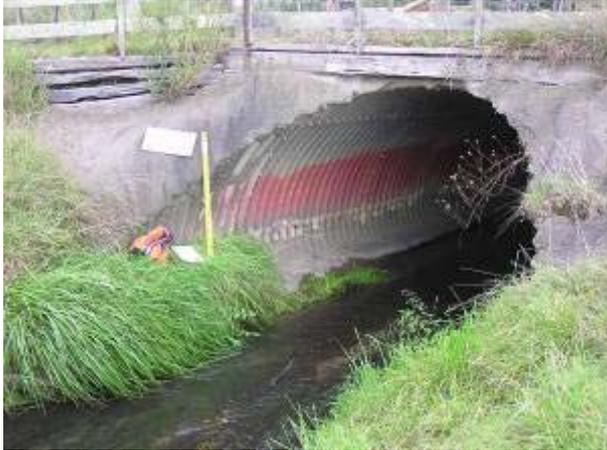
Above: Inlet

Potential as migratory barrier	Low
Priority for remediation	Low

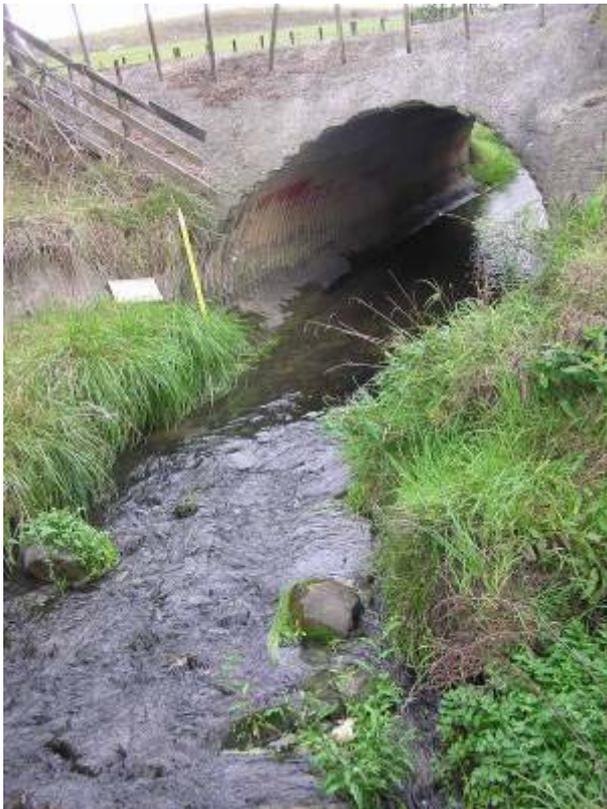
Below: Outlet

Site no.: S25:085659	
Location: Waoku Stream, Potts Rd, near Levin	
Easting	2708549
Northing	6065926
Date assessed	4/04/2008
Structure	culvert
Type	pipe
Construction	corrugated iron
Length	18.5 m
Diameter	3.55 m
Water depth (inlet)	0.09 m
Water depth (outlet)	0.11 m
Inlet cross section	flat
Outlet cross section	flat
If perched (height)	-
If perched (undercut)	-
Likely severity of barrier	None/minimal
Potential barriers known upstream	0
Potential barriers known downstream	0

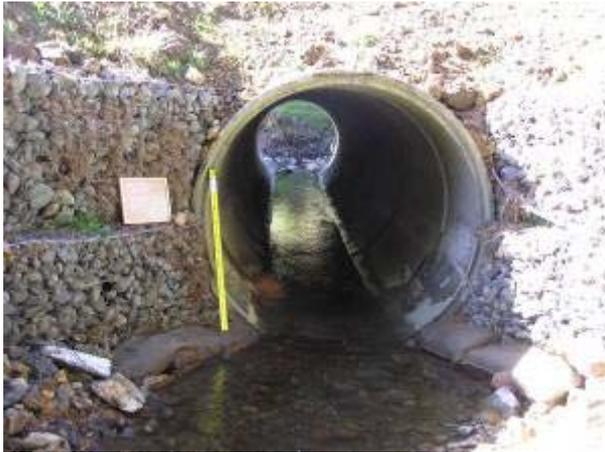
Above: Inlet

Potential as migratory barrier	Low
Priority for remediation	Low

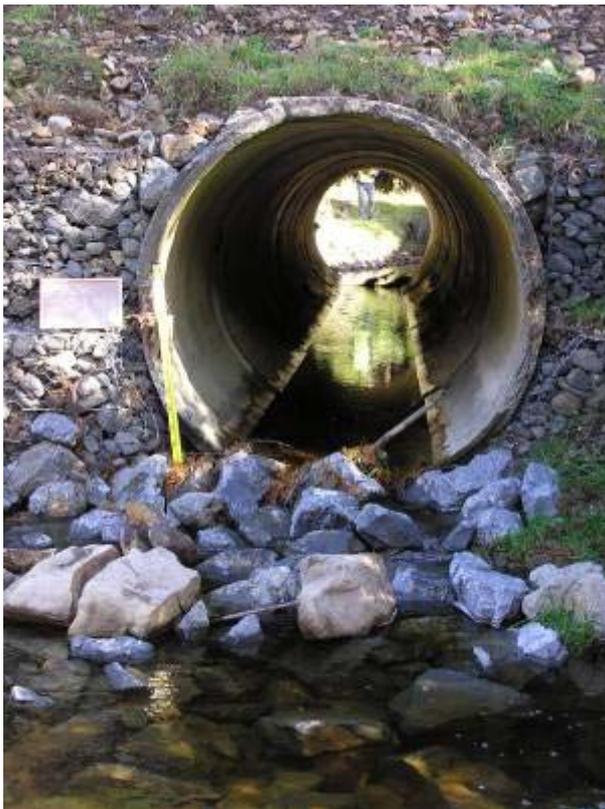
Below: Outlet

Site no.: S24:289749	
Location: unnamed stream, Scotts Rd, Gordon Kear Forest	
Easting	2728942
Northing	6074988
Date assessed	20/04/2008
Structure	culvert
Type	pipe
Construction	concrete
Length	16 m
Diameter	2.05 m
Water depth (inlet)	0.13 m
Water depth (outlet)	0.16 m
Inlet cross section	flat
Outlet cross section	flat
If perched (height)	-
If perched (undercut)	-
Likely severity of barrier	None/minimal
Potential barriers known upstream	6 (S24:287748, 284745, 284745clearing, 282744A+B, 280740)
Potential barriers known downstream	0

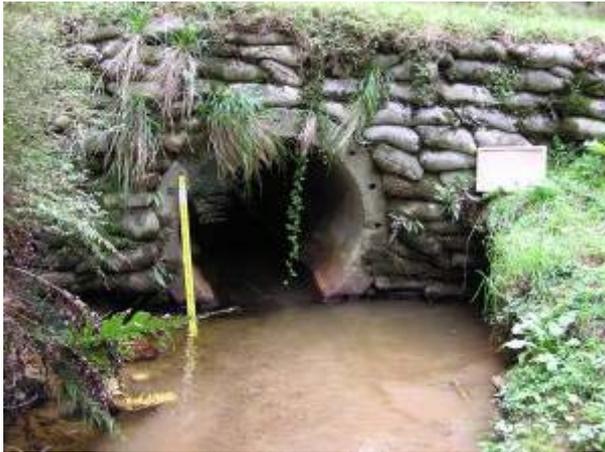
Above: Inlet

Potential as migratory barrier	Low
Priority for remediation	Low
