A preliminary assessment of potential barriers to fish migration in the Manawatu River catchment, North Island, New Zealand

A report prepared for Horizons Regional Council, June 2008

Dr Alex James and Dr Mike Joy

**Foundation of Research, Science & Technology
EnviroLink Contract Ref: 437-HZLC45**

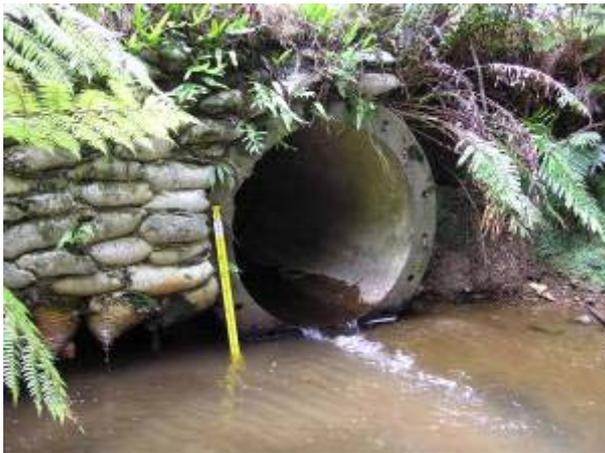
Below: Outlet.

Site no.: S24:287748	
Location: unnamed stream, Scotts Rd, Gordon Kear Forest	
Easting	2728741
Northing	6074869
Date assessed	20/04/2008
Structure	culvert
Type	pipe
Construction	concrete
Length	7.3 m
Diameter	1.3 m
Water depth (inlet)	0.1 m
Water depth (outlet)	0.04 m
Inlet cross section	flat
Outlet cross section	perched
If perched (height)	0.03 m
If perched (undercut)	0.65 m
Likely severity of barrier	None/minimal
Potential barriers known upstream	5 (S24:284745, 284745clearing, 282744A+B, 280740)
Potential barriers known downstream	1 (S24:287749)

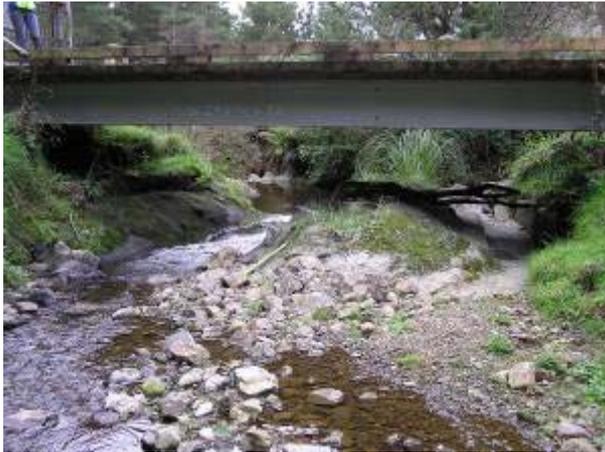
Above: Inlet

Potential as migratory barrier	Low
Priority for remediation	Low

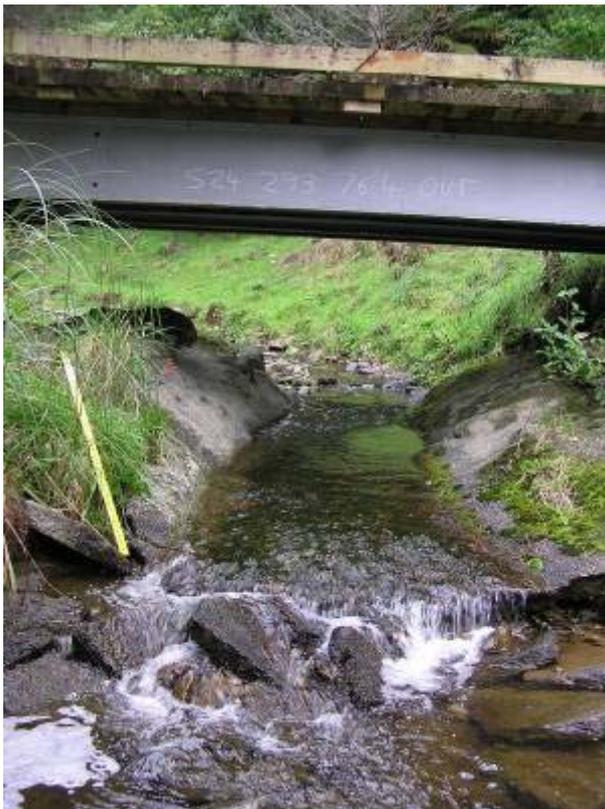
Below: Outlet.

Site no.: S24:293764	
Location: unnamed stream, Scotts Rd, Gordon Kear Forest entry gate	
Easting	2729353
Northing	6076491
Date assessed	20/04/2008
Structure	bridge
Type	box
Construction	concrete
Length	7.7 m
Diameter	2 m
Water depth (inlet)	0.11 m
Water depth (outlet)	0.04 m
Inlet cross section	flat
Outlet cross section	flat
If perched (height)	-
If perched (undercut)	-
Likely severity of barrier	None/minimal
Potential barriers known upstream	0
Potential barriers known downstream	0

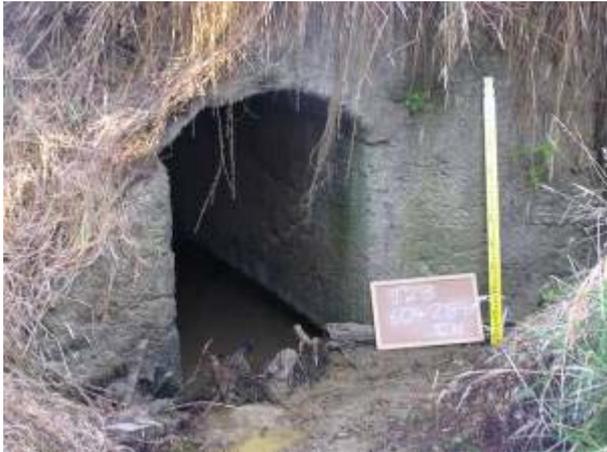
Above: Inlet with debris/mud dam.

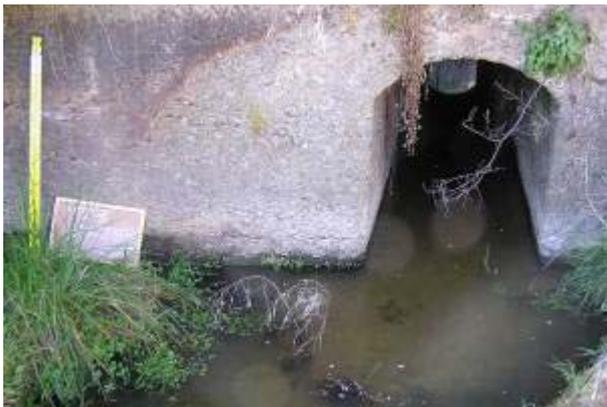
Below: Outlet

Site no.: T23:604284	
Location: Kainga Stream, Makoura Rd, near Utuwai.	
Easting	2760401
Northing	6128406
Date assessed	27/03/2008
Structure	culvert
Type	Box
Construction	concrete
Length	10.6
Diameter	0.6
Water depth (inlet)	0.20
Water depth (outlet)	0.33
Inlet cross section	pooled
Outlet cross section	pooled
If perched (height)	-
If perched (undercut)	-
Likely severity of barrier	High flow
Known barriers upstream	0
Known barriers downstream	0

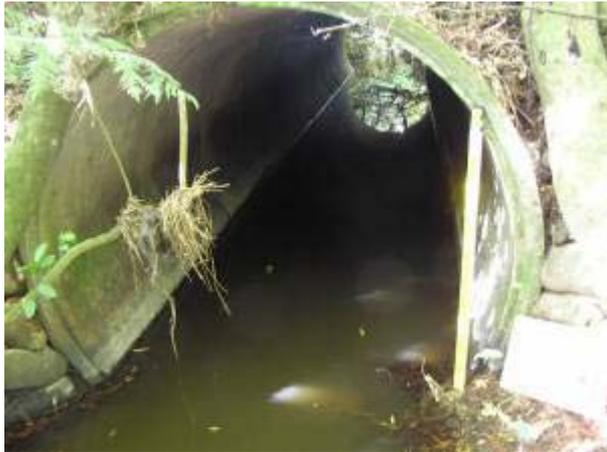
Above: Inlet

Potential as migratory barrier	Low
Priority for remediation	Low

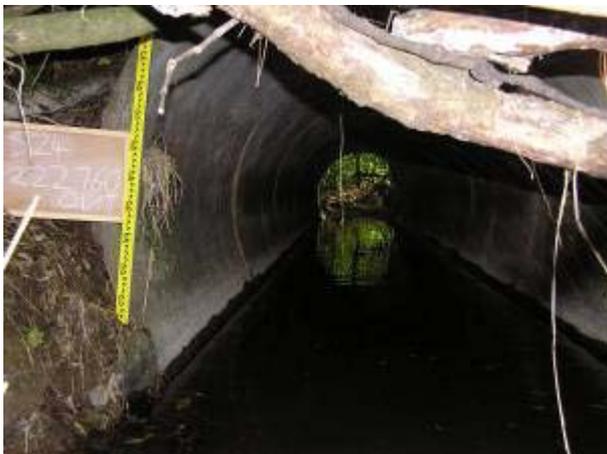
Below: Outlet

Site no.: S24:222760	
Location: Unnamed stream, Albert Rd, near Tokomaru	
Easting	2722291
Northing	6076002
Date assessed	3/04/2008
Structure	culvert
Type	pipe
Construction	concrete
Length	14.7
Diameter	2.05
Water depth (inlet)	0.41
Water depth (outlet)	0.42
Inlet cross section	flat
Outlet cross section	flat
If perched (height)	-
If perched (undercut)	-
Likely severity of barrier	High flows
Known barriers upstream	0
Known barriers downstream	1 (S24:213760)

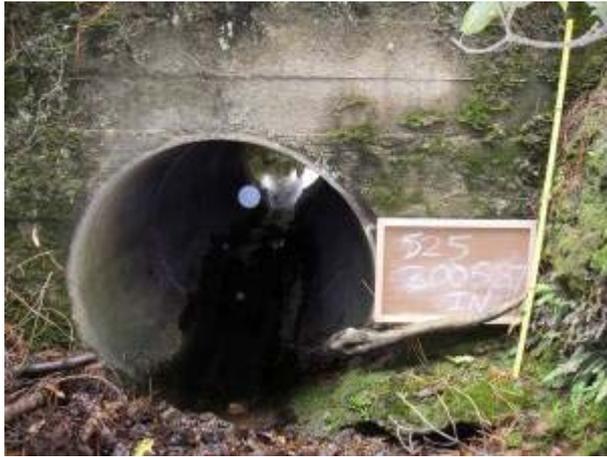
Above: Inlet

Potential as migratory barrier	Low
Priority for remediation	Low

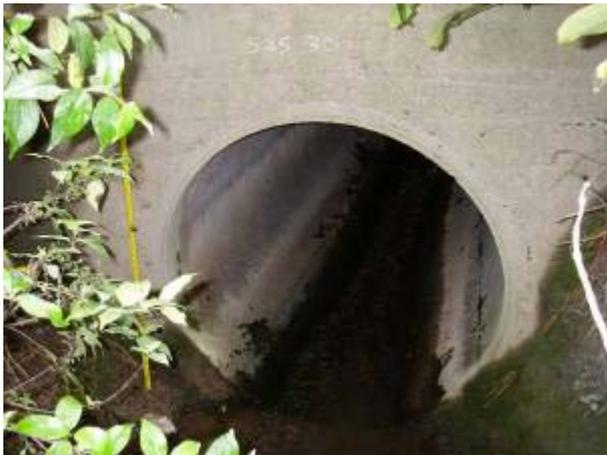
Below: Outlet

Site no.: S25:300587	
Location: unnamed stream, Putara Rd, near Eketahuna	
Easting	2730015
Northing	6058727
Date assessed	18/02/2008
Structure	culvert
Type	pipe
Construction	concrete
Length	6.1 m
Diameter	0.86 m
Water depth (inlet)	0.03 m
Water depth (outlet)	0.055 m
Inlet cross section	flat
Outlet cross section	pooled
If perched (height)	-
If perched (undercut)	-
Likely severity of barrier	Low flows
Known barriers upstream	0
Known barriers downstream	0

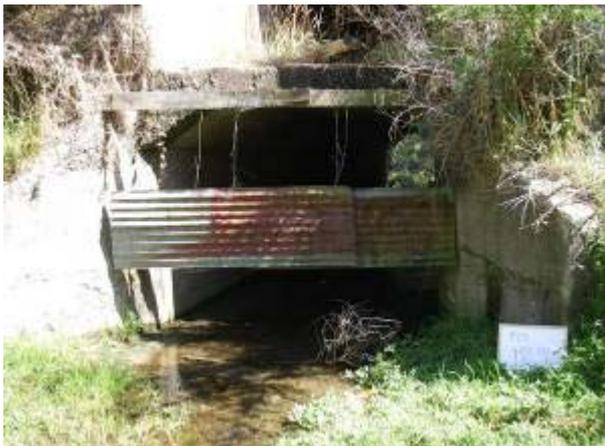
Below: Outlet

Site no.: T23:483114	
Location: Unnamed stream, Pohangina, Pohangina Valley West Rd	
Easting	2748374
Northing	6111460
Date assessed	30/01/2008
Structure	culvert
Type	box
Construction	concrete
Length	15.2 m
Diameter	2.4 m
Water depth (inlet)	0.09 m
Water depth (outlet)	0.05 m
Inlet cross section	flat
Outlet cross section	flat
If perched (height)	-
If perched (undercut)	-
Likely severity of barrier	Low flows
Potential barriers known upstream	1 (T23:485117)
Potential barriers known downstream	0

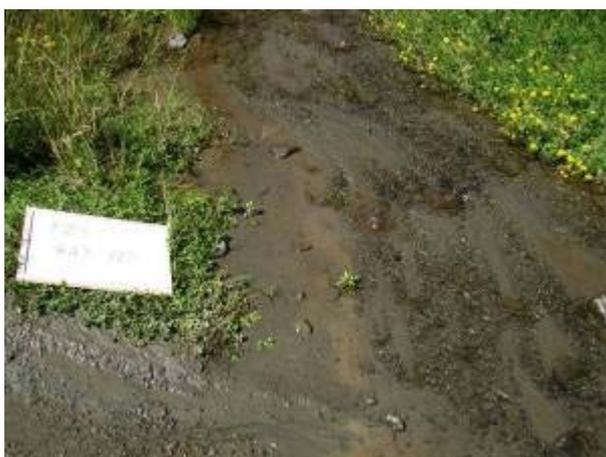
Below: Outlet

Site no.: T23:485117	
Location: Unnamed stream, Kuku Rd ford, Pohangina	
Easting	2748419
Northing	6111915
Date assessed	30/01/2008
Structure	ford
Type	ford
Construction	natural substrate
Length	4 m
Diameter	1.15 m
Water depth (inlet)	0.05 m
Water depth (outlet)	0.04 m
Inlet cross section	flat
Outlet cross section	flat
If perched (height)	-
If perched (undercut)	-
Likely severity of barrier	Low flows
Potential barriers known upstream	0
Potential barriers known downstream	1 (T23:483111)

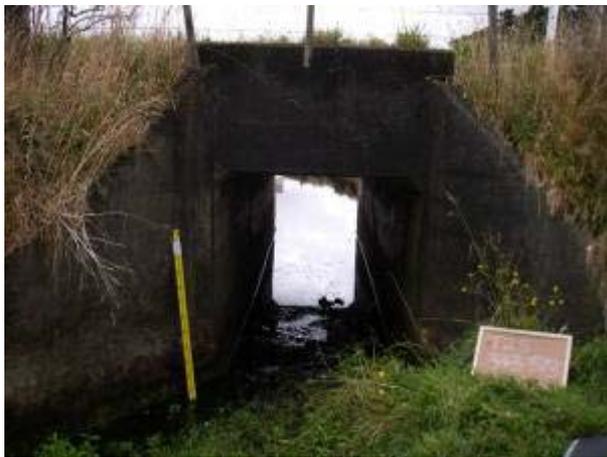
Above: Inlet

Potential as migratory barrier	Low
Priority for remediation	Low

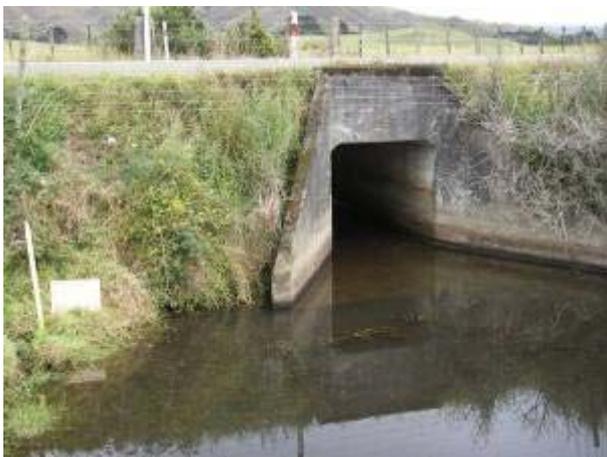
Below: Pooled outlet

Site no.: T25:343573	
Location: Unnamed stream, South Rd, near Eketahuna	
Easting	2734338
Northing	6057398
Date assessed	18/02/2008
Structure	culvert
Type	box
Construction	concrete
Length	7.75 m
Diameter	1.5 m
Water depth (inlet)	0.03 m
Water depth (outlet)	0.10 m
Inlet cross section	flat
Outlet cross section	pooled
If perched (height)	-
If perched (undercut)	-
Likely severity of barrier	Low flows
Potential barriers known upstream	0
Potential barriers known downstream	0

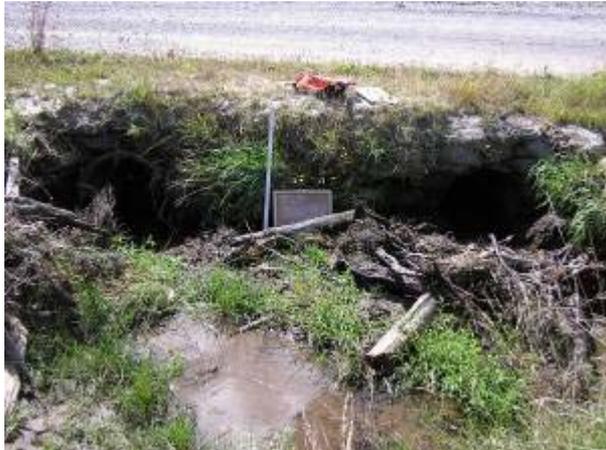
Potential as migratory barrier	Low
Priority for remediation	Low

Above: Inlet. Note the debris that had to be removed to access the second pipe.

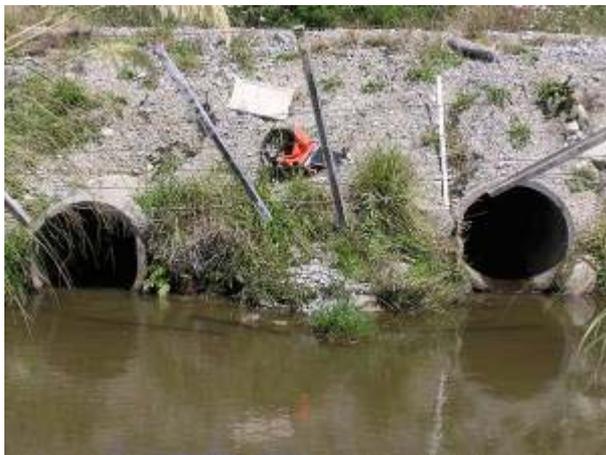
Below: Outlet

Site no.: T25:320650	
Location: Unnamed stream, Mangaraupiu Rd, near Eketahuna	
Easting	2732051
Northing	6065070
Date assessed	26/02/2008
Structure	culvert
Type	double pipe
Construction	concrete
Length	10 m
Diameter	0.74 m
Water depth (inlet)	0.02/0.07 m
Water depth (outlet)	0.02/0.19 m
Inlet cross section	flat
Outlet cross section	pooled
If perched (height)	-
If perched (undercut)	-
Likely severity of barrier	Low flows
Potential barriers known upstream	0
Potential barriers known downstream	0

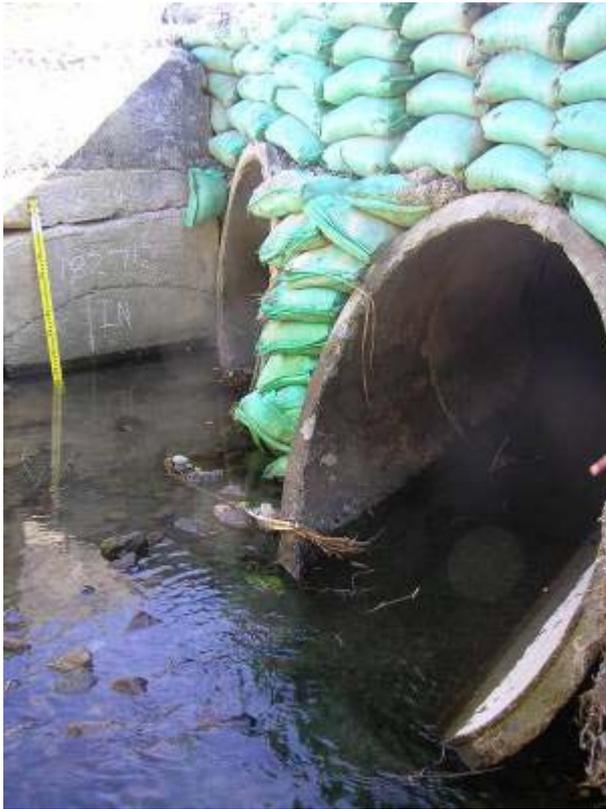
Above: Inlet

Potential as migratory barrier	Low
Priority for remediation	Low

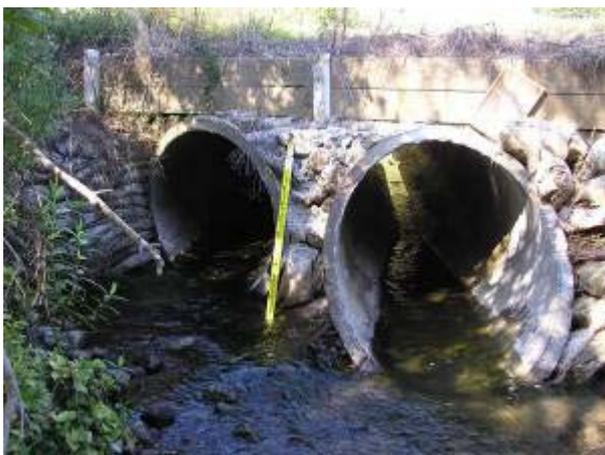
Below: Outlet

Site no.: S24:182712	
Location: Unnamed stream, Kingston Rd, north of Shannon	
Easting	2718266
Northing	6071293
Date assessed	3/04/2008
Structure	culvert
Type	double pipe
Construction	concrete
Length	13.56 m
Diameter	1.2 m
Water depth (inlet)	0.11/0.01 m
Water depth (outlet)	0.11/0.11 m
Inlet cross section	flat
Outlet cross section	flat
If perched (height)	-
If perched (undercut)	-
Likely severity of barrier	Low flows
Potential barriers known upstream	1 (S24:183711)
Potential barriers known downstream	1 (S24:182713)
