NEW ZEALAND FRESHWATER FISHERIES MISCELLANEOUS REPORT NO. 8

RISK ASSESSMENT REPORT ON PROPOSED
RESTOCKING OF PARTS OF THE
AKA AKA DRAINAGE SYSTEM

APRIL
1989

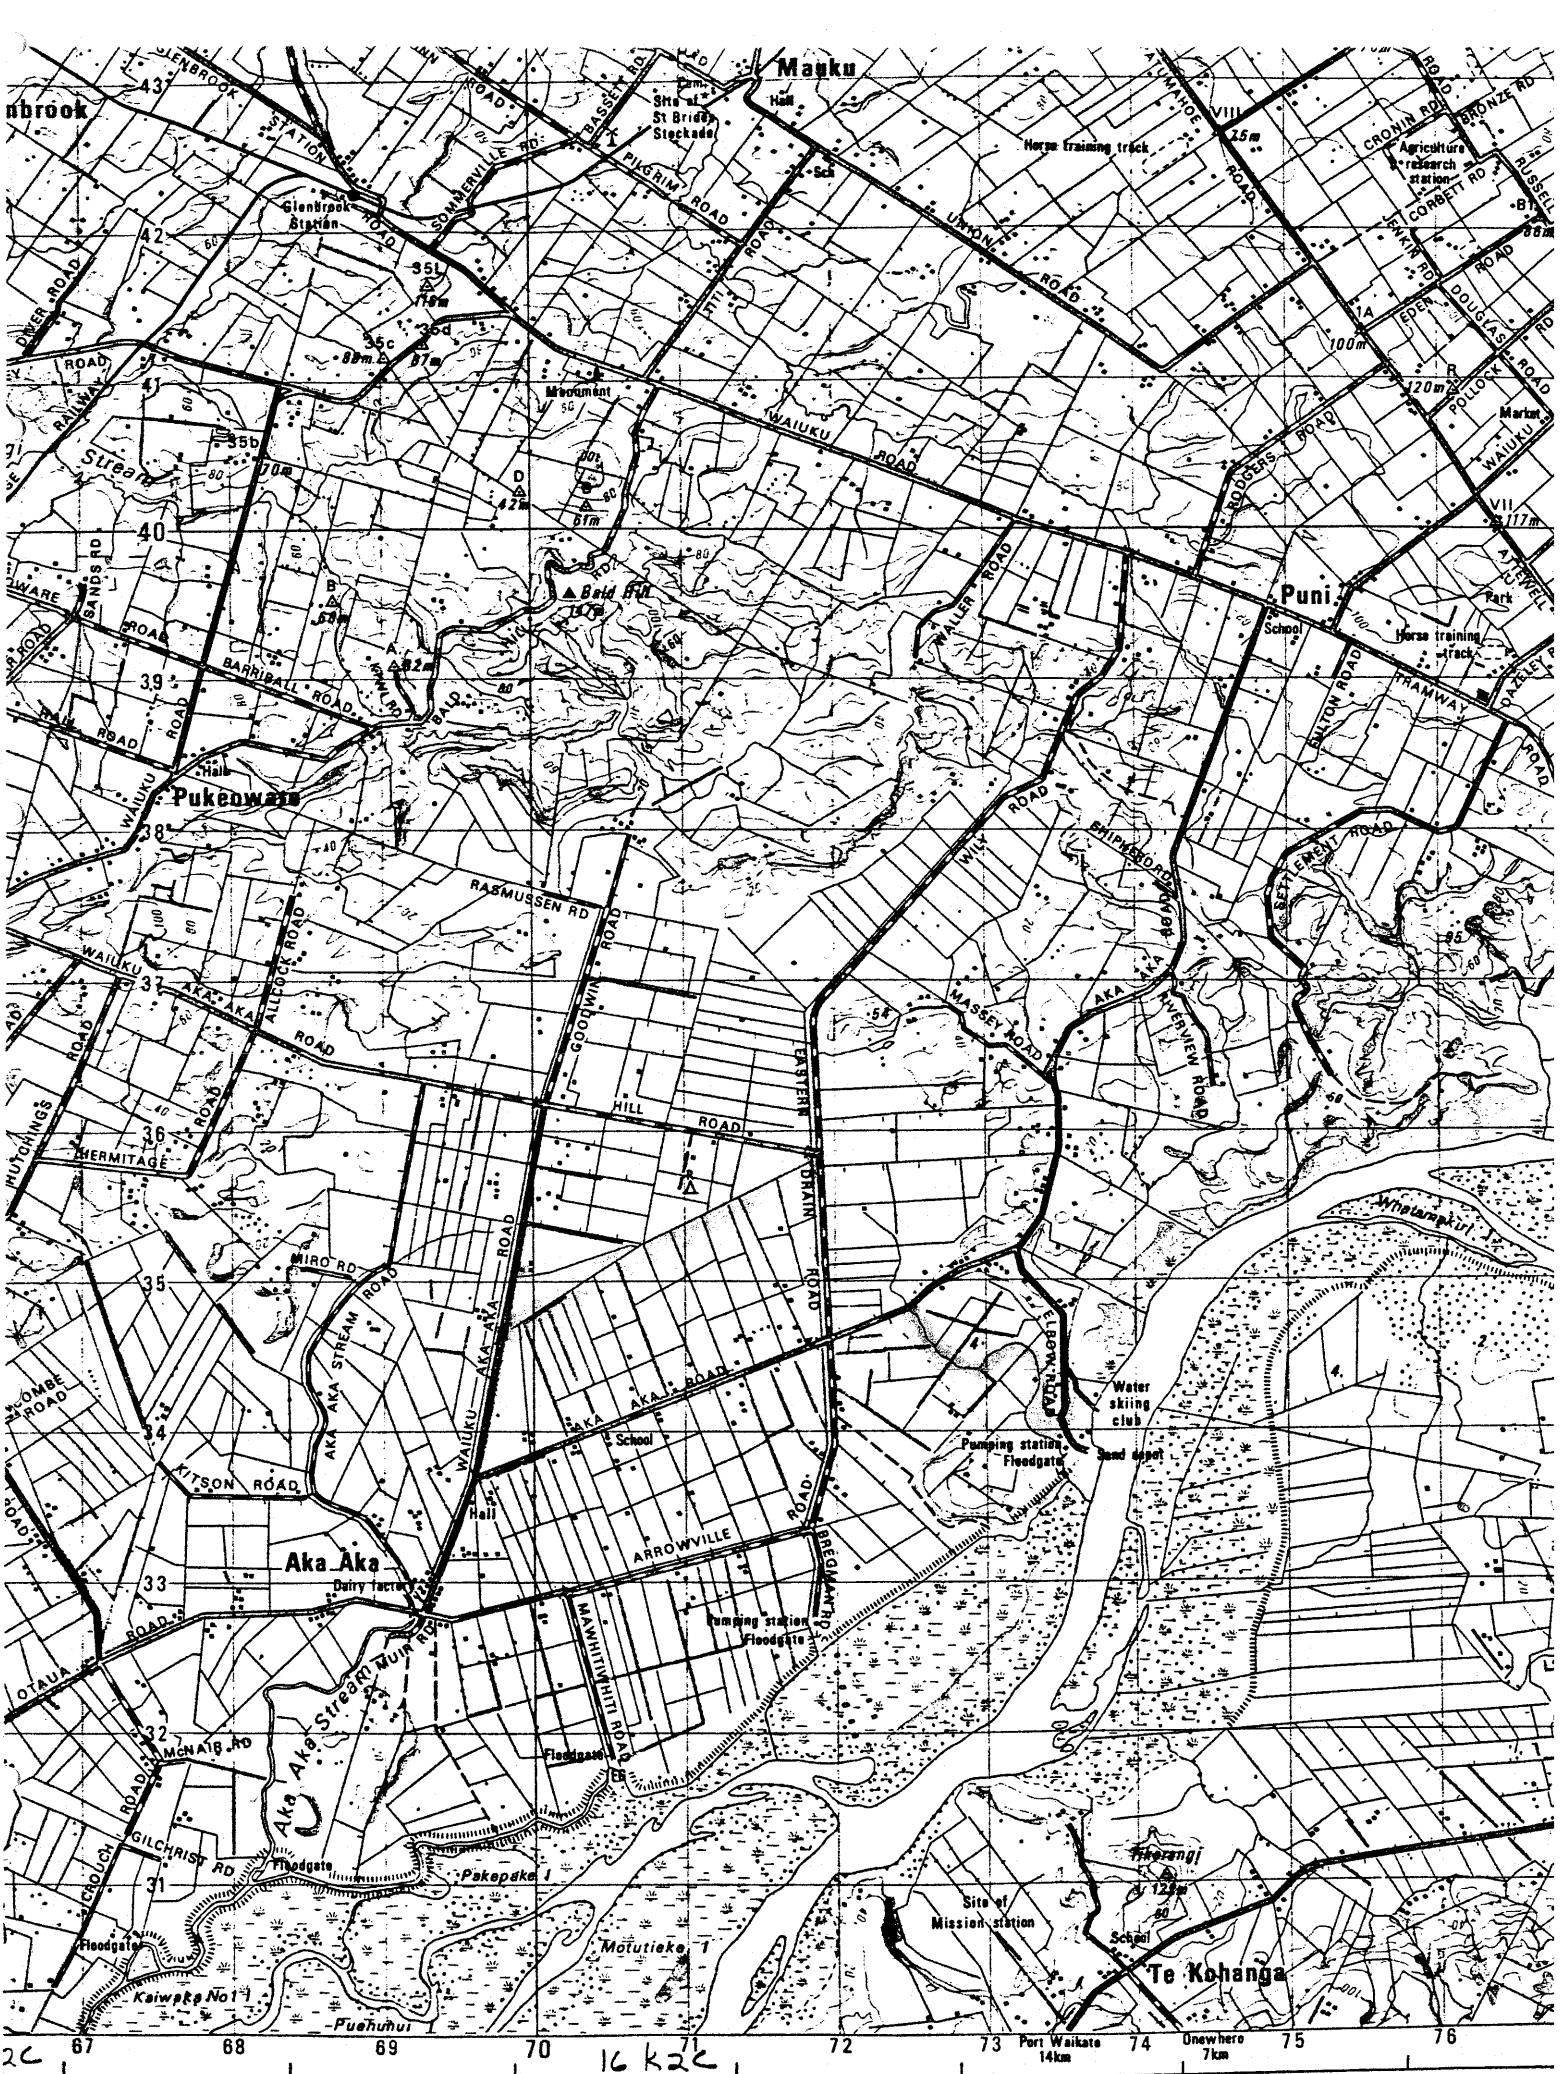
Trials in the Aka Aka area began in 1980 when MAF stocked a 2 km section of the Mangawhero Stream (Map 1). MAF released more grass carp into McCarthy's and the Eastern drains in 1983 and 1984. At the beginning of 1984, some fish escaped into the Waikato River via badly fitting and poorly constructed screens.
